SANTA ANA WATERSHED PROJECT AUTHORITY

REGULAR COMMISSION MEETING TUESDAY, OCTOBER 16, 2018 – 9:30 A.M.

A. INLAND EMPIRE BRINE LINE REACH 4D REHABILITATION WORK PLAN (CM#2018.106)..... 19

Reach 4D Manned Entry Condition Assessment

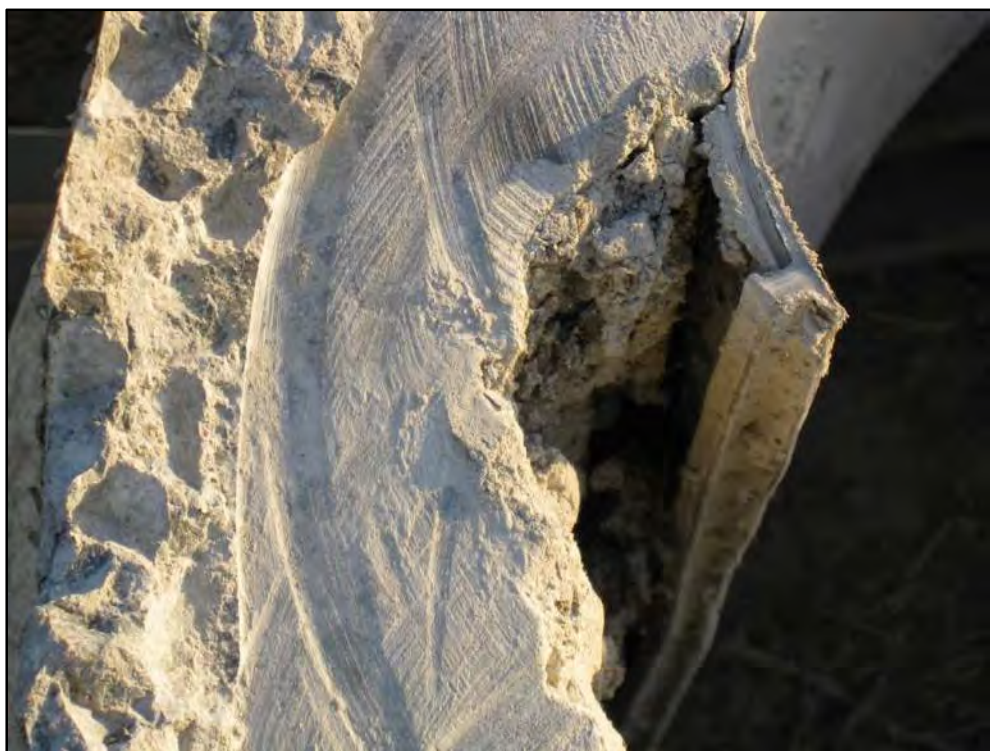
Figure 2: Concrete deterioration and uplifting of T-Lock liner in section of RCP removed in 2011. Photo Courtesy of SAWPA.

In 2011, approximately 1,054 feet of RCP was abandoned or removed and replaced with 895 feet of 360-degree PVC lined RCP. The unlined portion of the removed pipeline exhibited concrete deterioration and uplifting of the T-Lock lining at the liner termination interface (Figure 2). It is thought that low flows during initial years of operation likely exposed the liner/concrete termination point allowing H₂S corrosion of the unlined concrete and uplifting of the T-Lock Liner. However, this theory has not been proven.

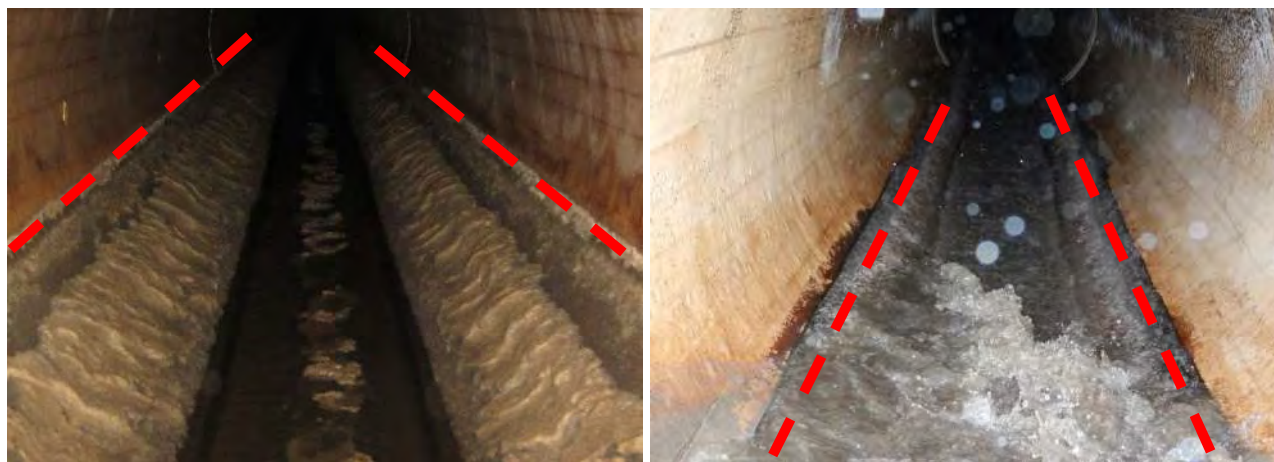
Figure 7: Typical Water Level (dashed red line) Indicated by Slime Layer (Left). Typical Water Level (dashed red line) in Steep Slope Between MAS 4D-0160 and 4D-0150 (Right).

These water level observations confirm the estimated water levels during the current average and peak dry weather flows listed in Table 2 and Table 3, respectively. With a slope of 0.0600, the water level during current average and peak dry weather flows is 5.13-inches and 5.39-inches, respectively. With the liner termination approximately 6.1-inches above the pipe invert, the water level is typically 0.7 to 1-inch below the liner in this segment. The manned entry condition assessment tests indicate the steep influent pipe at MAS 4D-0150 is in a worse condition than the

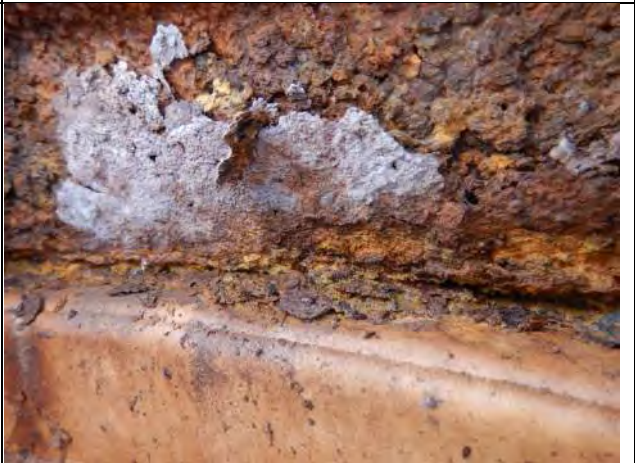
Observations:		
<p>A</p>	<p>Rim had moderate corrosion (exfoliation). Liner termination was in good condition.</p>

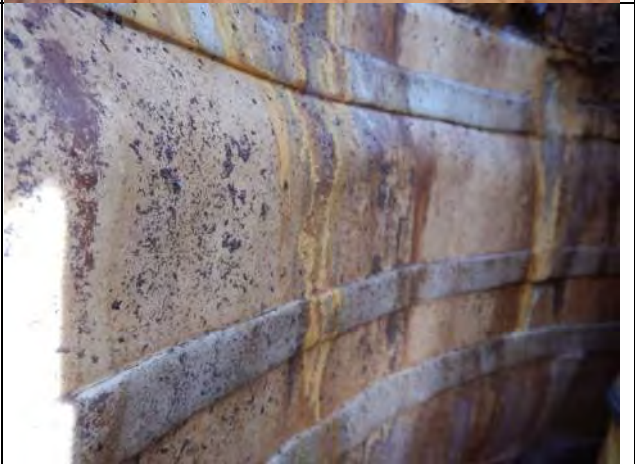
<p>B</p>	<p>Chimney liner was in good condition.</p>

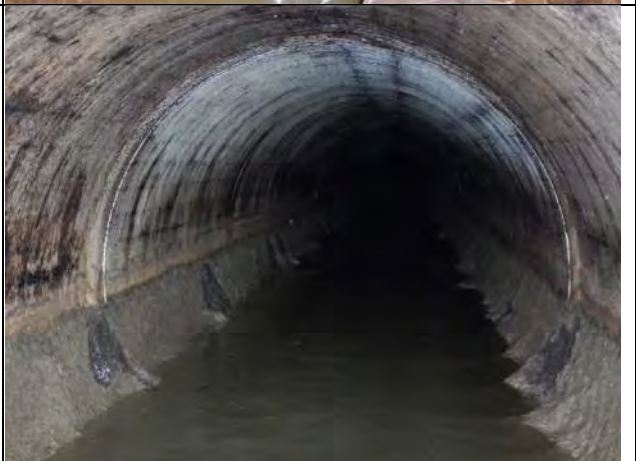
<p>E</p>	<p>Effluent pipe liner had minor blisters.</p>

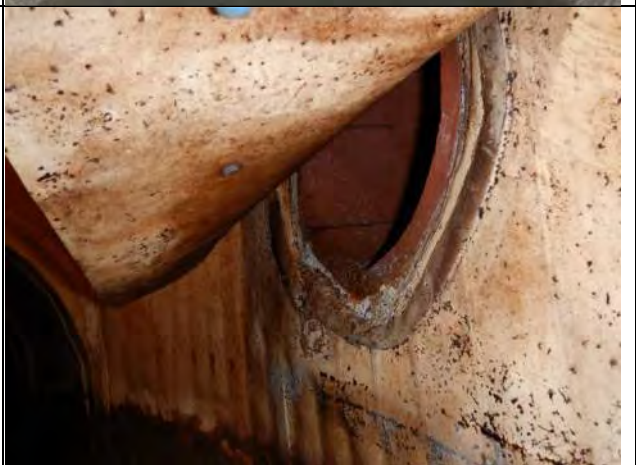
<p>F</p>	<p>Lateral with gas flap. Liner termination at pipe penetration was in good condition, yet had minor encrustation. Flap appeared to be attached and operable.</p>

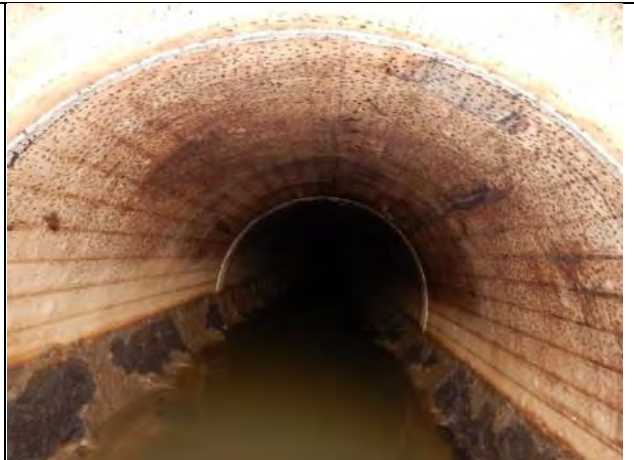
<p>G</p>	<p>Influent pipe liner had minor blisters.</p>

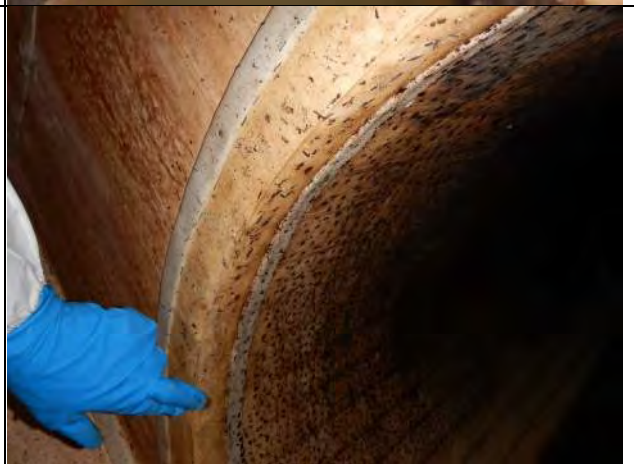
<p>H</p>	<p>Liner at pipe connections in good condition.</p>

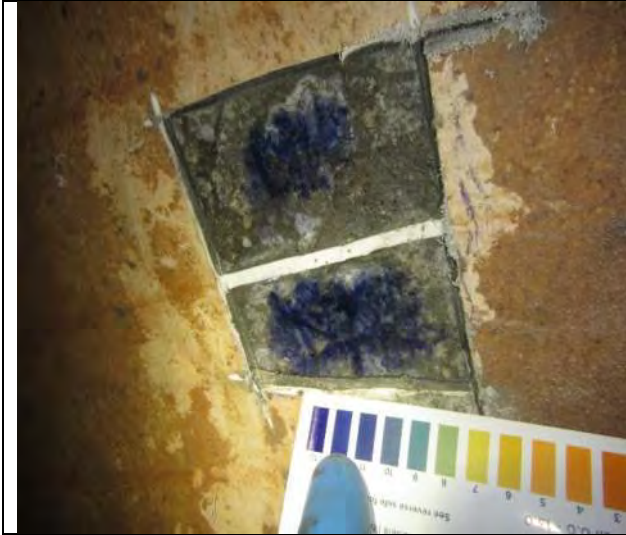
Influent pipe liner cut at crown (11:00)

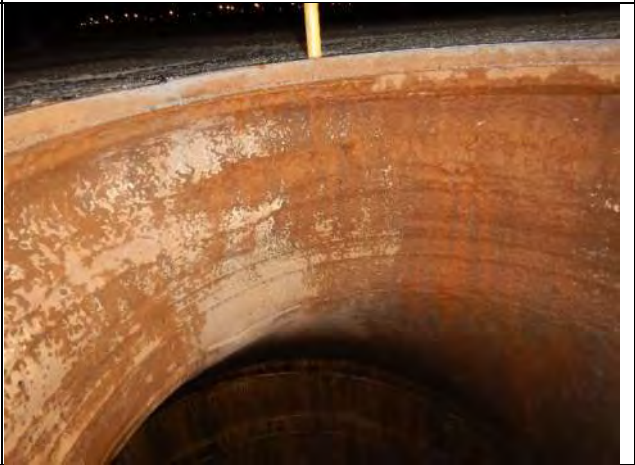
Observations:		
A	Rim and liner termination was in good condition.

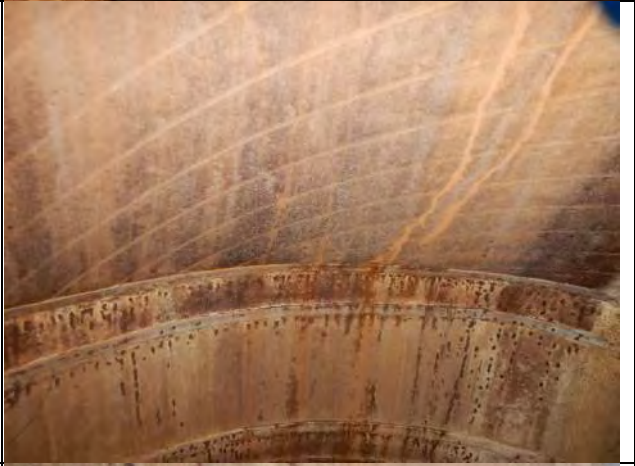
B	Chimney liner was in good condition.

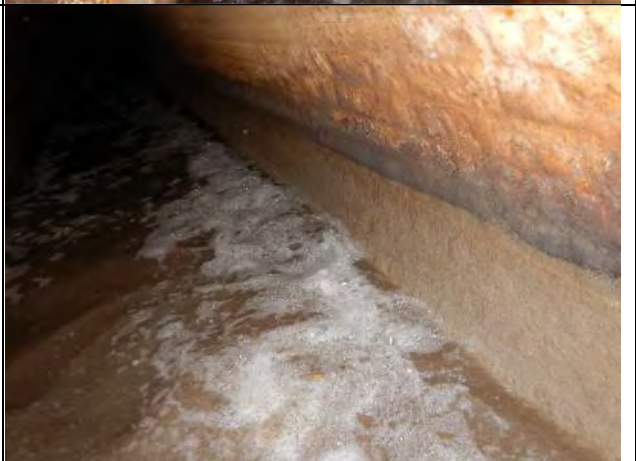
<p>E</p>	<p>Miner liner blisters on effluent pipe. The liner termination was undermined and unattached. Slime layer appeared to be up to the typical waterline.</p>

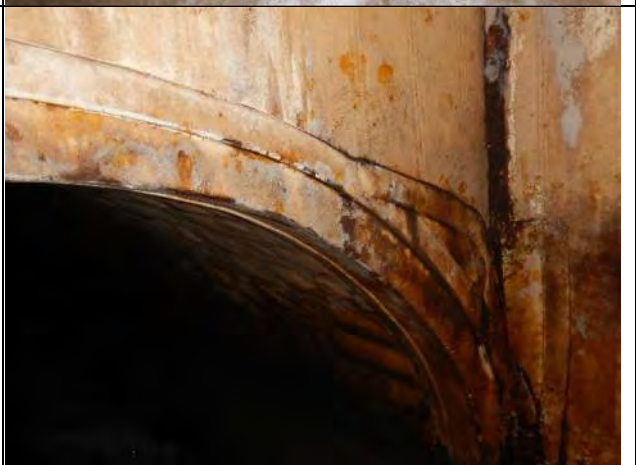
<p>F</p>	<p>Liner at pipe connections was in good condition.</p>

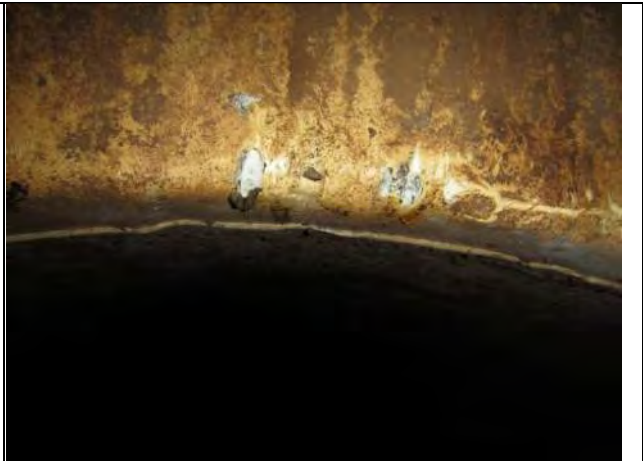
<p>D</p>	<p>Cut in liner at effluent pipe crown. Cuts appeared to be from a CCTV camera cable.</p>

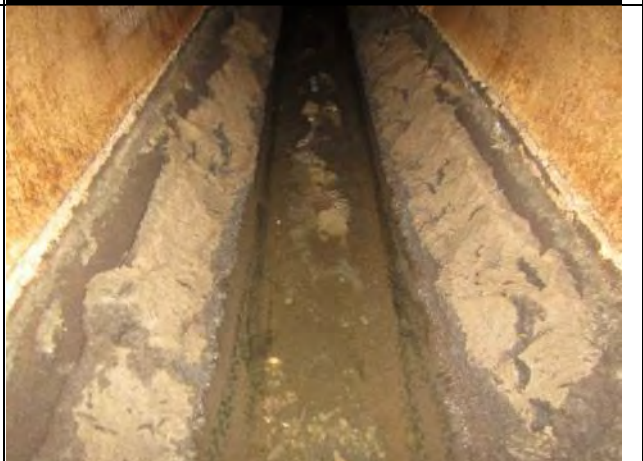
<p>E</p>	<p>CCTV crawler camera tracks observed in slime.</p>

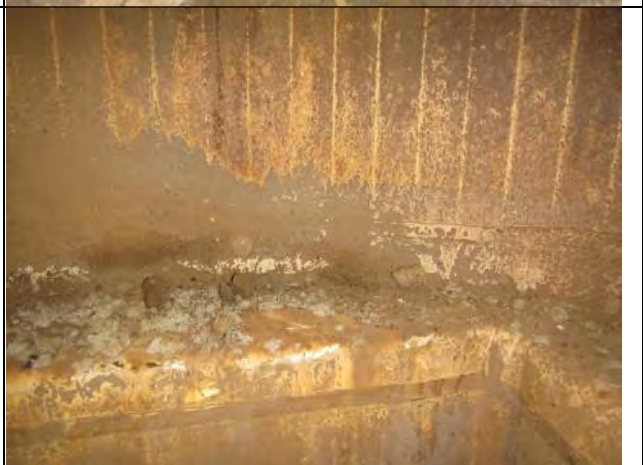
<p>F</p>	<p>Liner was not embedded in bench, yet still covered concrete surface.</p>

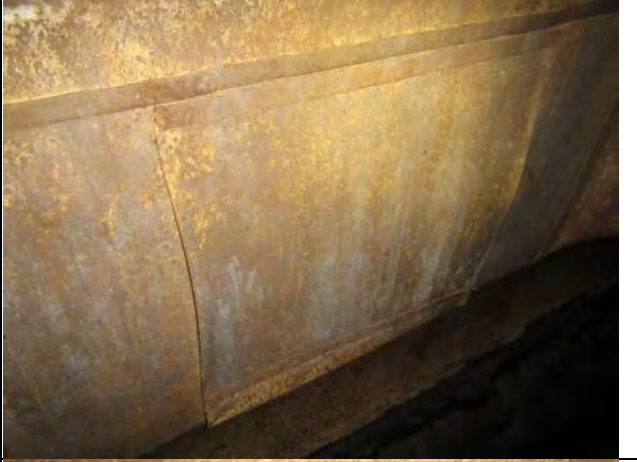
<p>G</p>	<p>Lateral with gas flap. Liner termination at pipe penetration was in good condition. Flap appeared to be attached and operable.</p>

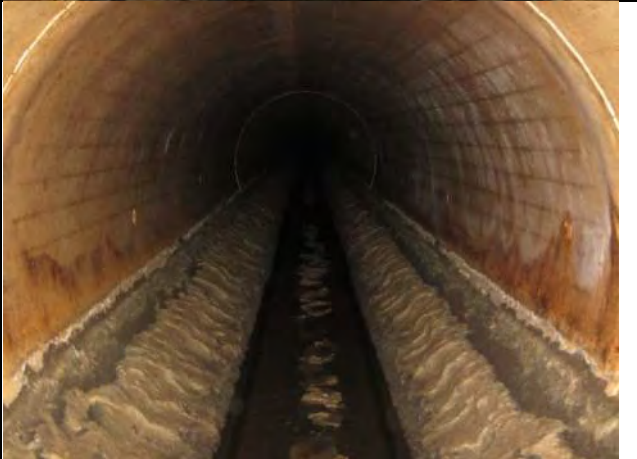
<p>I</p>	<p>Influent pipe had minor liner blisters.</p>

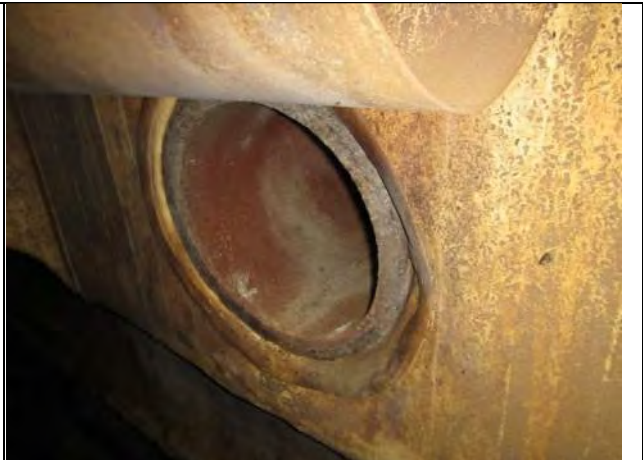
<p>J</p>	<p>Lateral with gas flap. Liner termination at pipe penetration was in good condition. Flap appeared to be attached and operable.</p>

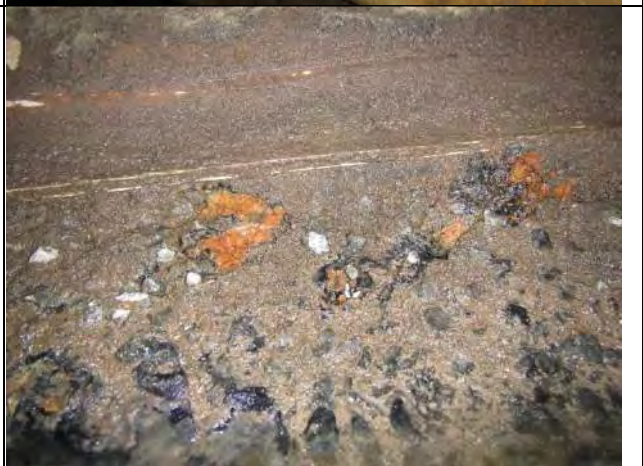
<p>K</p>	<p>Corrosion staining evidence of embedded reinforcement corrosion. Exposed aggregate at unlined concrete channel.</p>

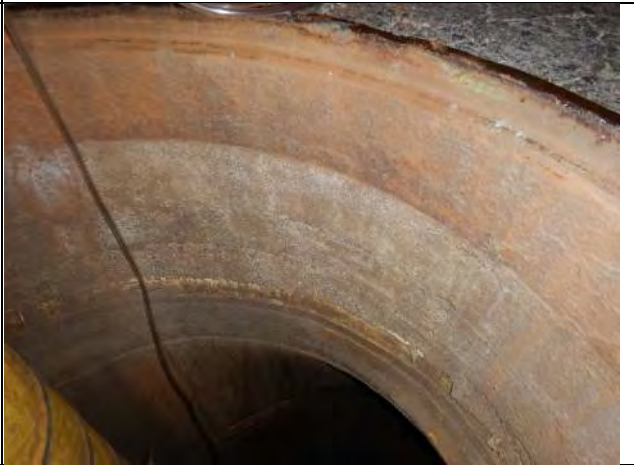
Observations:		
A	Rim was in good condition.

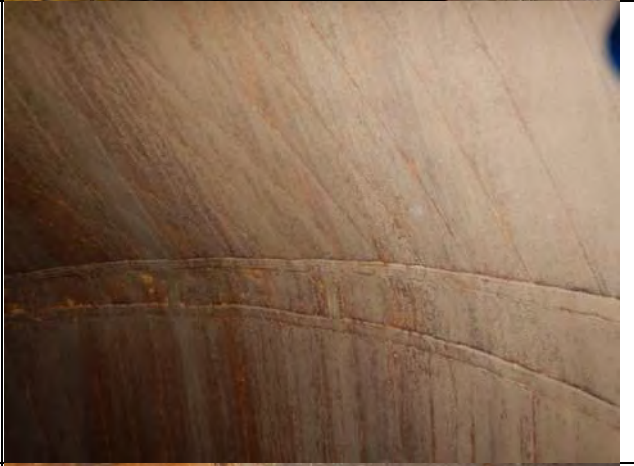
B	Liner at chimney was in good condition.

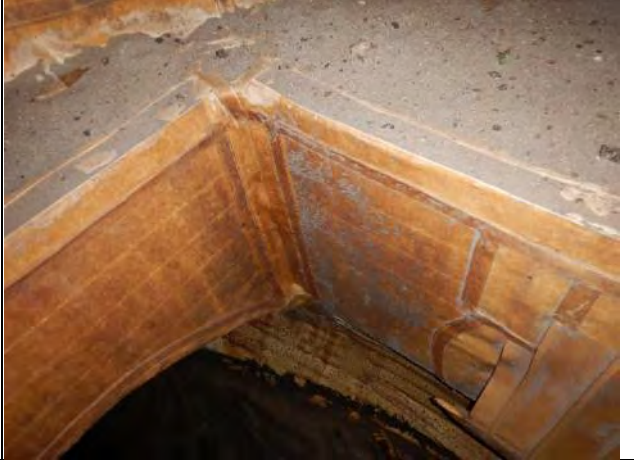
C	Liner at bench was in good condition.

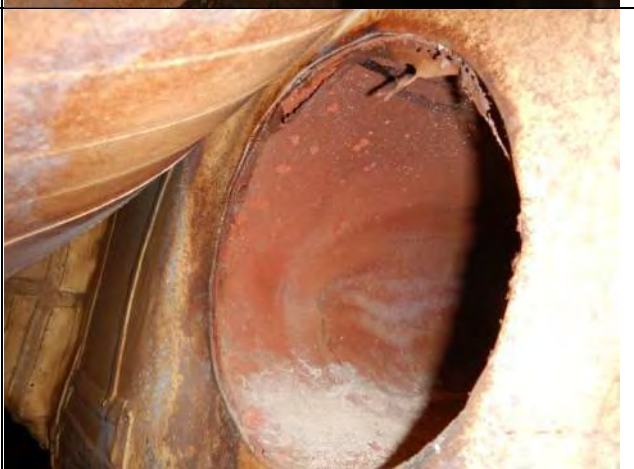
<p>F</p>	<p>Lateral with gas flap. Liner termination at pipe connection was in good condition. Flap appeared to be attached and operable.</p>

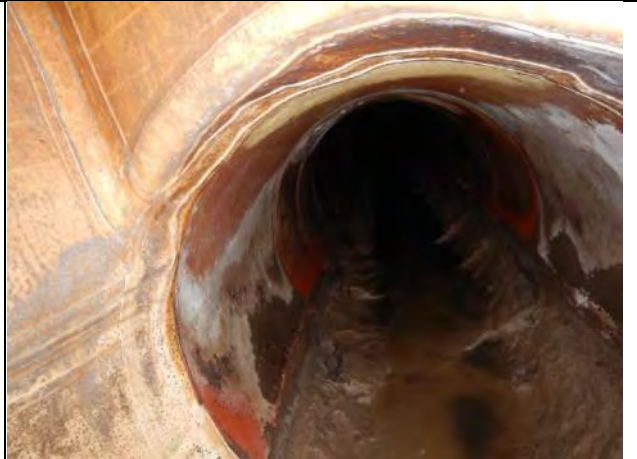
<p>G</p>	<p>Influent pipe was constructed of vitrified clay. Liner at pipe connection was in good condition. Slime layer appeared to be up to the typical waterline.</p>

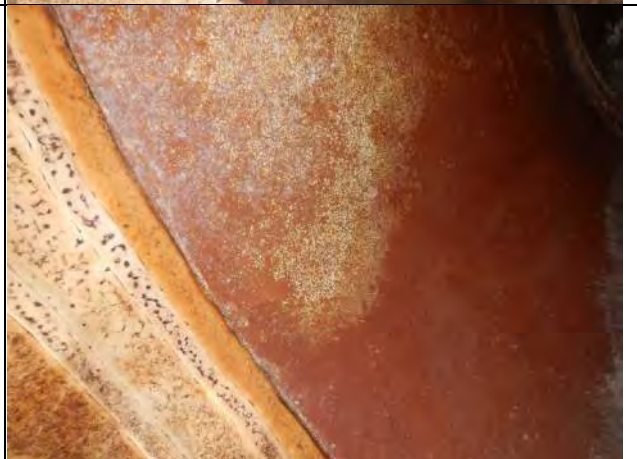
<p>H</p>	<p>Liner termination at vitrified clay pipe connection was in good condition.</p>

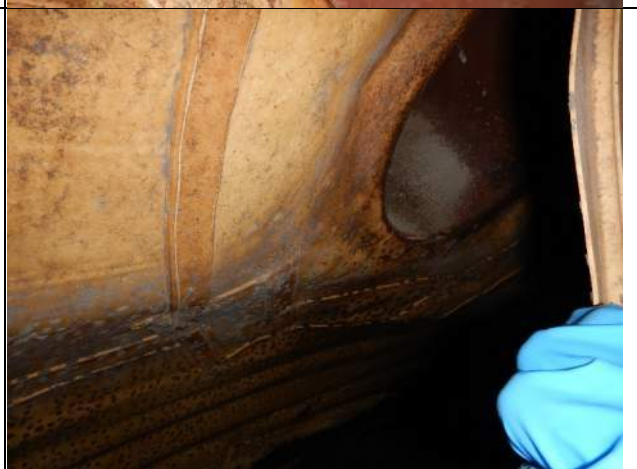
<p>I</p>	<p>Lateral with gas flap. Liner termination at pipe connection was in good condition.</p>

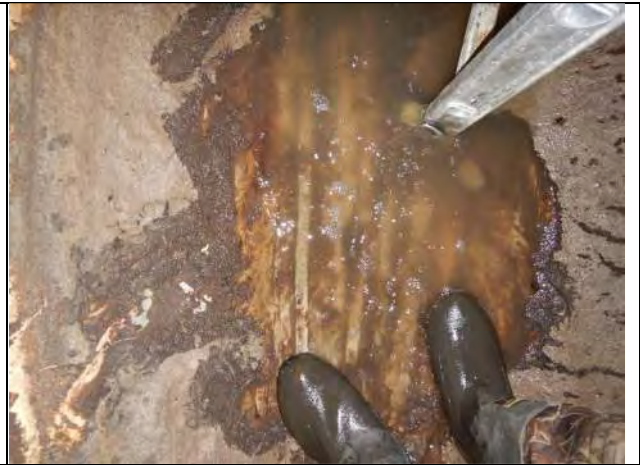
J	Channel liner was in good condition.

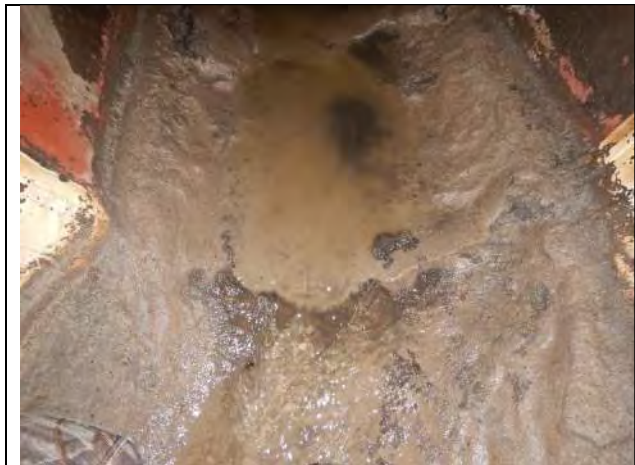
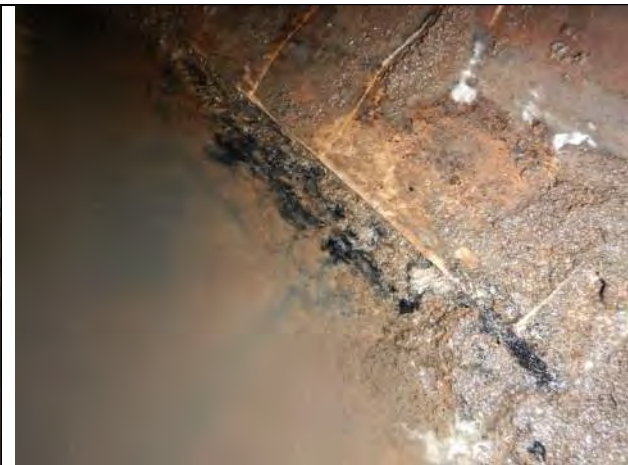
Influent pipe liner termination in good condition	Effluent pipe liner termination in good condition

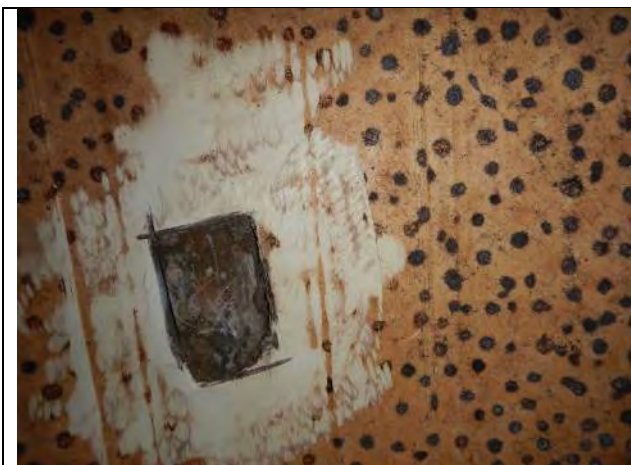
Effluent pipe liner cut at crown (12:00)
