SANTA ANA WATERSHED
PROJECT AUTHORITY

Reach IV Condition Assessment Status Update

PA 24 Committee
Item No. 6.A
Daniel Vasquez
Manager of Operations
July 2, 2024

Inland Empire Brine Line Reach IV-D Condition Assessment

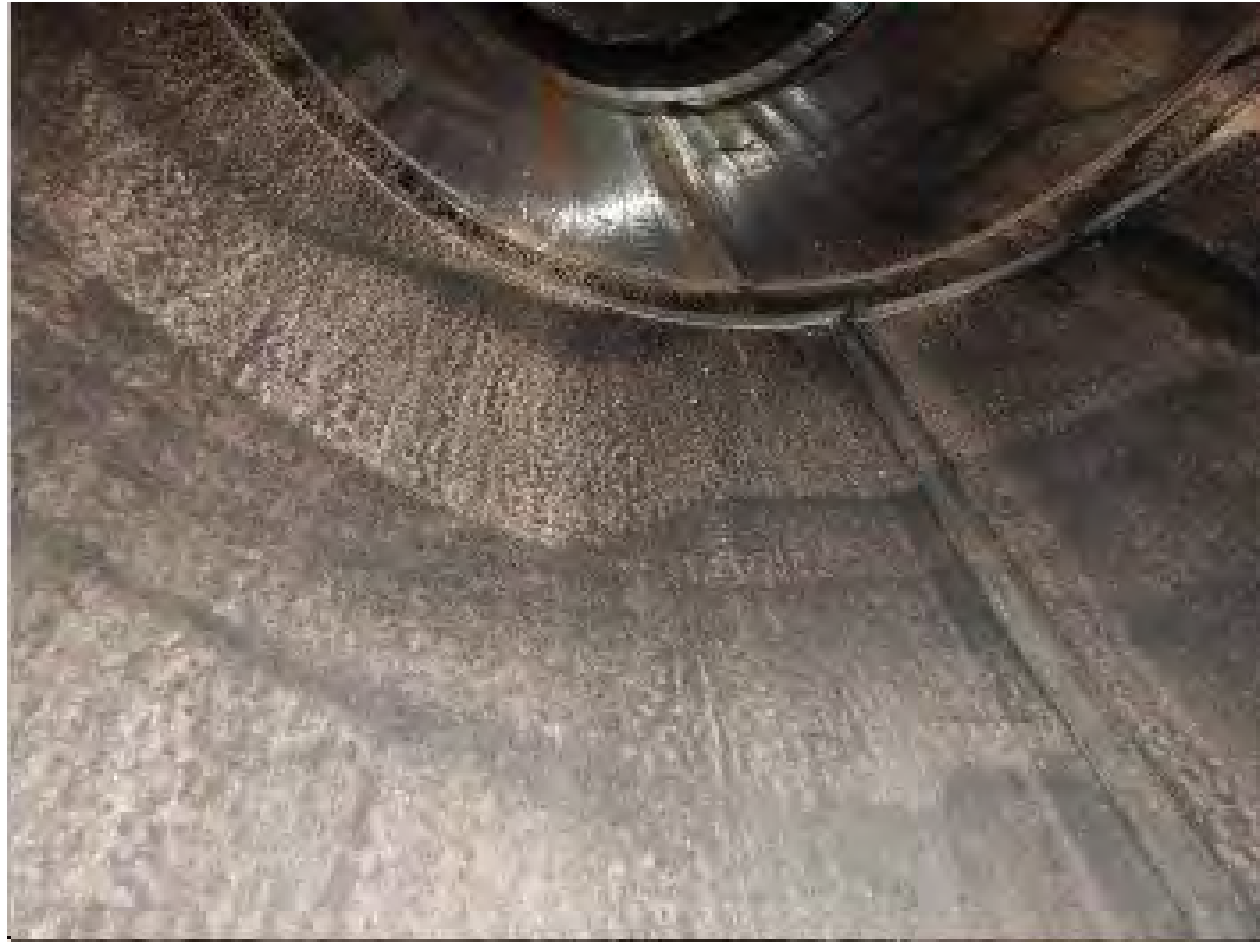
Interior of MAS in good condition

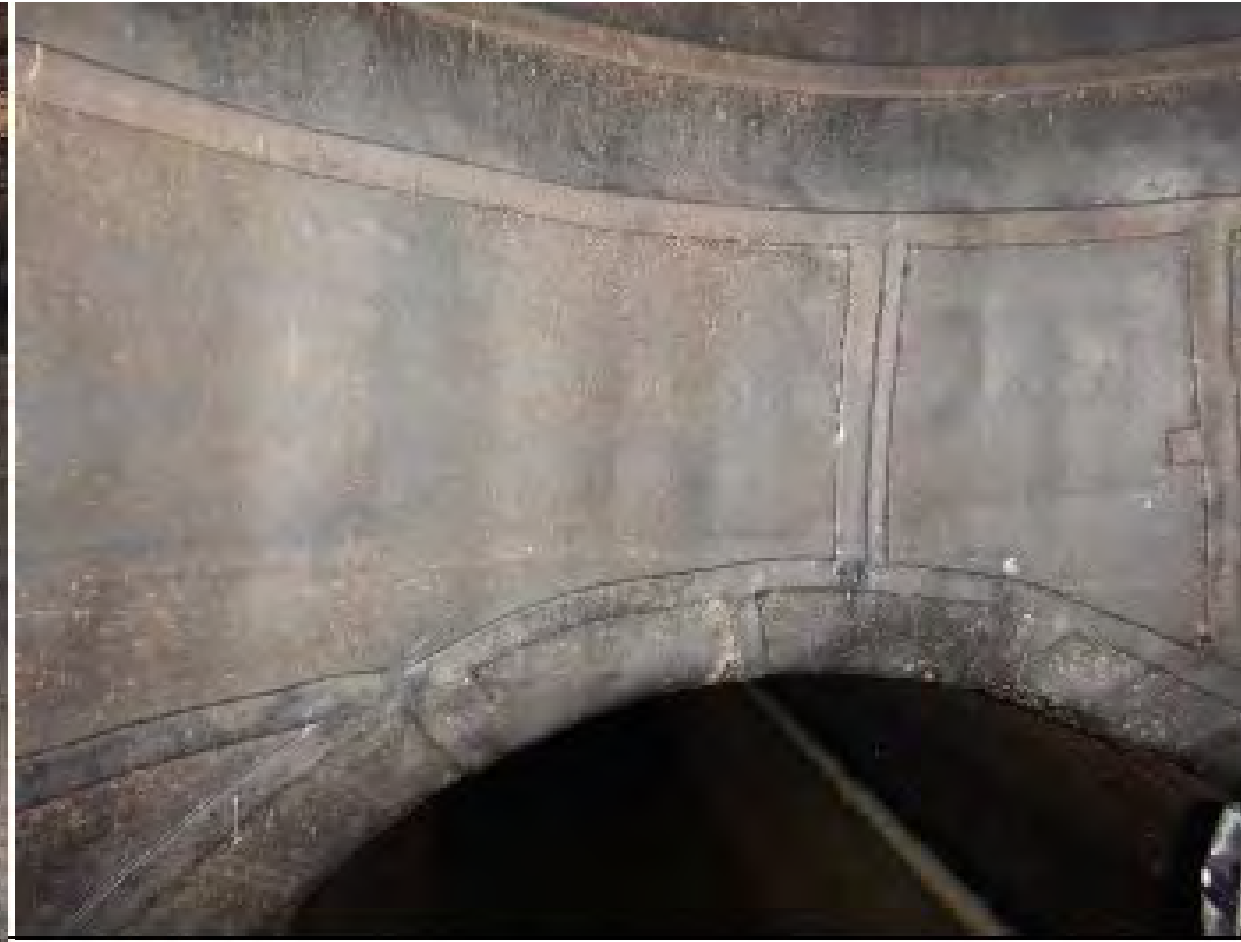
Liner Termination at influent pipe good condition

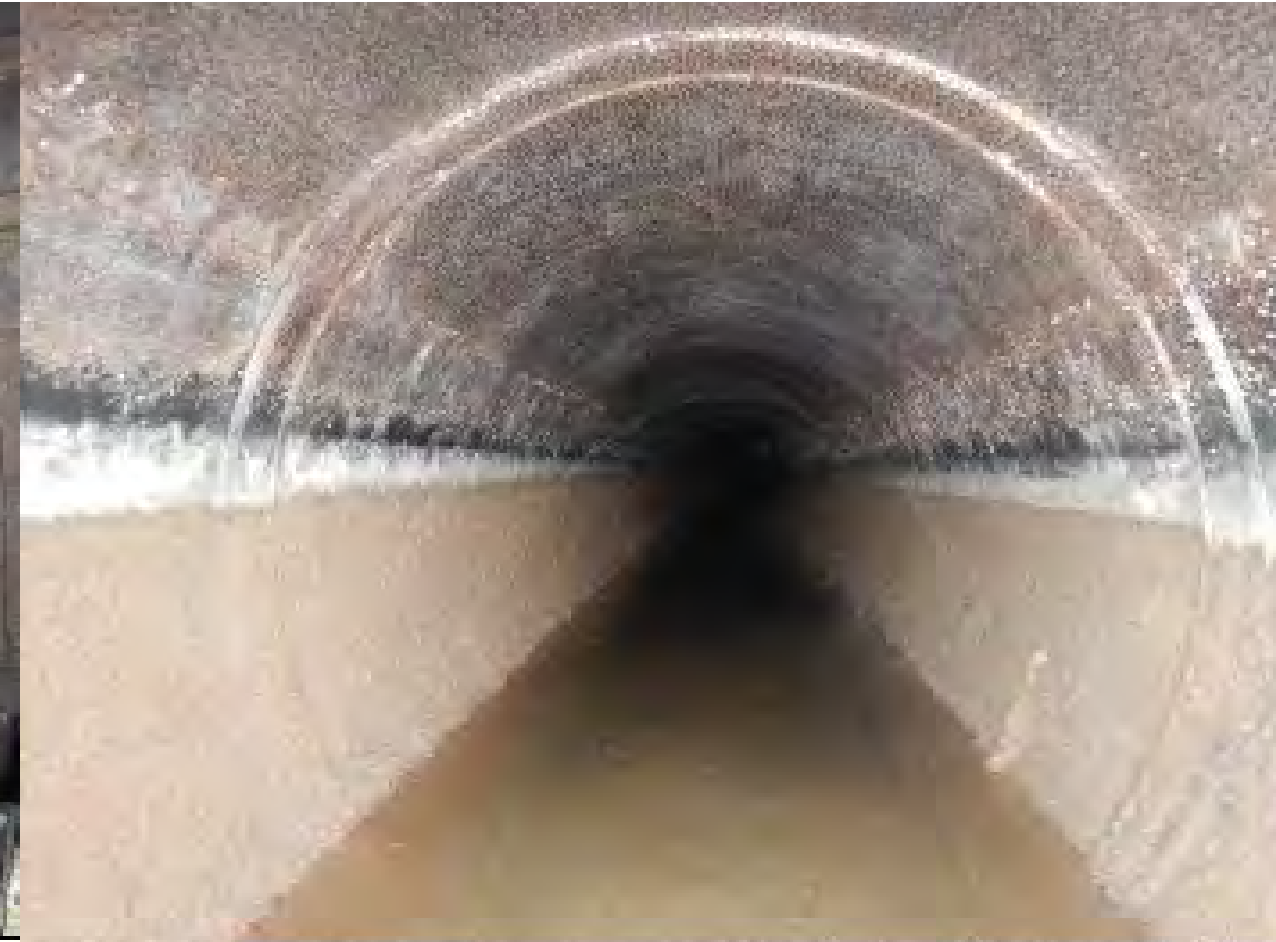
Up to 1/4" of sediment observed on pipe walls
