SANTA ANA WATERSHED PROJECT AUTHORITY
11615 Sterling Avenue, Riverside, California 92503 • (951) 354-4220

REGULAR MEETING OF THE PROJECT AGREEMENT 24 COMMITTEE

DATE: September 3, 2024
TO: PA 24 Committee
SUBJECT: Reach IV-B Condition Assessment Final Report
PREPARED BY: Daniel Vasquez, Manager of Operations

**FIP FINDINGS AND
REHABILITATION
RECOMMENDATIONS
REPORT - REACH IV-B**

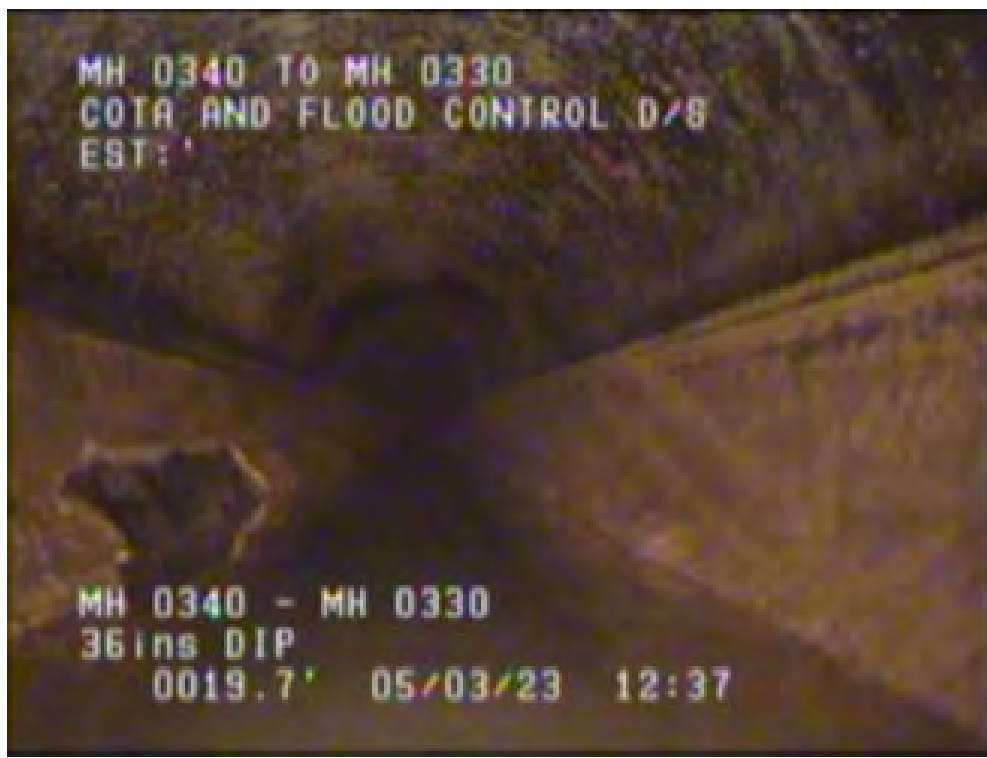
Missing Lining

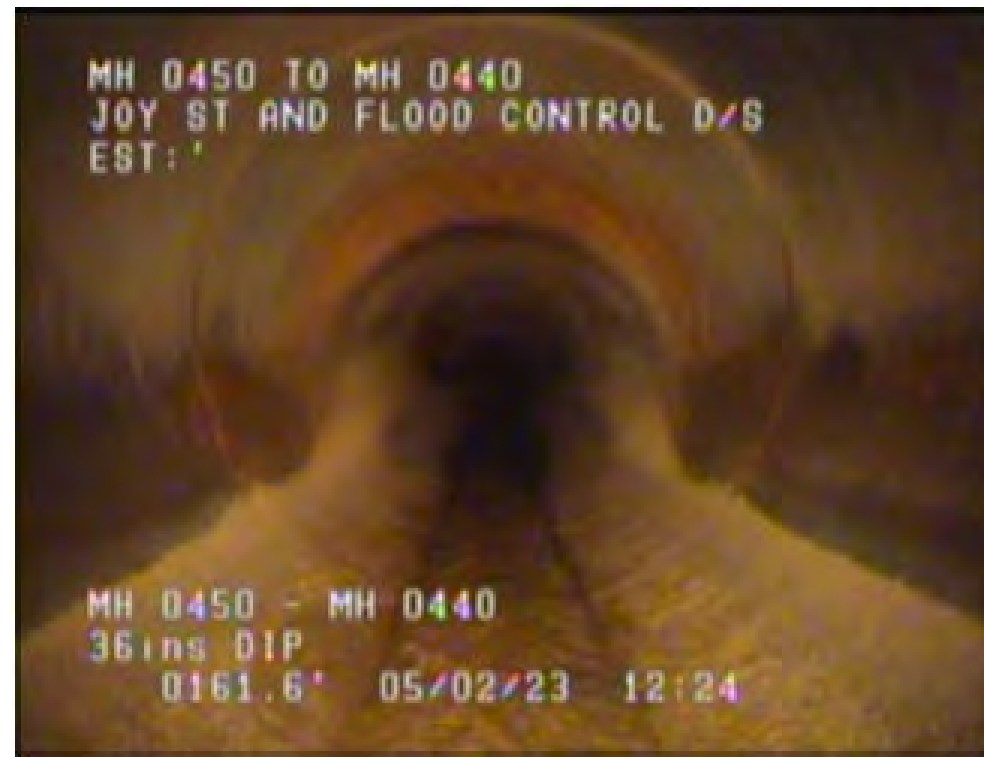
Corrosion Discoloration at Crown and Joint

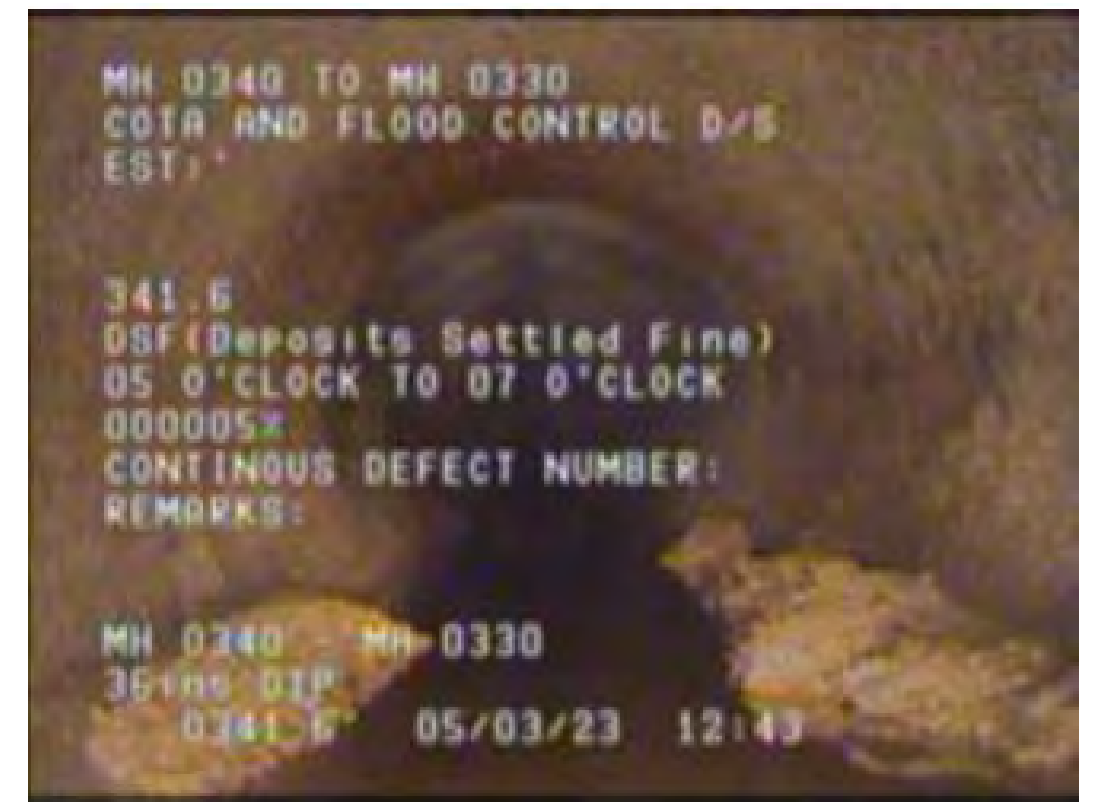
Deposits

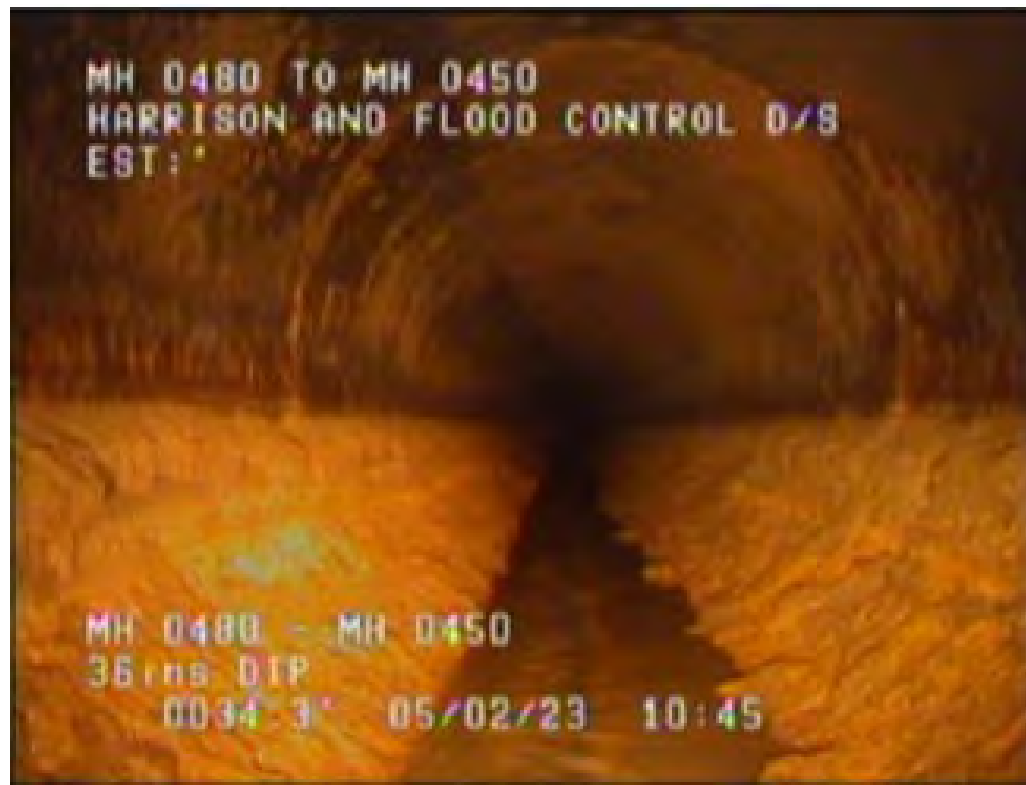
Deposits and Missing Liner

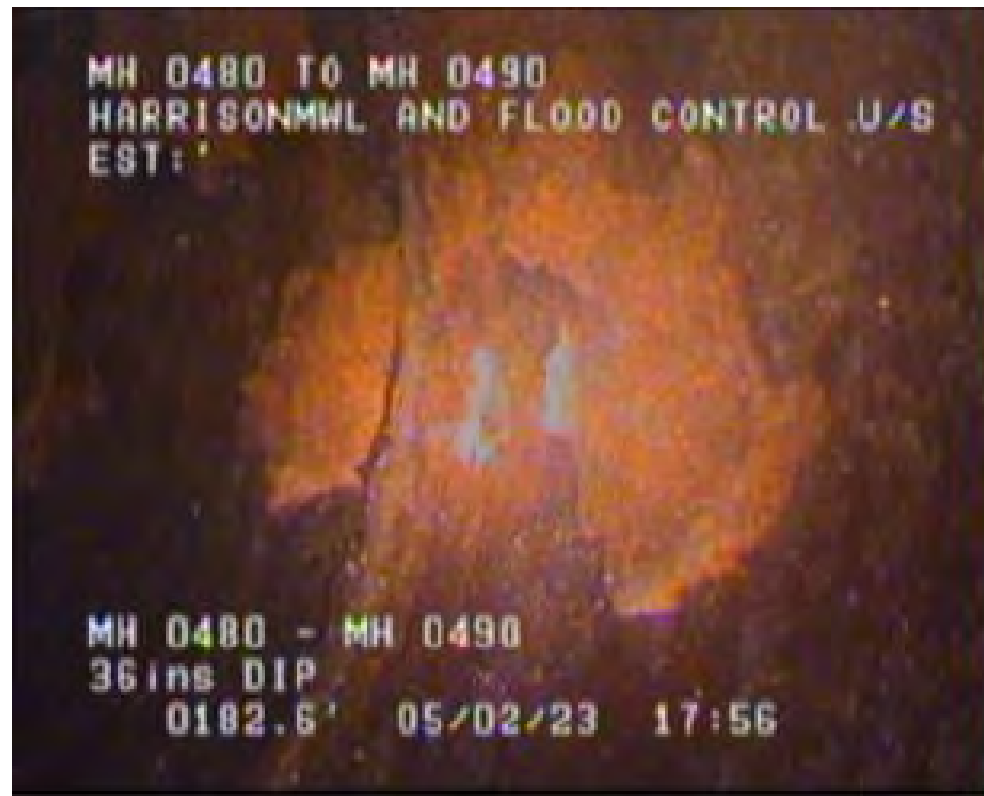
Missing Liner and Damaged Metallic Pipe Wall

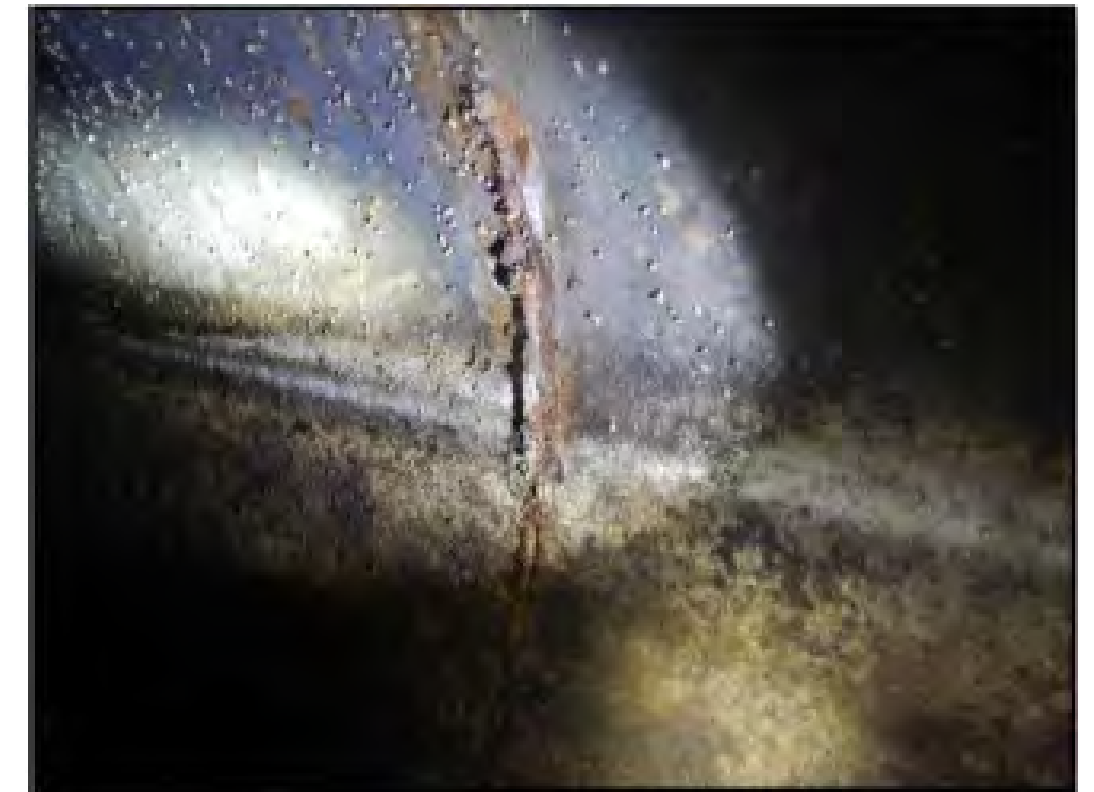
Coating Failure at Joint

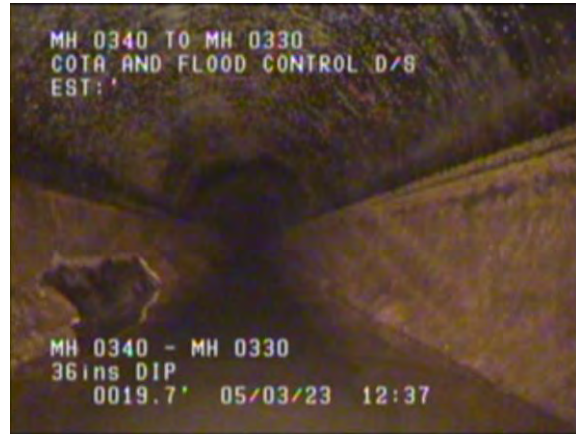
Figure 4: Missing Lining Material at 8 o'clock

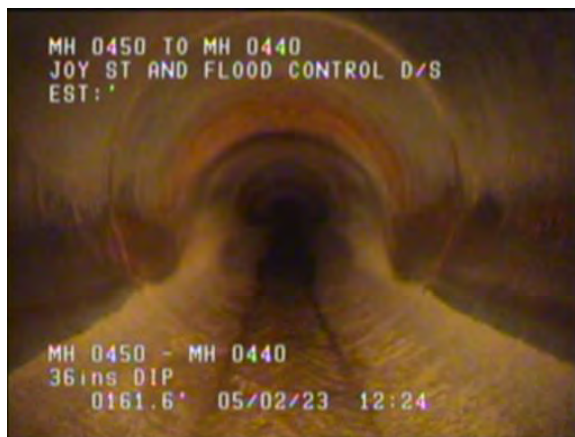
Figure 5: Corrosion Discoloration at Crown and Joint

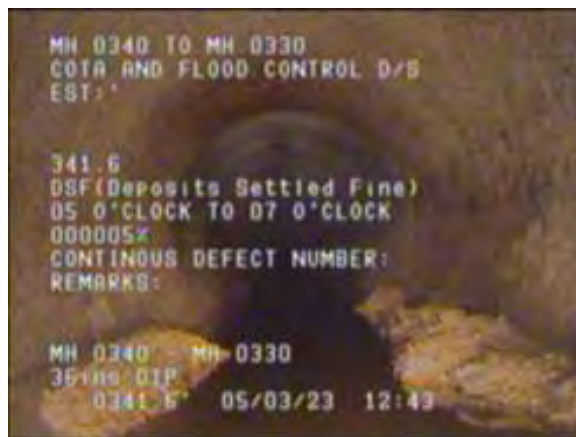
Figure 6: Deposits

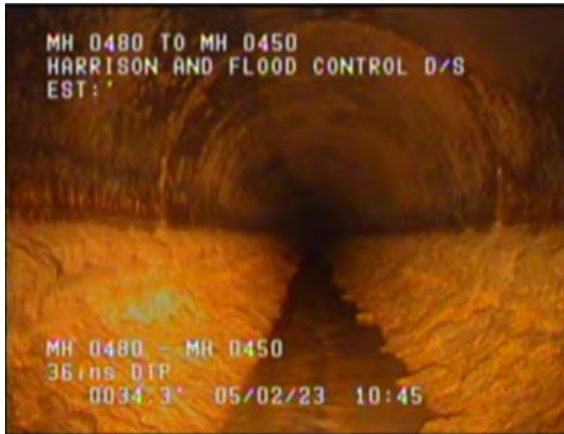
Figure 7: Deposits and Missing Liner

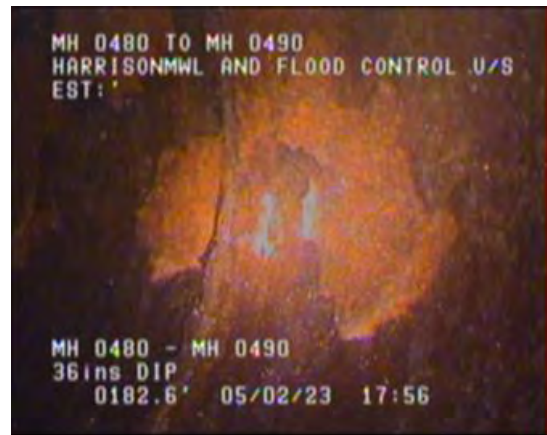
Innerline Engineering’s CCTV reports are provided in **Appendix C** along with W&C’s detailed summary of observations. Example screen grabs of the pipe condition throughout Reach IV-B are provided below. It should be noted that the pipe segment between MAS 4B-0480 and 4B-0490 exhibited liner failure in the upstream-most 42-feet of pipeline. This is the only pipe segment that was inspected with CCTV that exhibited this level of corrosive degradation. An example is shown in **Figure 8**.

Figure 8: Missing Liner, Damaged Metallic Pipe Wall

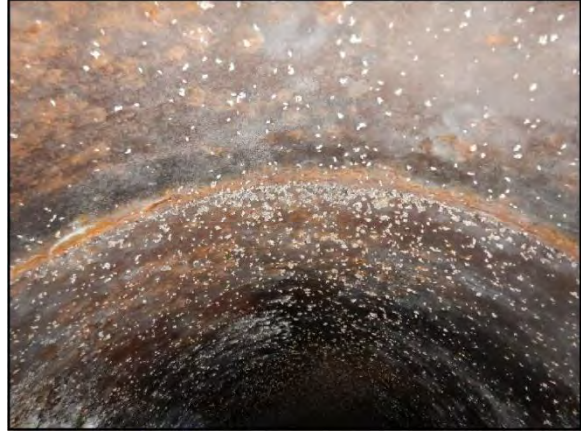
Figure 10: Corrosion at Crown

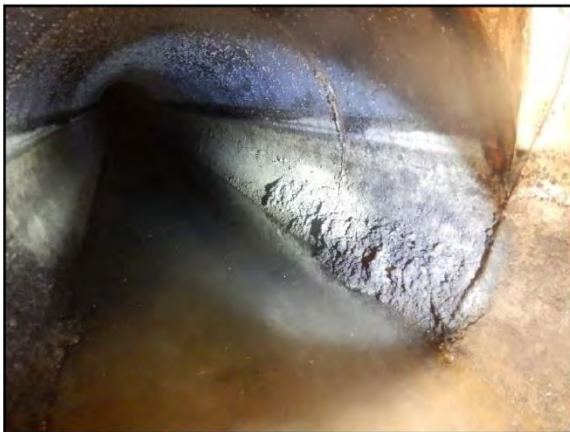
Figure 11: Sediment/Deposits

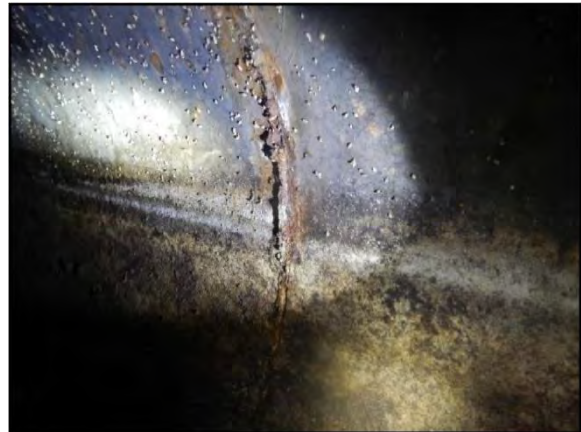
Figure 12: Coating Failure at Joint

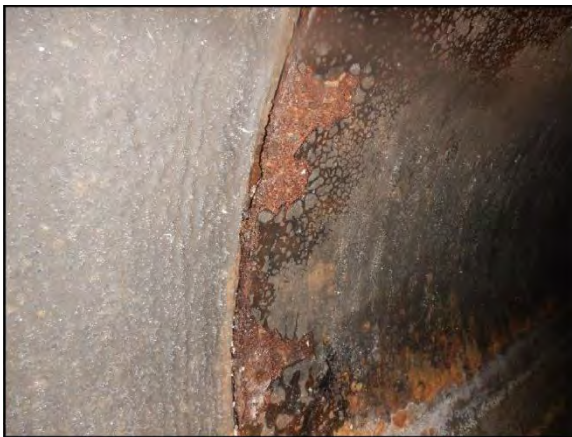
Figure 15: Lining Failure at U/S Joint

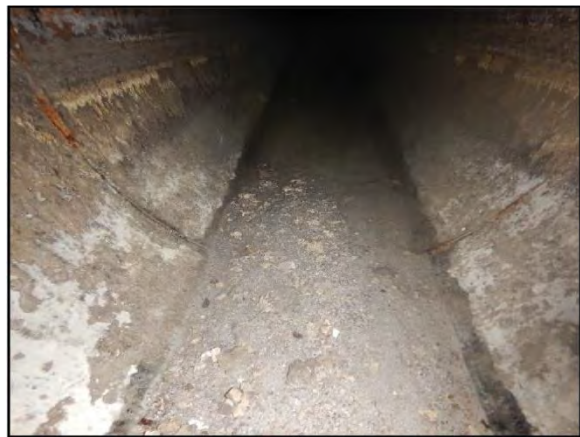
Figure 16: Sediment in Invert

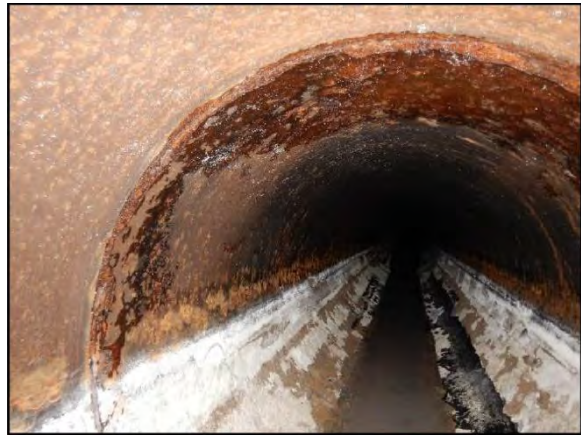
**Figure 18: Moderate Corrosion
(Looking Upstream)**

1. Bypass flows as necessary to complete the Near-Term recommended work. Perform joint repairs at MAS 4B-0480. By completing joint repairs at a single MAS location, SAWPA will gather valuable information regarding the duration and cost for joint repairs and be able to use that data to assess the overall benefit of future individual joint repairs versus CIPP lining of the entire pipeline.
2. Perform physical testing as MAS 4B-0320 in order to fill in the gap on missing physical testing data on the downstream end of the alignment.
3. Consider the addition of two new MASs for access improvements while the pipeline flows are bypassed.

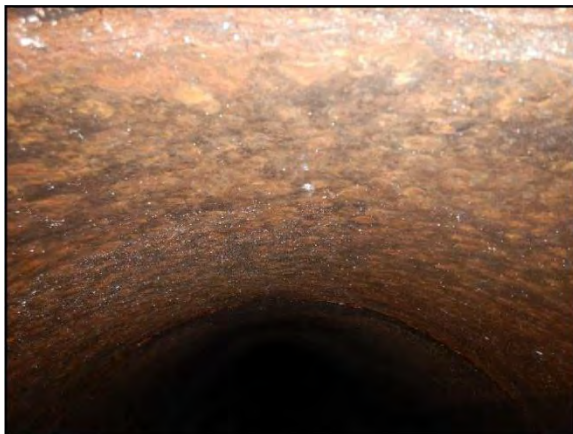
**Figure 19: Moderate Corrosion at
Crown**

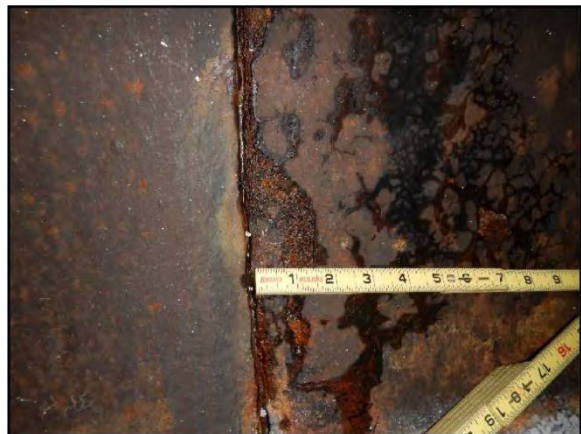
Figure 20: Coating Failure at Joint

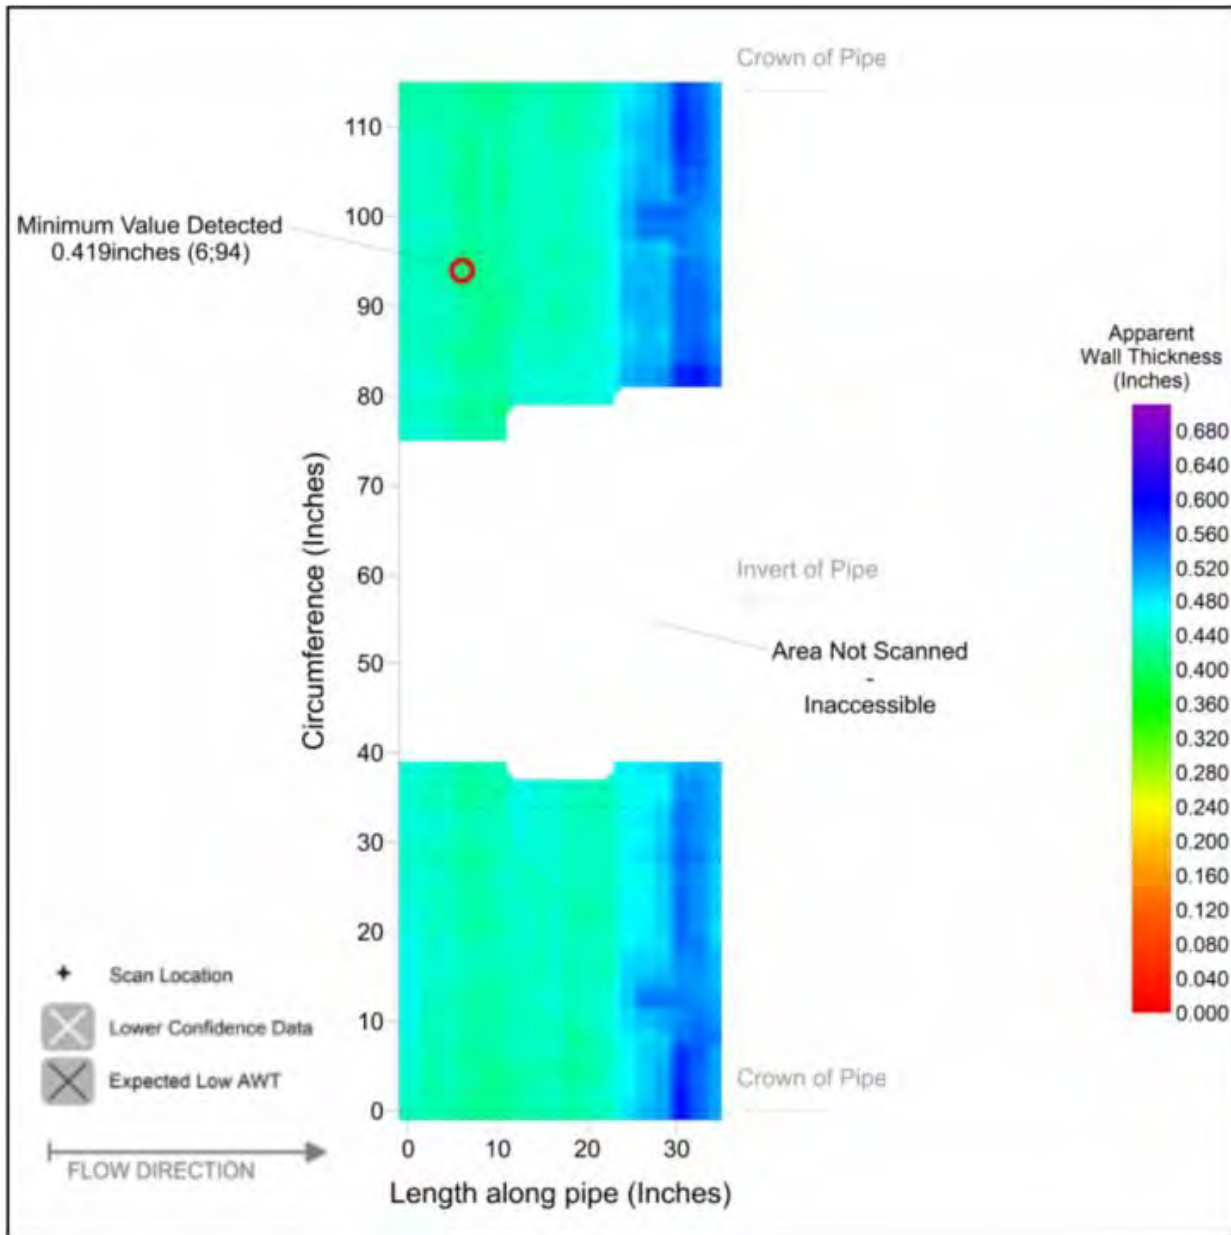
Figure 21: MAS 4B-0340 BEM Scan Results

MAS	Minimum Thickness (in.)	Average Thickness (in.)	Maximum Thickness (in.)	Maximum Thickness Loss (%)
4B-0340	0.419	0.466	0.584	13%
4B-0450	0.456	0.492	0.545	5%
4B-0480	0.471	0.558	0.617	2%
