SANTA ANA WATERSHED PROJECT AUTHORITY
11615 Sterling Avenue, Riverside, California 92503 • (951) 354-4220

REGULAR MEETING OF THE PROJECT AGREEMENT 24 COMMITTEE TUESDAY, APRIL 1, 2025 – 10:00 A.M. (or immediately following the 9:30 a.m. SAWPA Commission meeting)

- B. **INLAND EMPIRE BRINE LINE REACH IV-D CONDITION ASSESSMENT FINAL REPORT (PA24#2025.10)**53

Inland Empire Brine Line Reach IV-D Condition Assessment Report

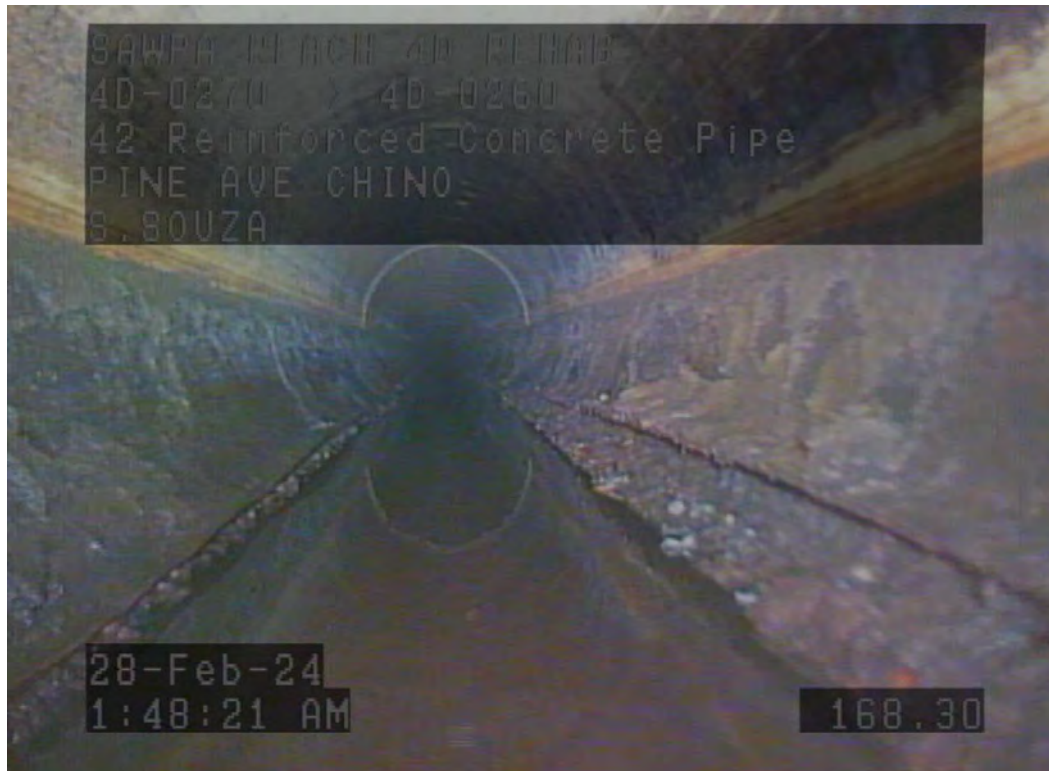
Figure 2: Liner Termination Uplift and Longitudinal Groove from Aggregate Loss Under Liner Between MAS 4D-0260 and 4D-0270

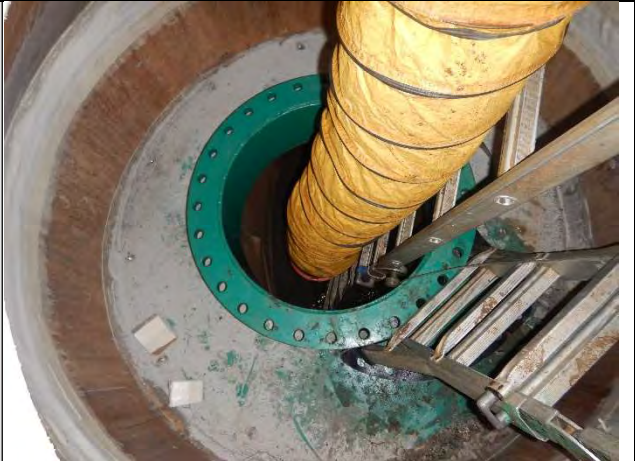
Observations:		
<p>A</p>	<p>Interior of the access framing and cover added in the 2020 rehabilitation project. Composite material and epoxy coated blind flange in good condition with no defects noted.</p>

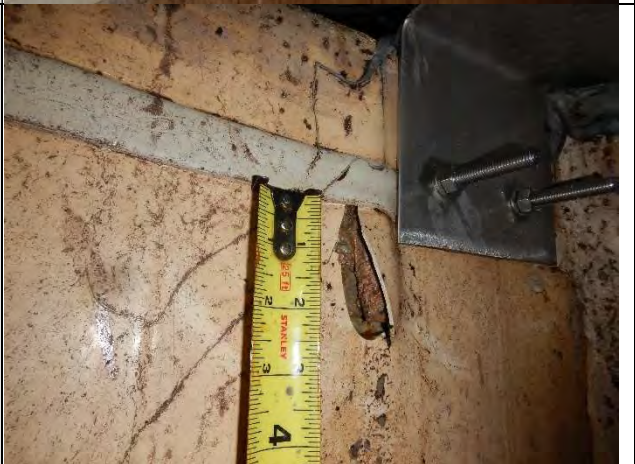
<p>D</p>	<p>Liner termination at pipe and MAS interface in good condition (typical).</p>

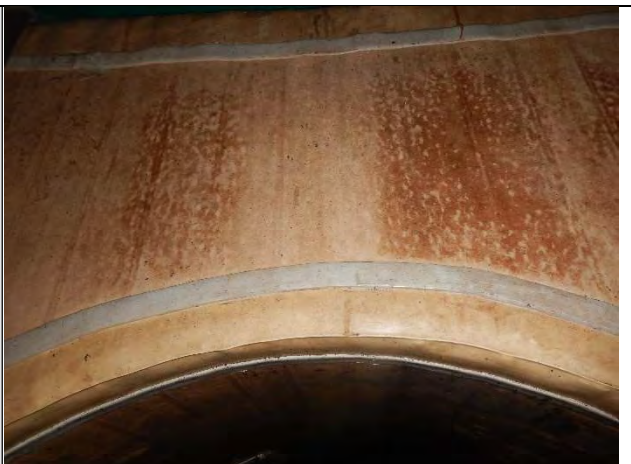
<p>E</p>	<p>Influent pipe. sludge layer nearly reaches the springline.</p>

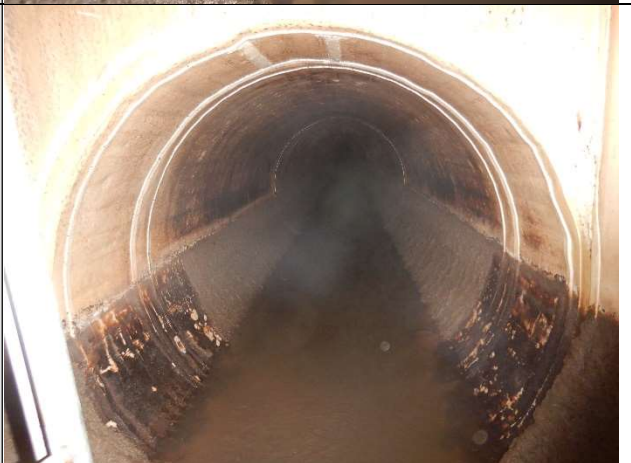
<p>I</p>	<p>Effluent Pipe. Heavy staining on liner beneath the sludge layer.</p>

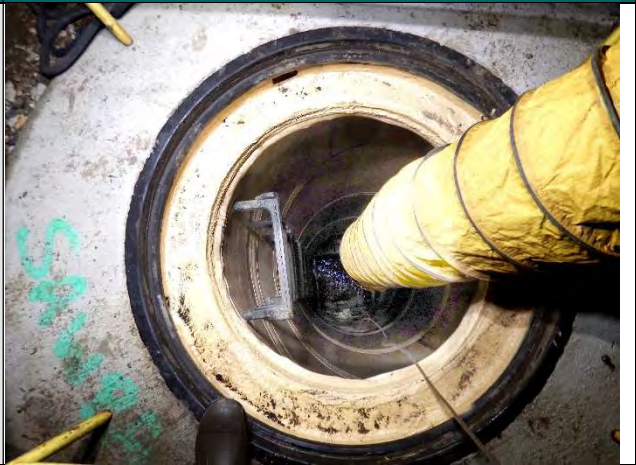
<p>B Minor blisters up to 1-in in diameter near the top of the MAS. Blisters were intact and concrete was not exposed.</p>

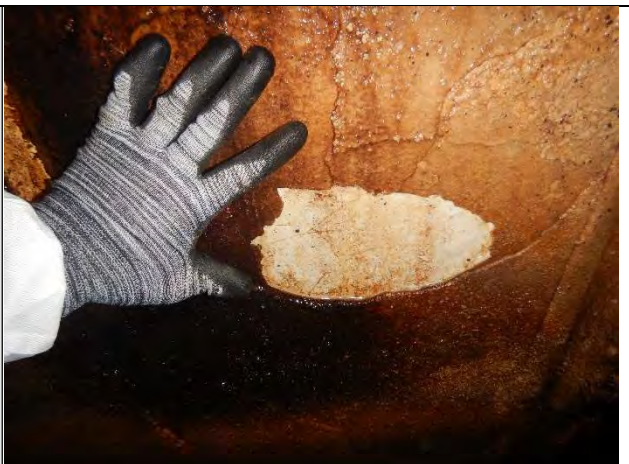
<p>E</p>	<p>12-in vertical segment of weld strip that was detached in the northeast corner of the MAS, centered near the springline of the pipe.</p>

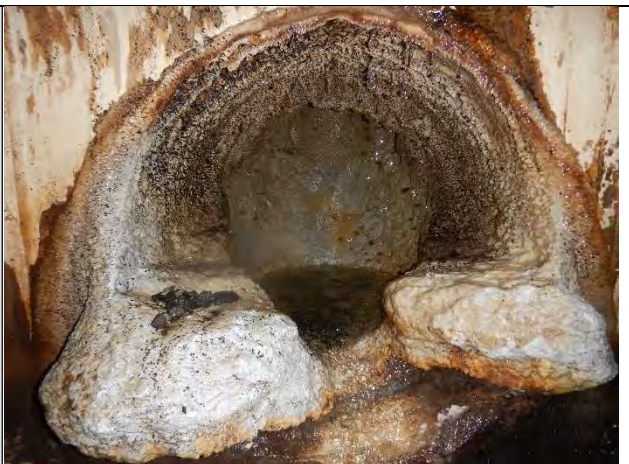
<p>H</p>	<p>Infiltration entering the MAS from beneath the 30-in VCP drop-inlet pipe penetration.</p>

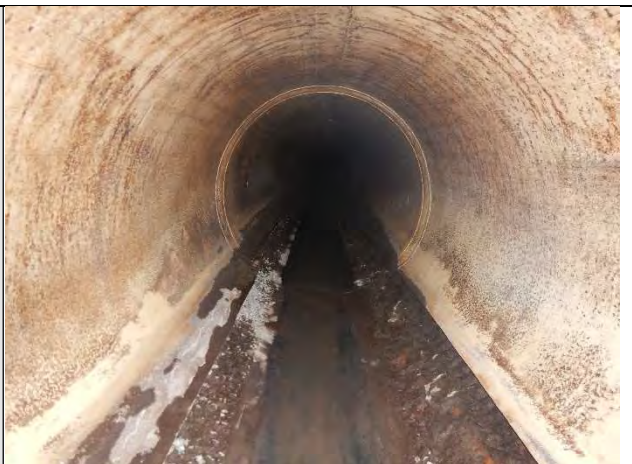
<p>E</p>	<p>The effluent pipe liner has blisters up to 4 inches.</p>

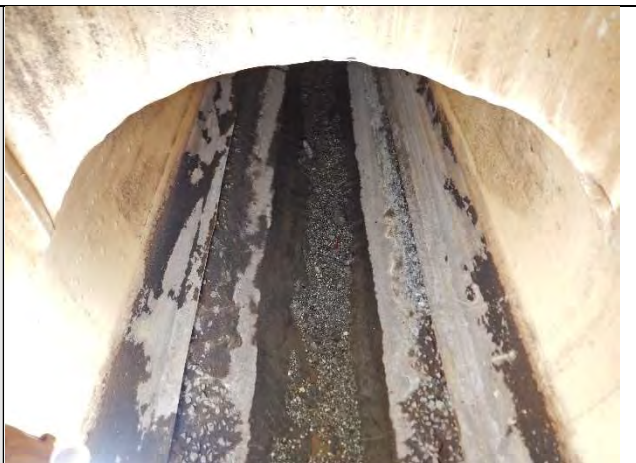
<p>E</p>	<p>Effluent pipe liner was embedded with multiple blisters. Slime layer appeared to be up to typical waterline.</p>

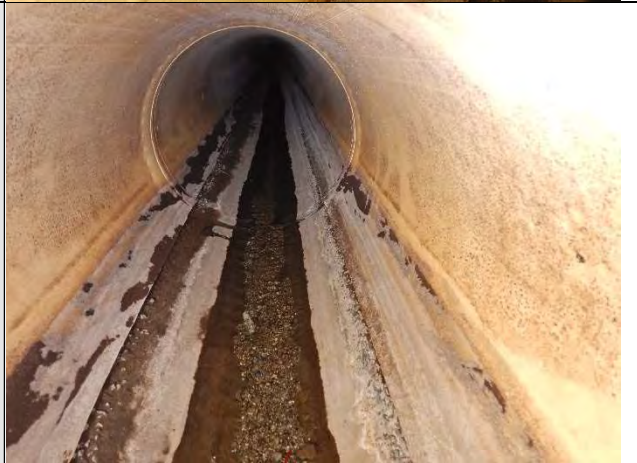
<p>L</p>	<p>Corrosion staining evidence of embedded reinforcement corrosion. Exposed aggregate at unlined concrete channel.</p>

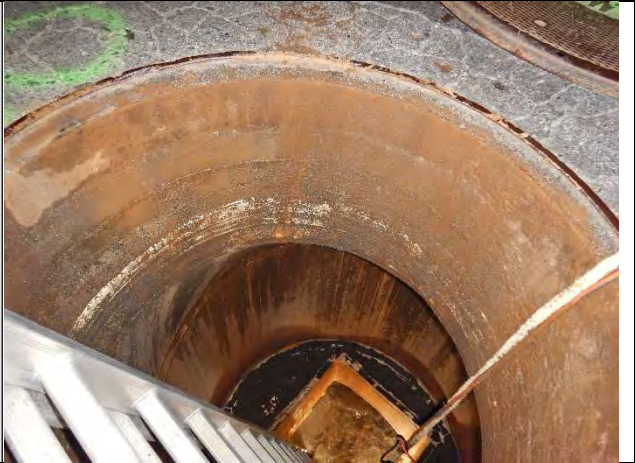
B	Liner at chimney was in good condition with slight miscoloring.

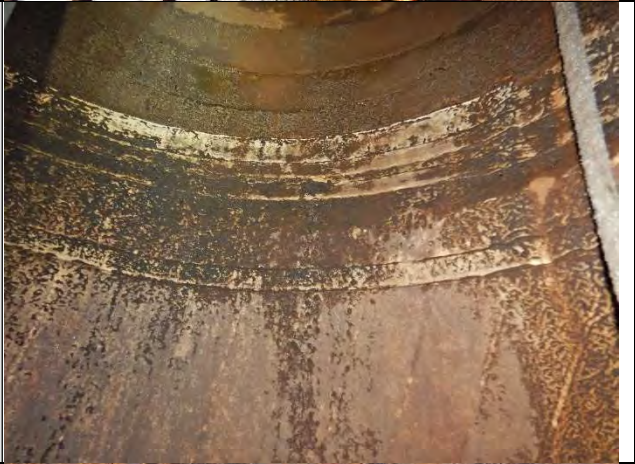
C	The liner at the bench was in good condition with a build-up of fine sediment.

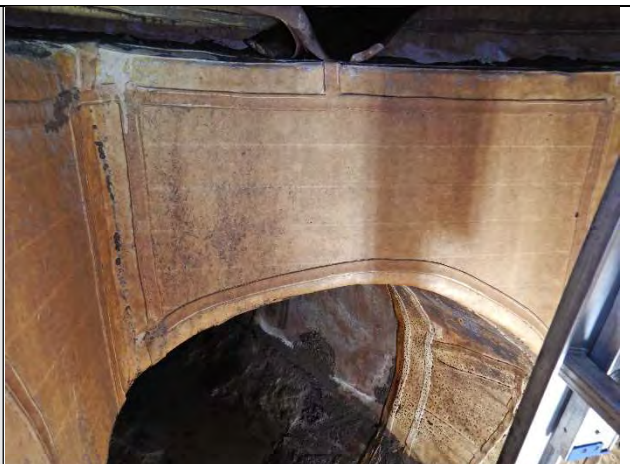
<p>E</p>	<p>Effluent pipe liner was in good condition with no blisters. Shown is repair patch from previous assessment. Patch in good condition.</p>

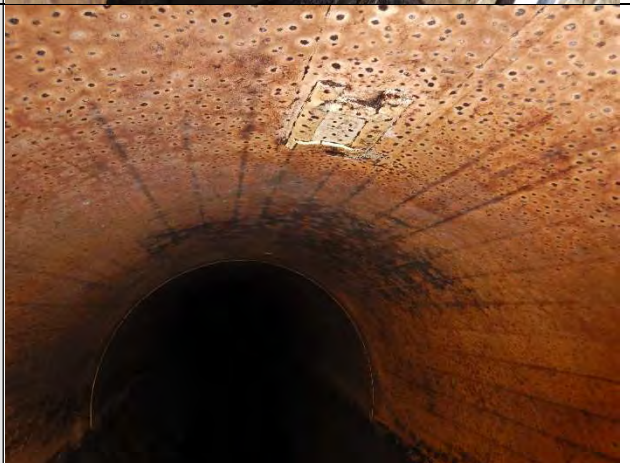
<p>F</p>	<p>Lateral with gas flap. Liner termination at pipe connection was in good condition. Flap appeared to be attached and in operating condition.</p>
