SUNNYSLOPE CREEK NATIVE FISH HABITAT RESTORATION PROJECT MONITORING REPORT

January 2016

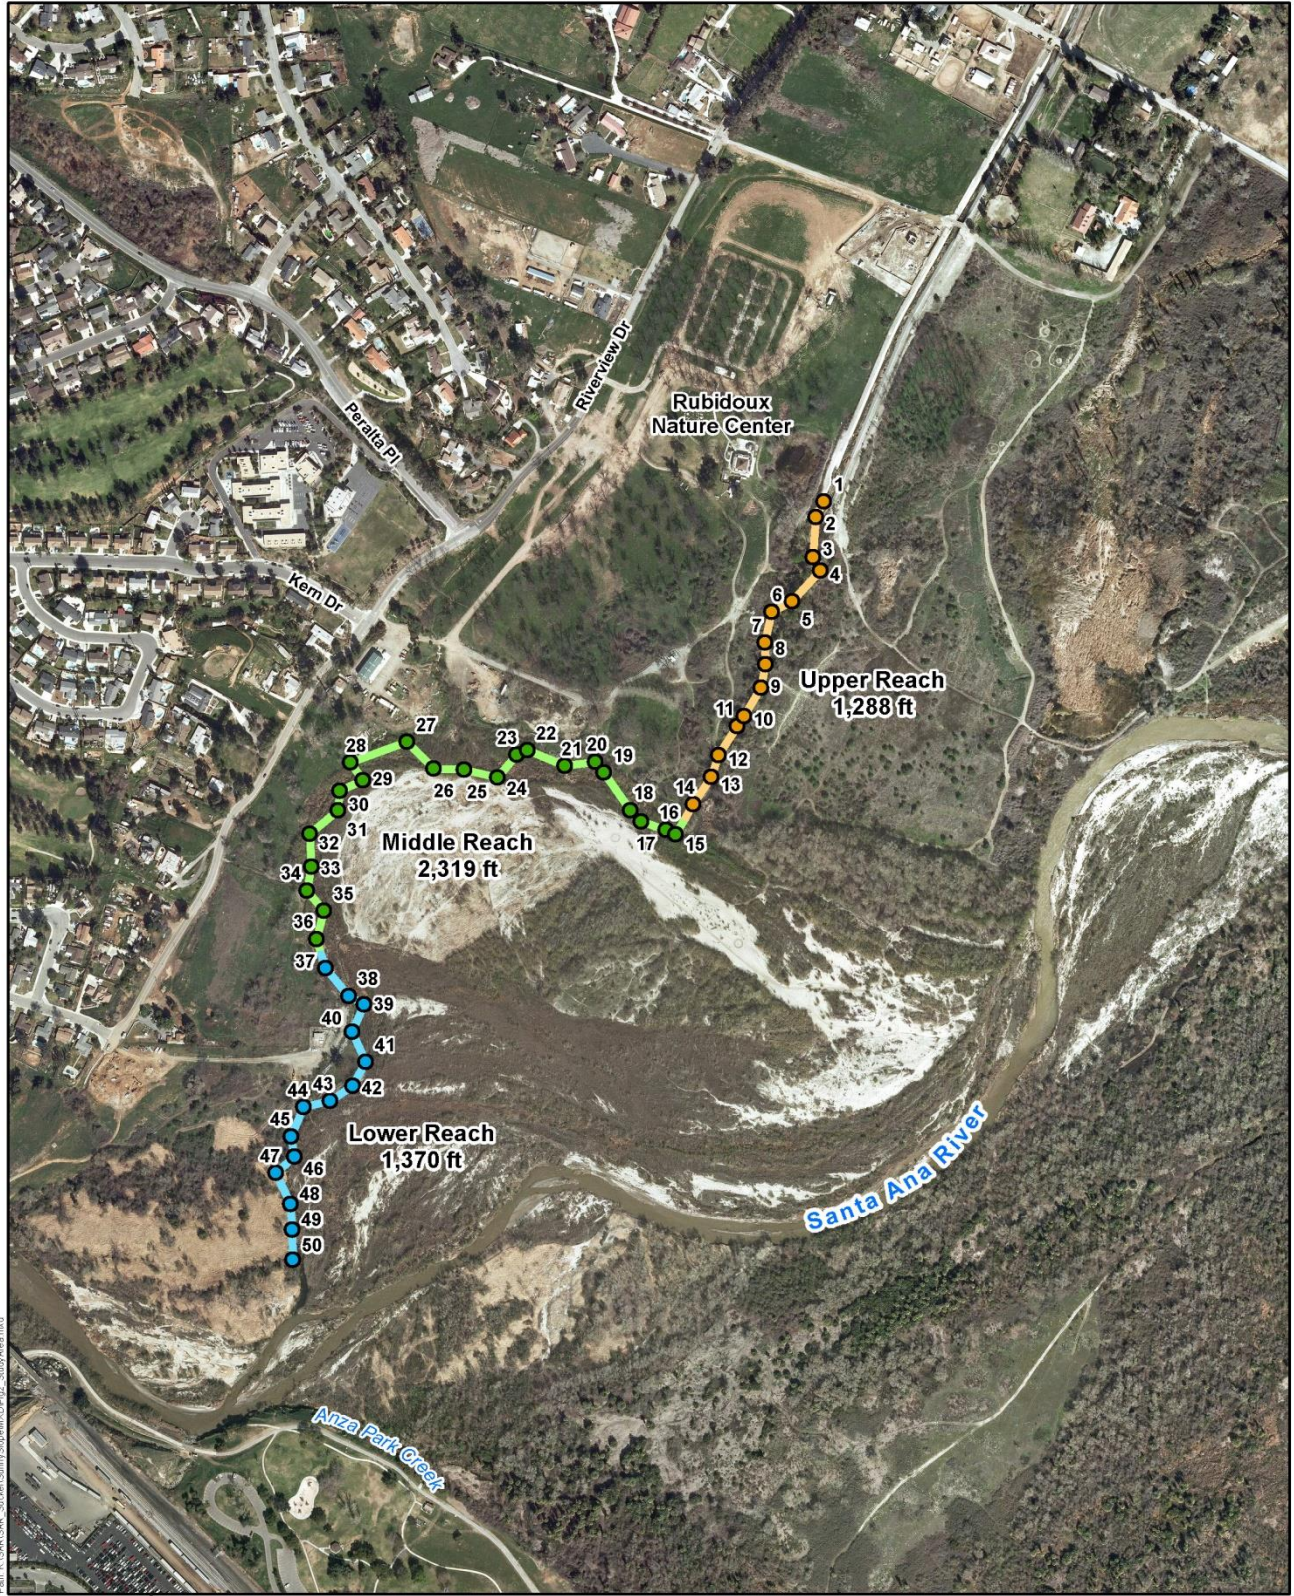
Figure 2: Study Area Map

The Sunnyslope Creek Native Fish Habitat Restoration Project area consists of the 0.95 mile earthen segment between the concrete-lined channel and the river. As shown in Figure 2, the earthen segment of the creek has been divided into three reaches. The upper reach begins at the terminus of the concrete-lined portion of Sunnyslope Creek and extends approximately 1,340 feet downstream to Station 15 (approximate location of the pre-2005 river confluence). Along the upper reach of the creek there is a 10-foot elevation change. Vegetation along the lower and upper segments of the upper reach consists mostly of native plants, while the middle segments of the upper reach between Station 4 and Station 9 consist of a higher percentage of non-native cover.

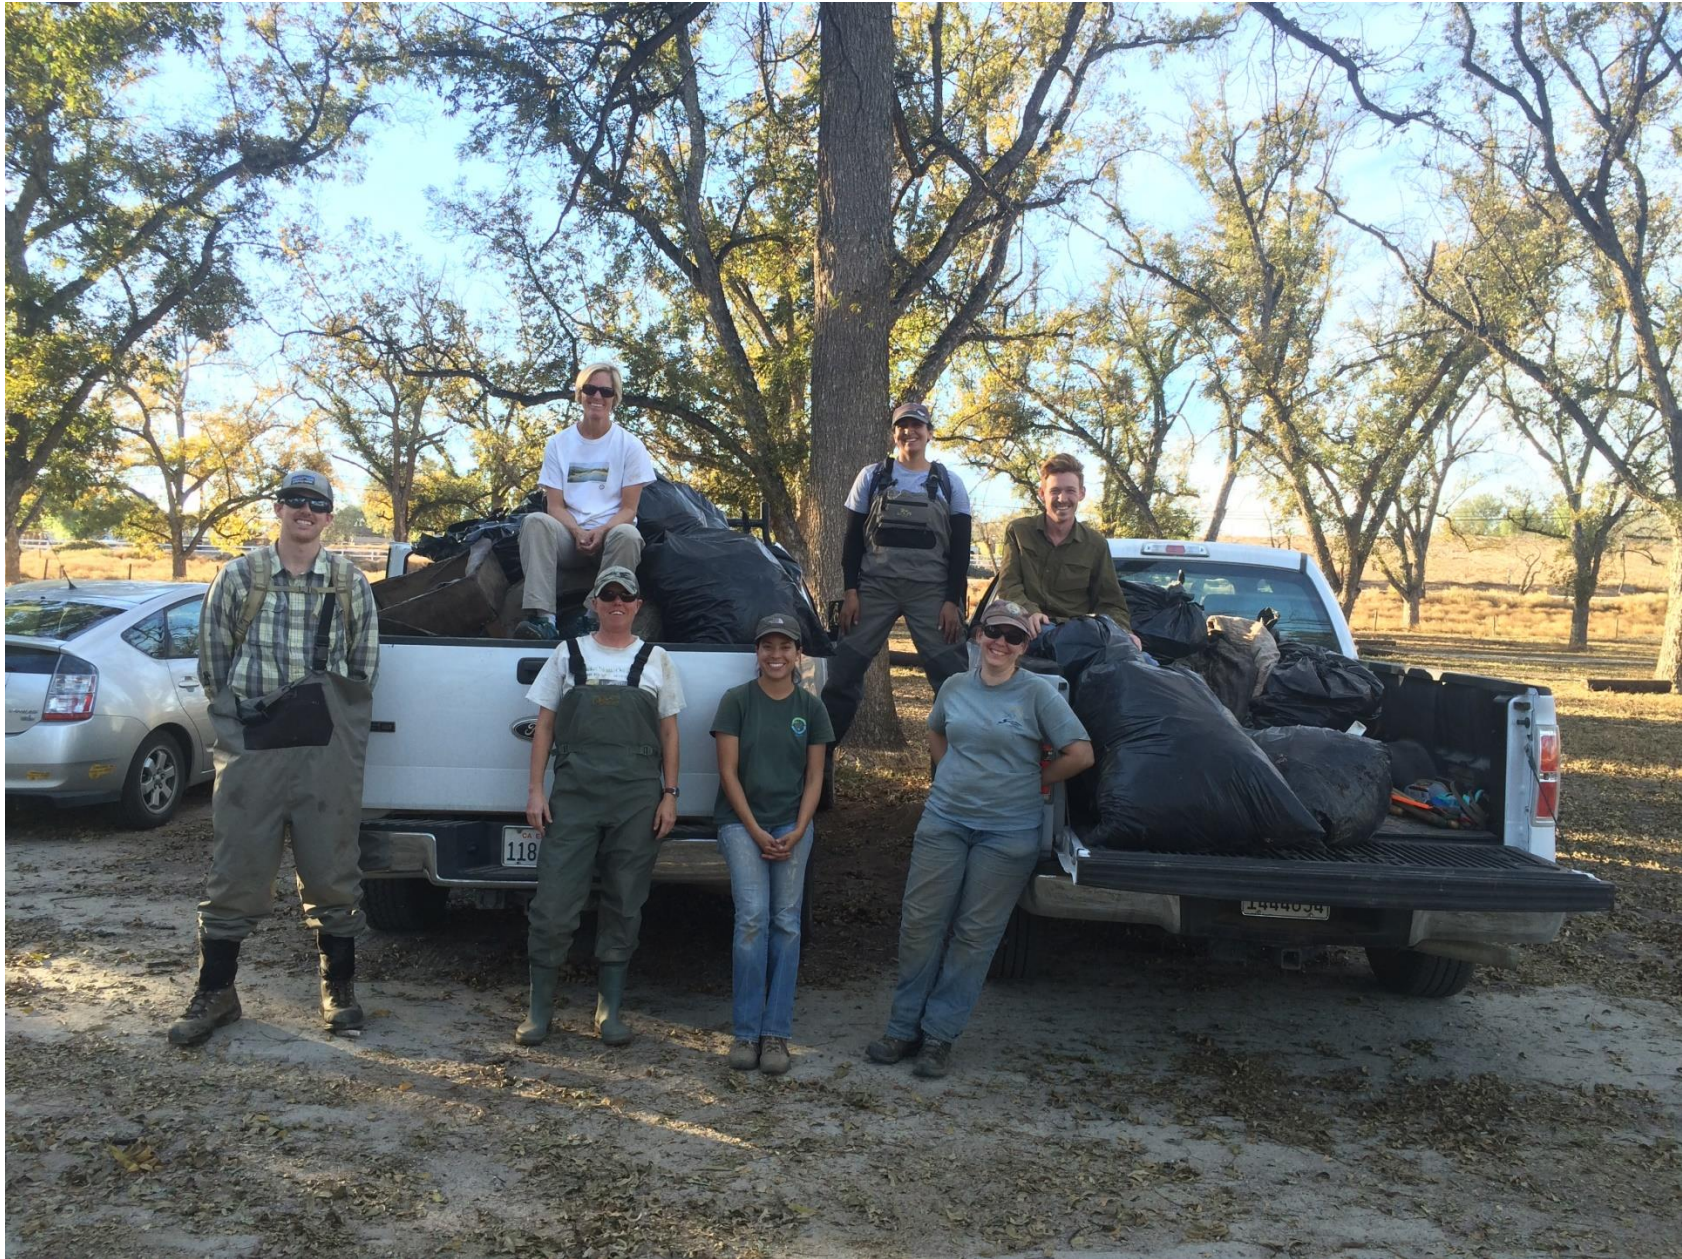
The sediment, debris and vegetation plug management carried out in 2015 was similar to past efforts and occurred largely in the flat middle and lower reaches of the creek. Trash was collected from banks and in the creek whenever field crew was on site, but a large cleanup yielding thirty-nine 30-gallon trash bags was done in December (Figure 3). In addition, large items such as a mattress, tires, a car seat and others items were removed from Sunnyslope. Fallen trees that caused debris build up were also removed from the creek. The biggest effort was a large black willow (*Salix gooddingi*), approximately 12m tall, that fell parallel into the creek. High flow events can cause trees to fall and block the creek. These fallen trees force sheet flow and small side channels to form. Once the high flows subside, these debris dams and side flows further reduce the current on the main channel; the lower flows allow more fine particles to drop out of the water thereby burying desirable rockier substrate. Emergent plants were pulled by hand and sediment plugs were shoveled out.

Figure 3: Trash clean-up crew.

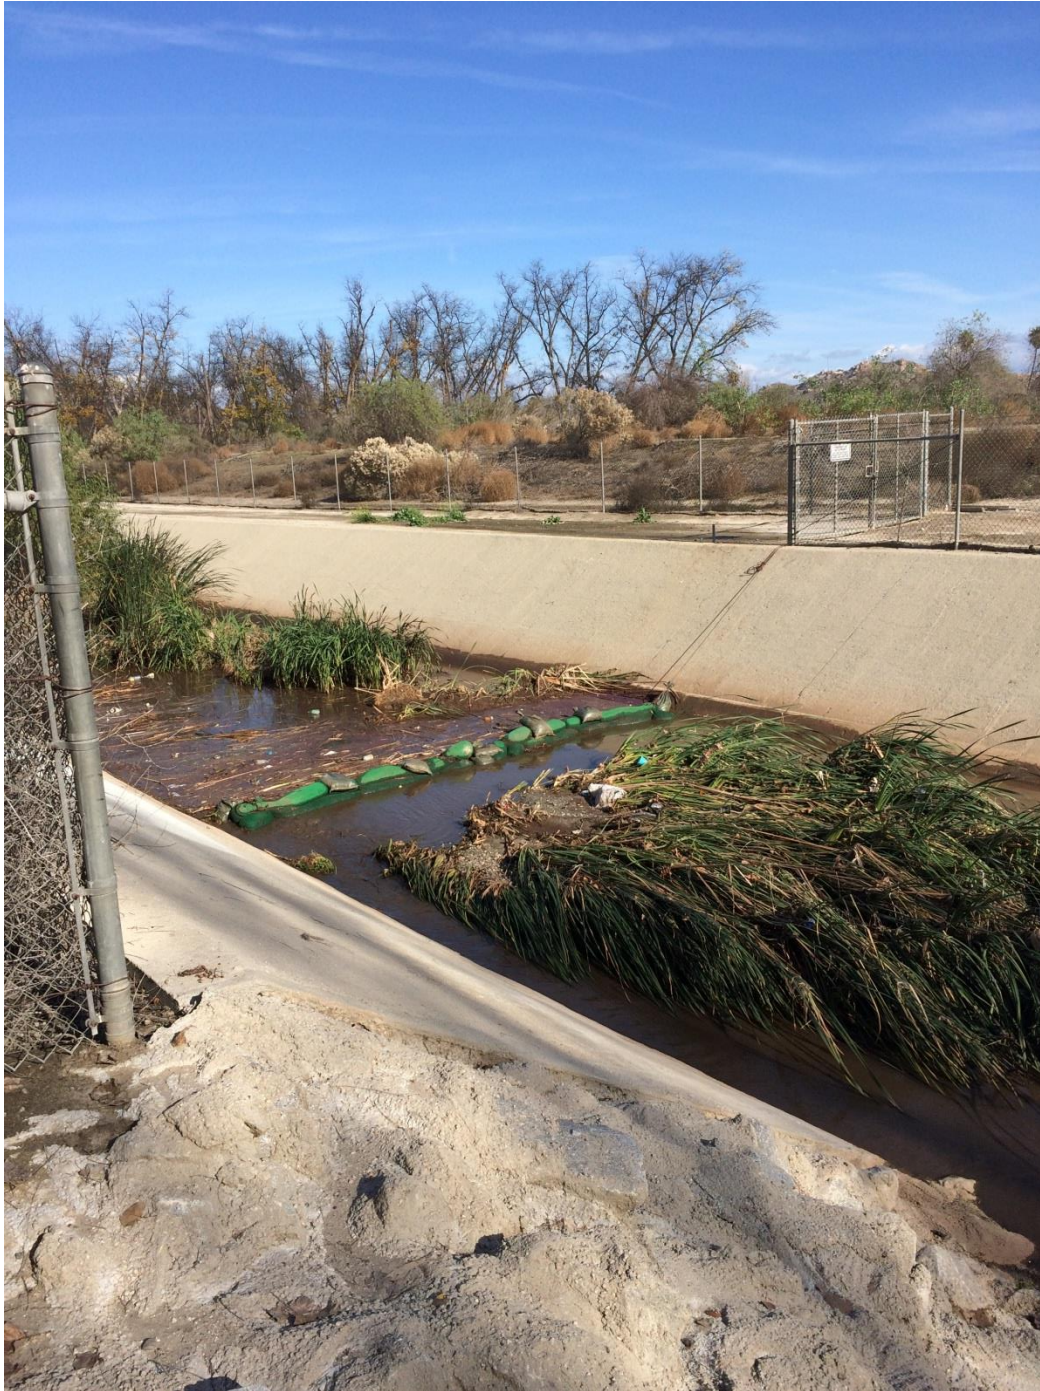
In 2014 and 2015, Riverside County Flood Control removed vegetation in the concrete lined channel just upstream of Sunnyslope. Crews from Flood Control installed check dams downstream of work being done in the channel to prevent sediment and trash entering the creek (Figure 4). Extra precaution was taken by our crew to have a block net in place while they were working within the last 50 meters of the concrete lined channel. This net was checked periodically to ensure no native fish were in the net.

Figure 4: Riverside County Flood Control check dam set in place to prevent sediment and trash from entering creek while removing vegetation from concrete-lined channel.

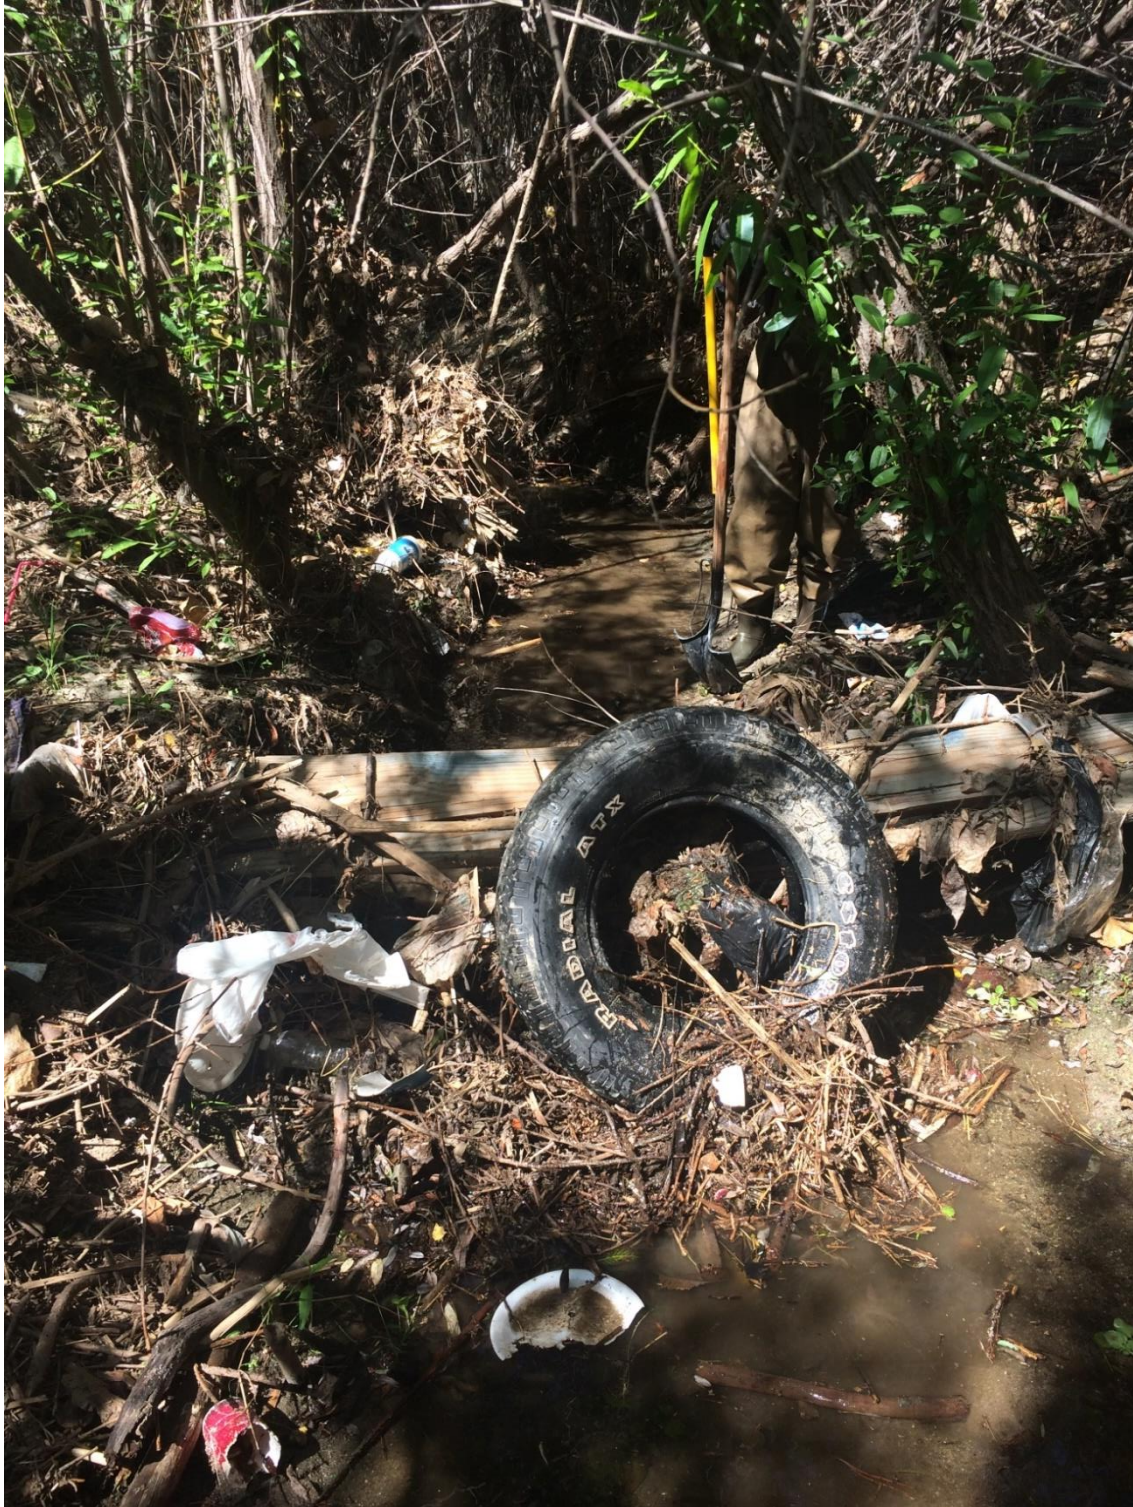
Trash accumulation continues to be a problem in Sunnyslope Creek, especially after storm events (Figure 5). Previous meetings to discuss the feasibility of installing a trash boom have led to additional research on the effectiveness of utilizing this method or an alternate that would reduce trash buildup and sediment plugs in the creek system. Care would be taken to install the trash boom in a way that would not compromise the integrity of the cemented channel or otherwise interfere with the flood control function of the facility.

Figure 5: Trash debris buildup after a storm event.

5. Remove non-native predators and competitors in February and October of each year.
6. Explore options that would reduce the trash buildup and increase the removal of debris and trash along the upper reach of the creek.

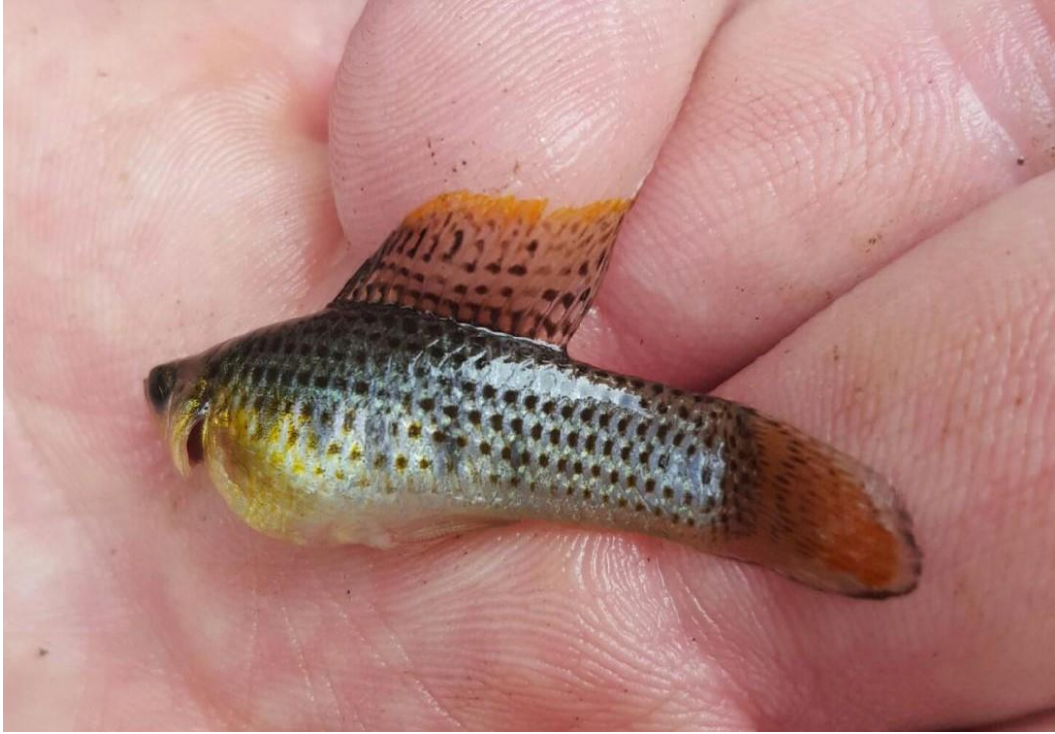
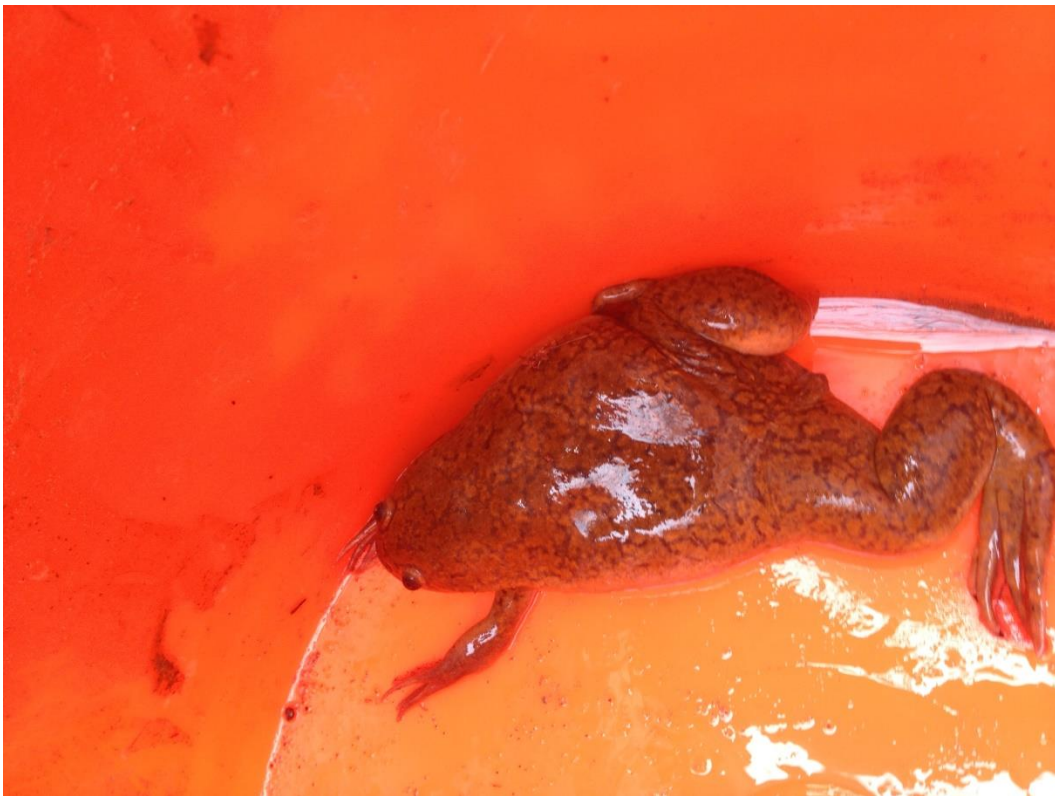
Figure 6: Top: Sailfin Molly removed during non-native removal.
Below: African-clawed Frog caught in crayfish trap.

From 2011-2015, 16,839 individuals comprising 13 species of non-native predators and competitors have been removed from Sunnyslope Creek (Table 1). Figure 6 shows a few of the non-natives removed from the system.

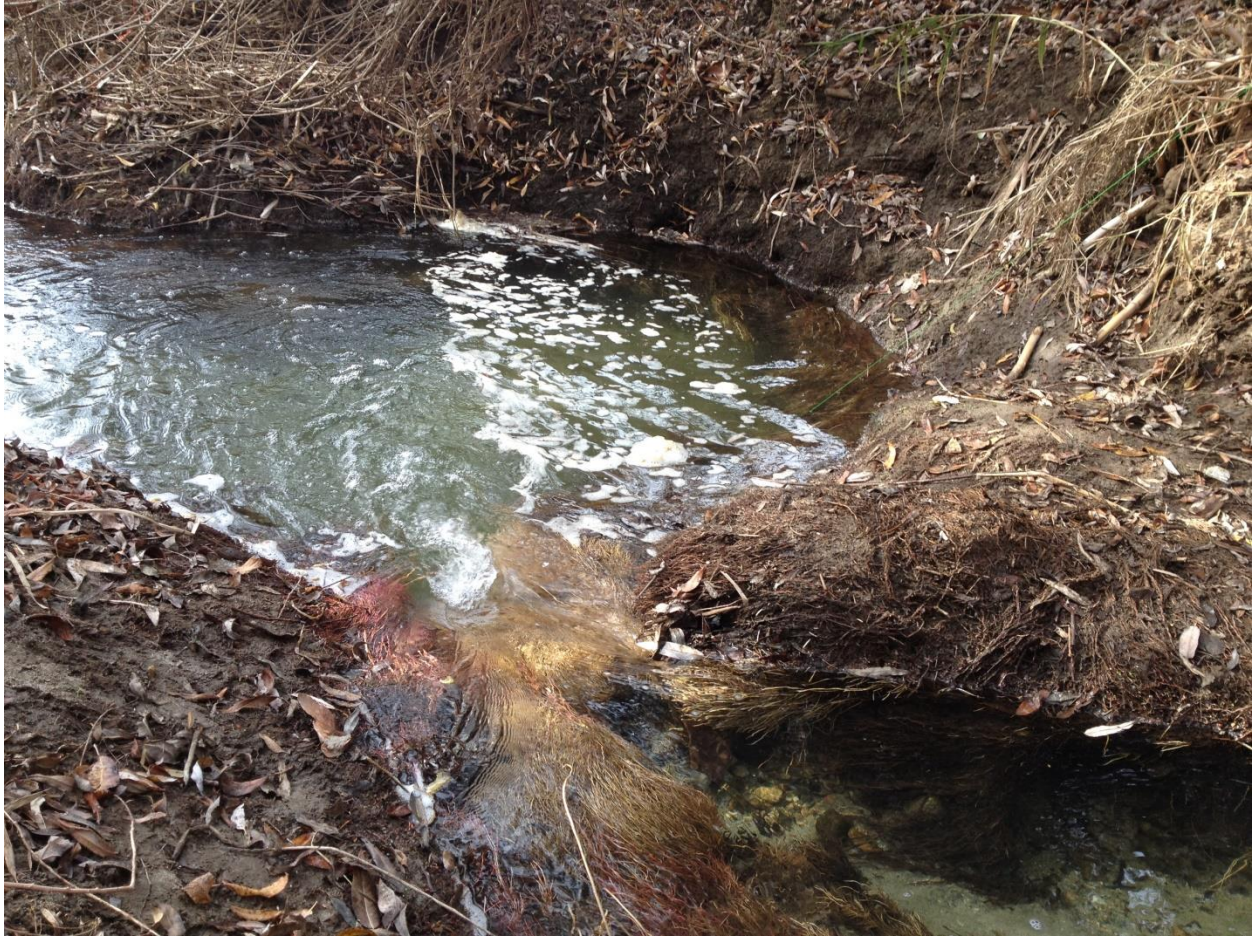
Throughout the year, on visits for vegetation removal, at least 31 suckers were observed in Sunnyslope Creek near the lower reach. This observation was in a highly aerated gravel filled pool that was occupied with sucker throughout the spawning season (Figure 7). A GoPro camera was used throughout the year to get footage of

the fish and approximate abundance (Figure 8). The aeration level in this pool has been greatly reduced due to both summer drought and then later, rain events that resulted in the deposition of sand.

Figure 7: Aerated pool where numerous Santa Ana Sucker were observed.

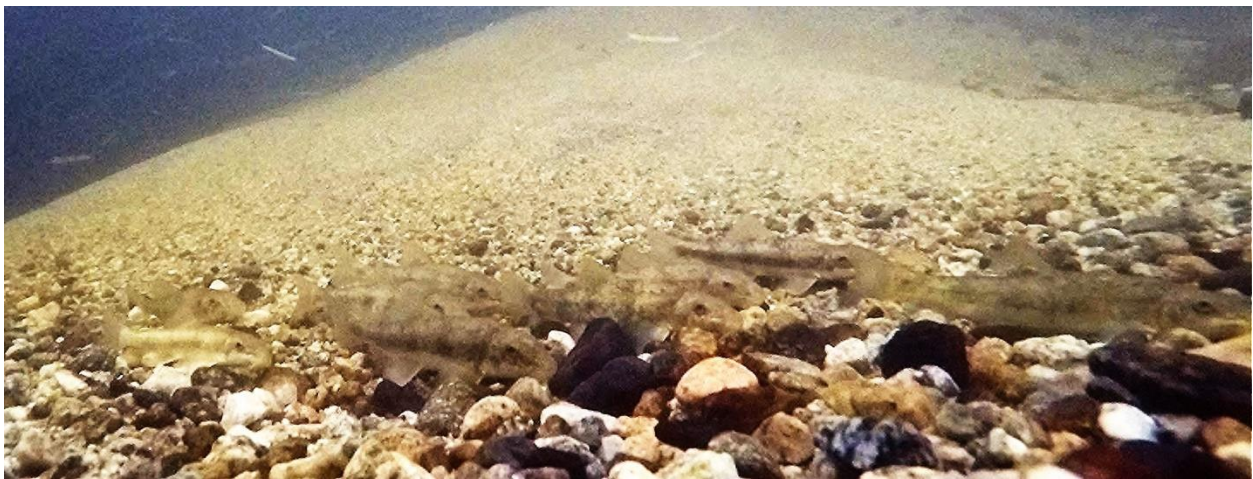
Figure 8: Santa Ana Sucker recorded during GoPro Survey in aerated pool.

- 11.** Continue native fish surveys and GoPro surveys to determine the presence of sucker and other native fish.
