**Finding of Emergency and Urgent  
Necessity to Act to Complete the Reach  
V Rehabilitation and Repair Project**

# Inland Empire Brine Line Rehabilitation and Improvement Project

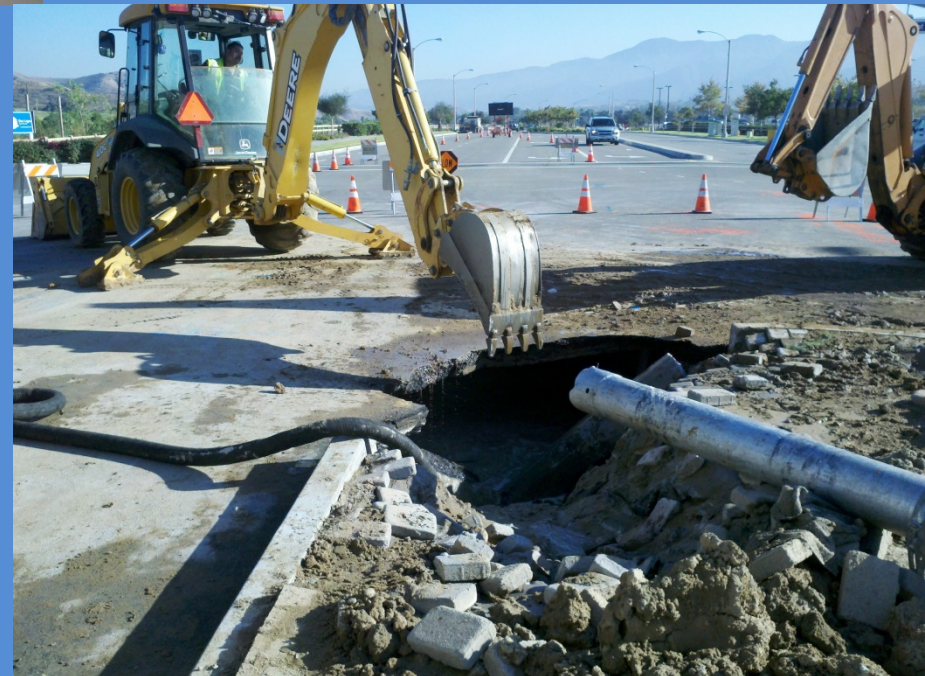
10/18/2011

# Brine Line Spill Oct 2011

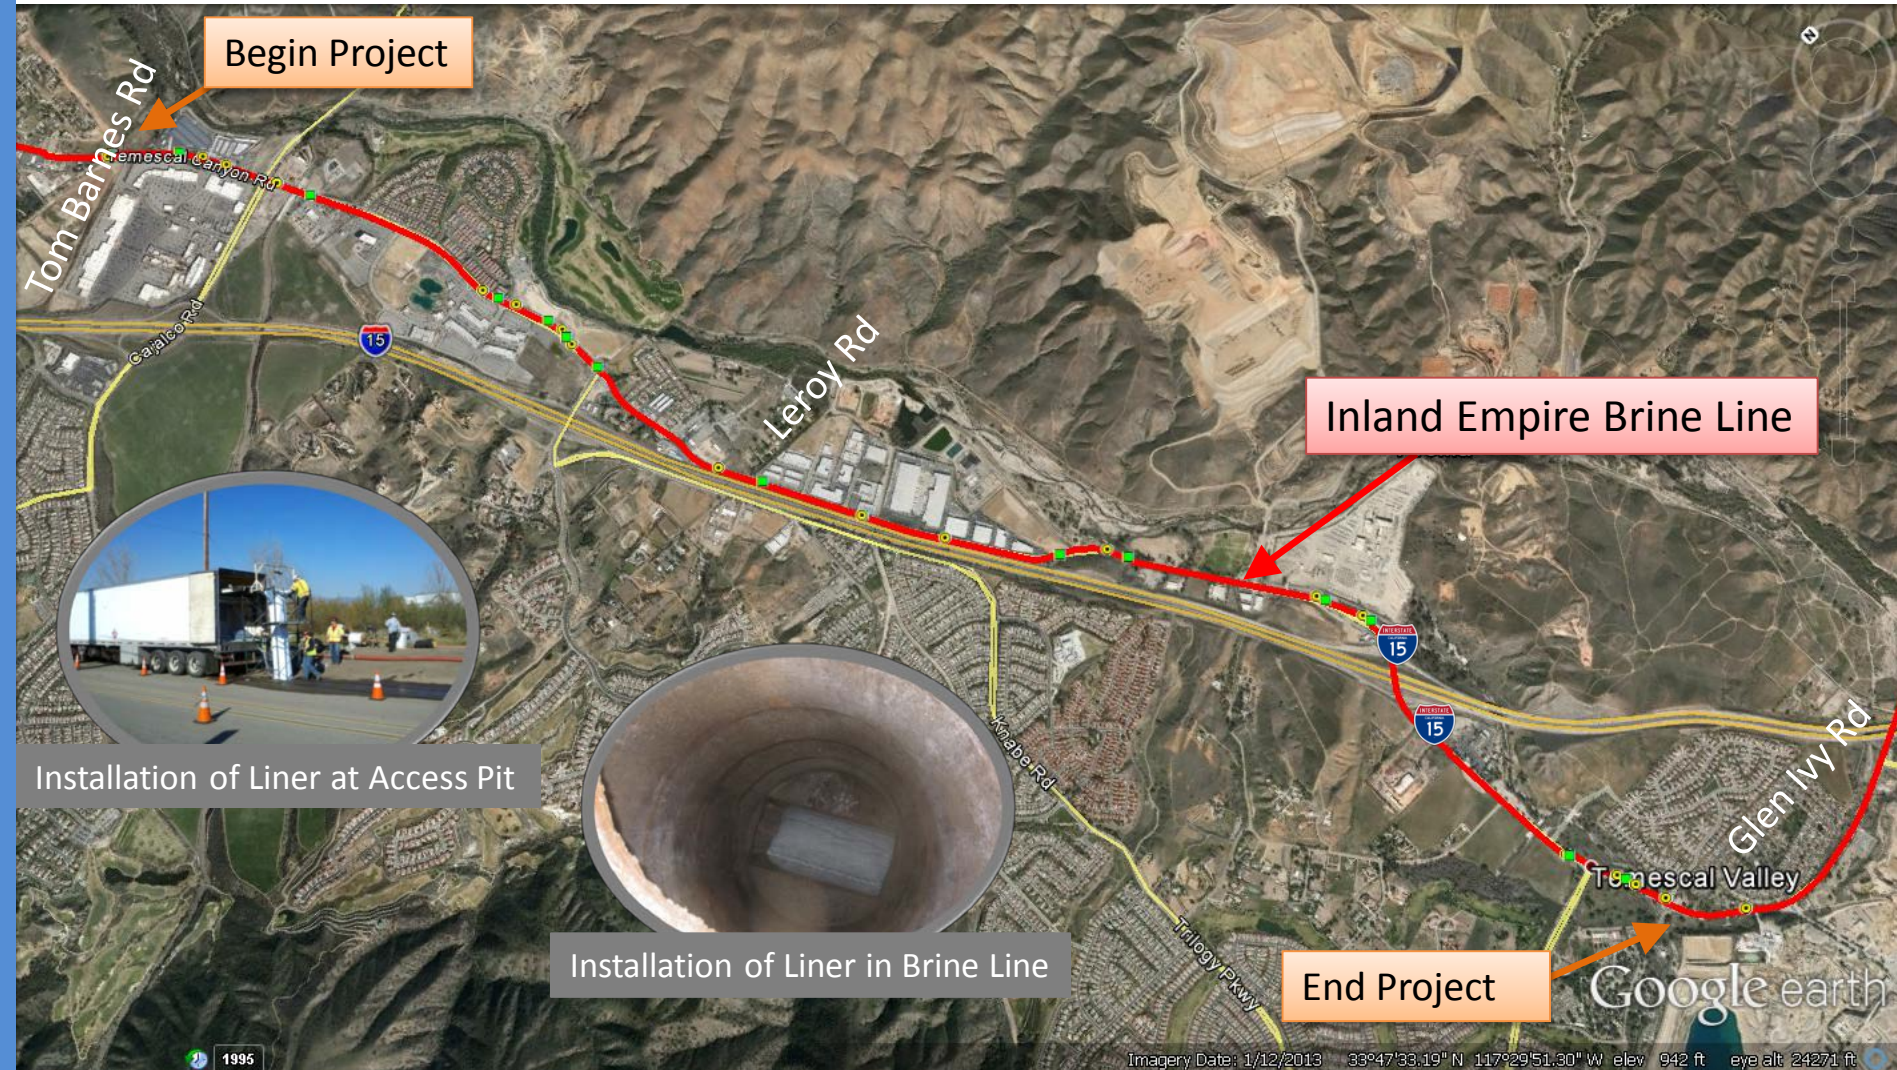
Begin Project

Installation of Liner at Access Pit

Installation of Liner in Brine Line

End Project

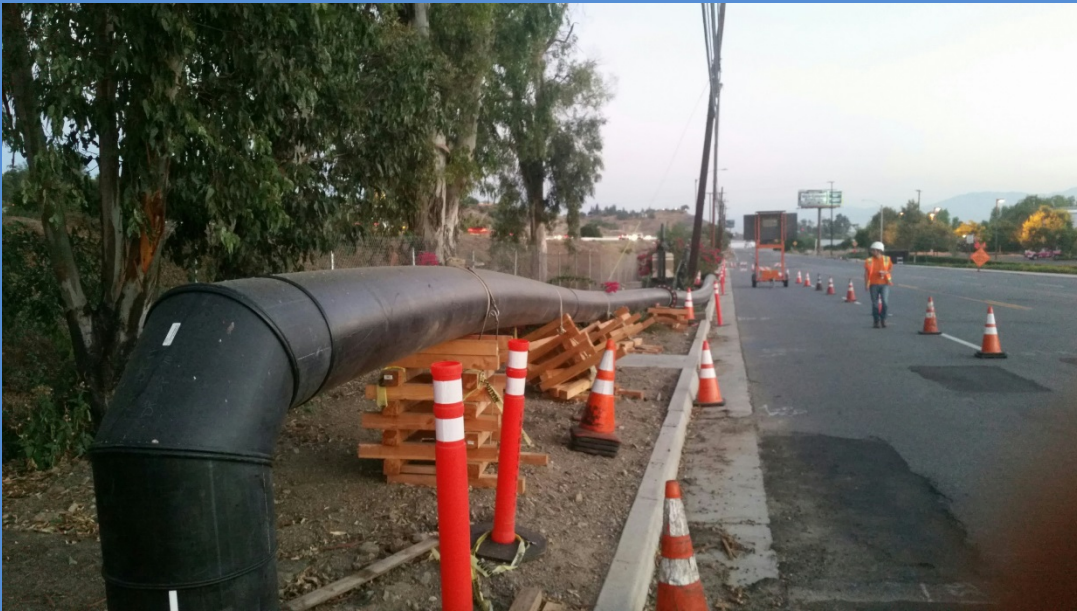
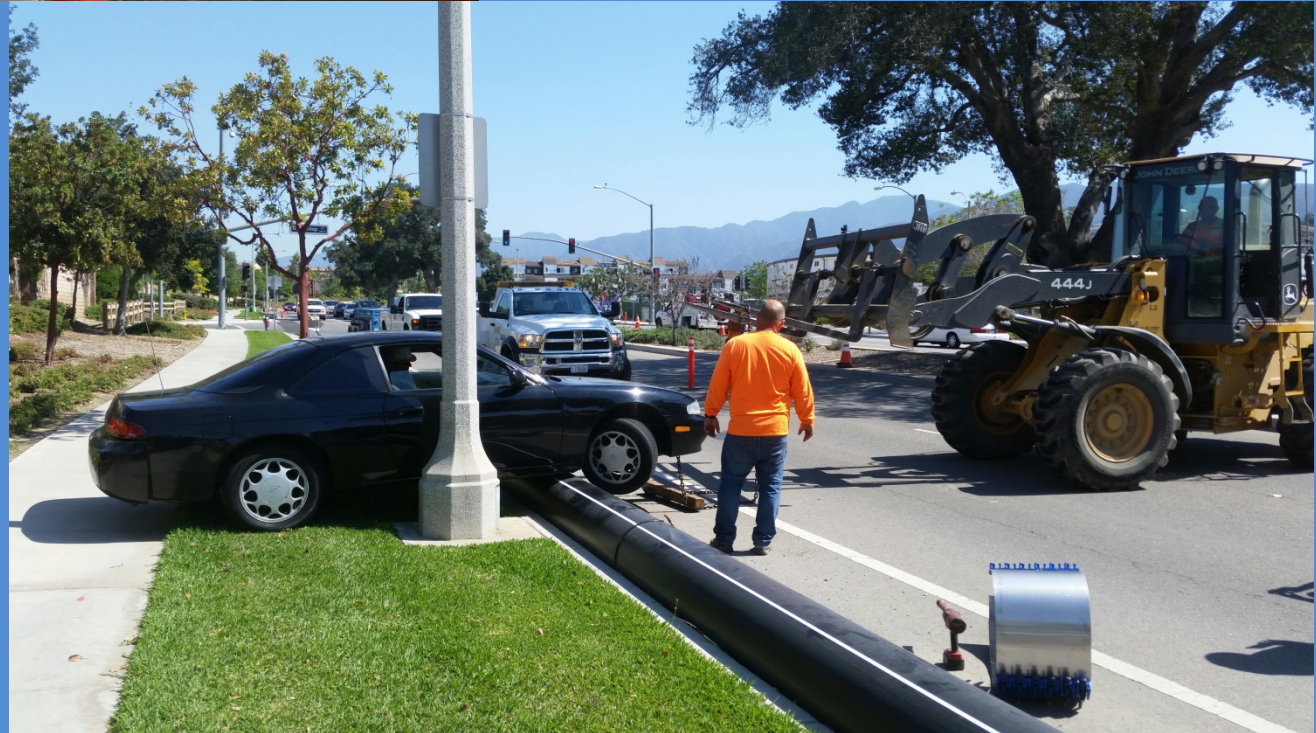
# By-Pass Line Risks
