Inland Empire Brine Line
Reach V Rehabilitation and
Improvement Project – Phase 1

January 3, 2017

Inland Empire Brine Line

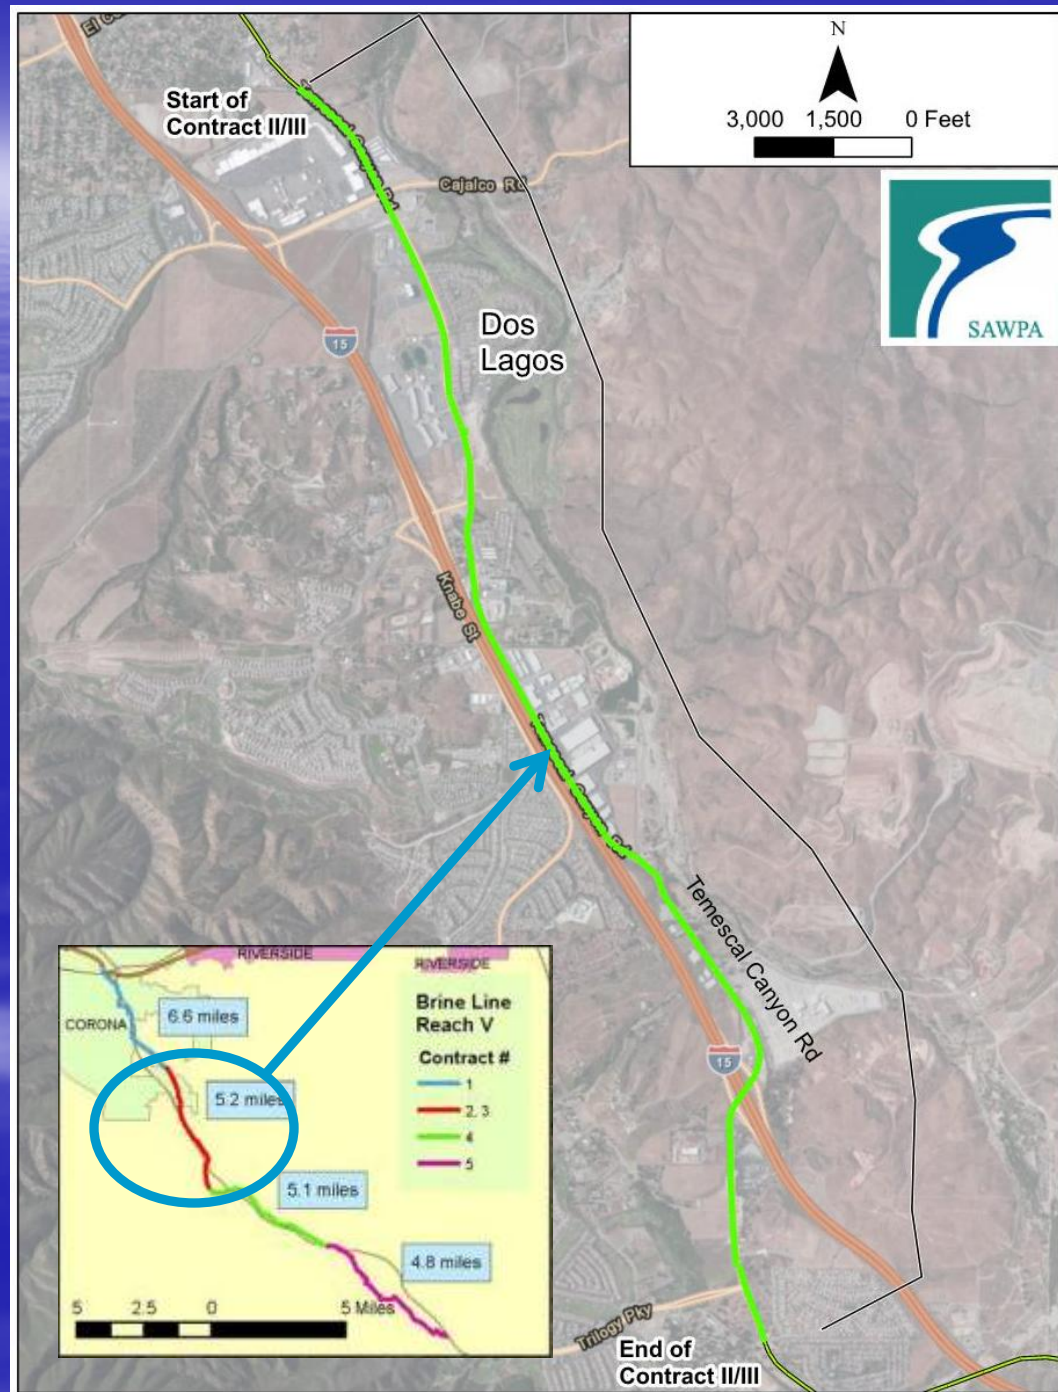
- Constructed in 2001
- 26,000 ft of 24" PVC
- Gravity and Low Pressure
- Major flow contributors from EMWD:
 - Power plant
 - Two desalters
 - Industrial manufacturer

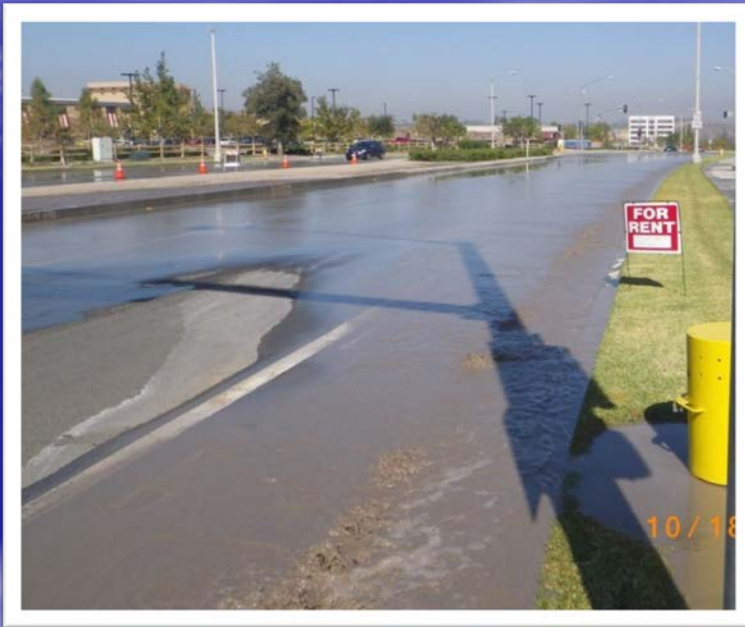
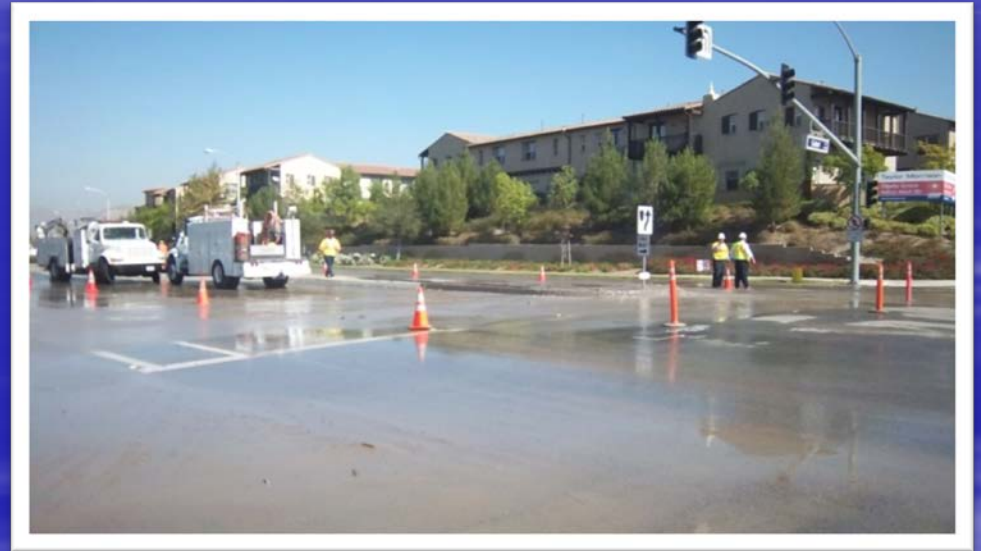
October 18, 2011 SSO at Temescal Canyon Road and Cabot Road

- Cause of Failure Unknown
- Pipe was oval in shape
- Initiate investigation (collect data)

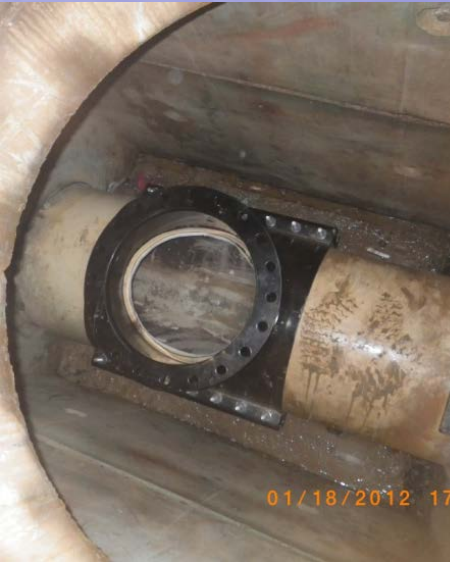
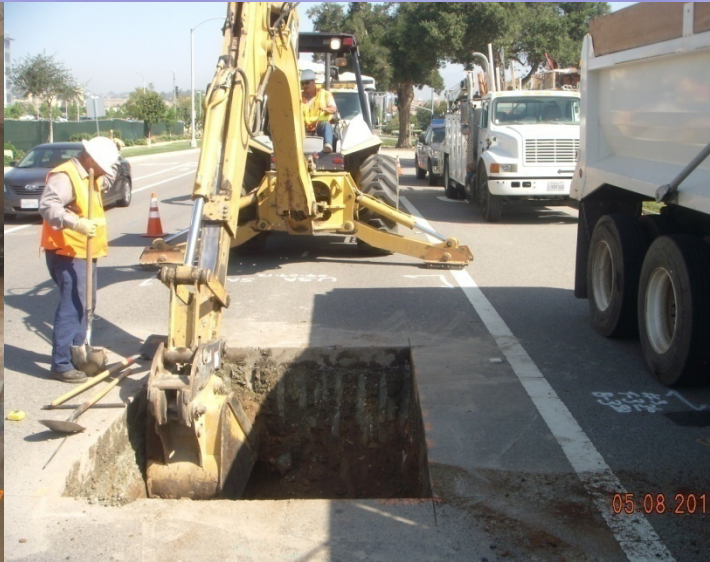
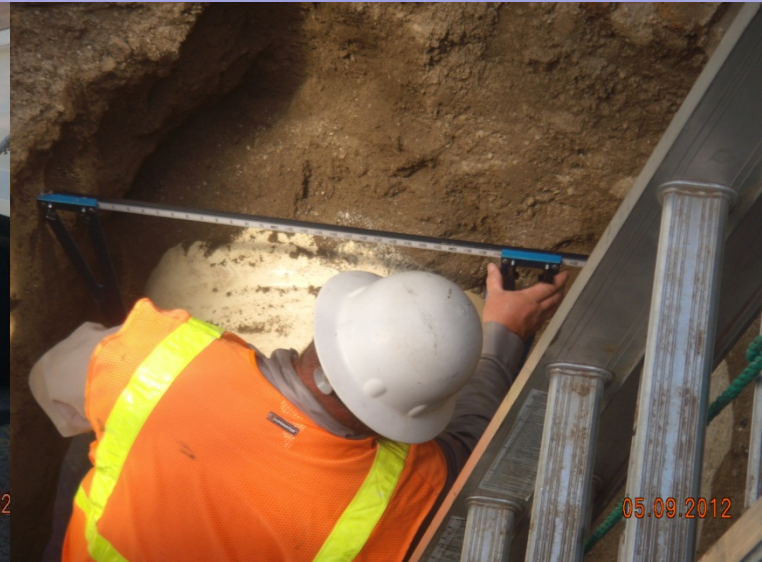
Investigative Work

- Added 3 access points for CCTV
- Pothole to determine location of pipe
- Construct test pits
 - Determine soil composition and compaction
 - Measure pipe ovality

- Determined likely cause of pipe failure
 - Poor installation /compaction
 - Lack of specified bedding material
 - Poor sidewall support
 - Rocks in pipe zone
 - Added roadway fill
- Evaluated repair/replacement
- Developed list of recommended actions

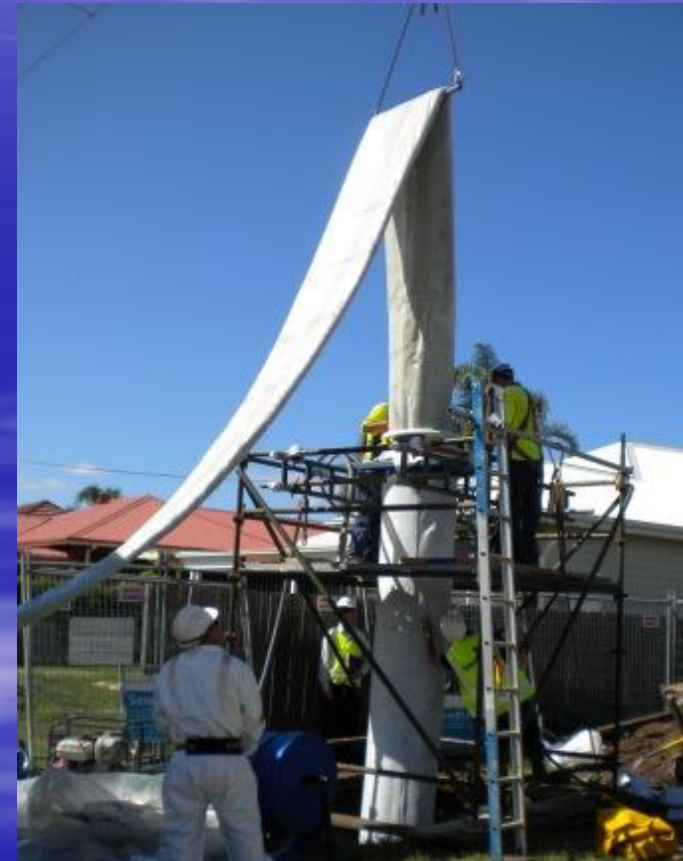
- ~~Pressure Grouting~~
- ~~Tight Fit Lining~~
- ~~Pipe Bursting~~
- ~~Open Cut Replacement~~
- Pressure Cured-In-Place Lining (CIPP)
 - Cost \$11.5 \$16.3 Million

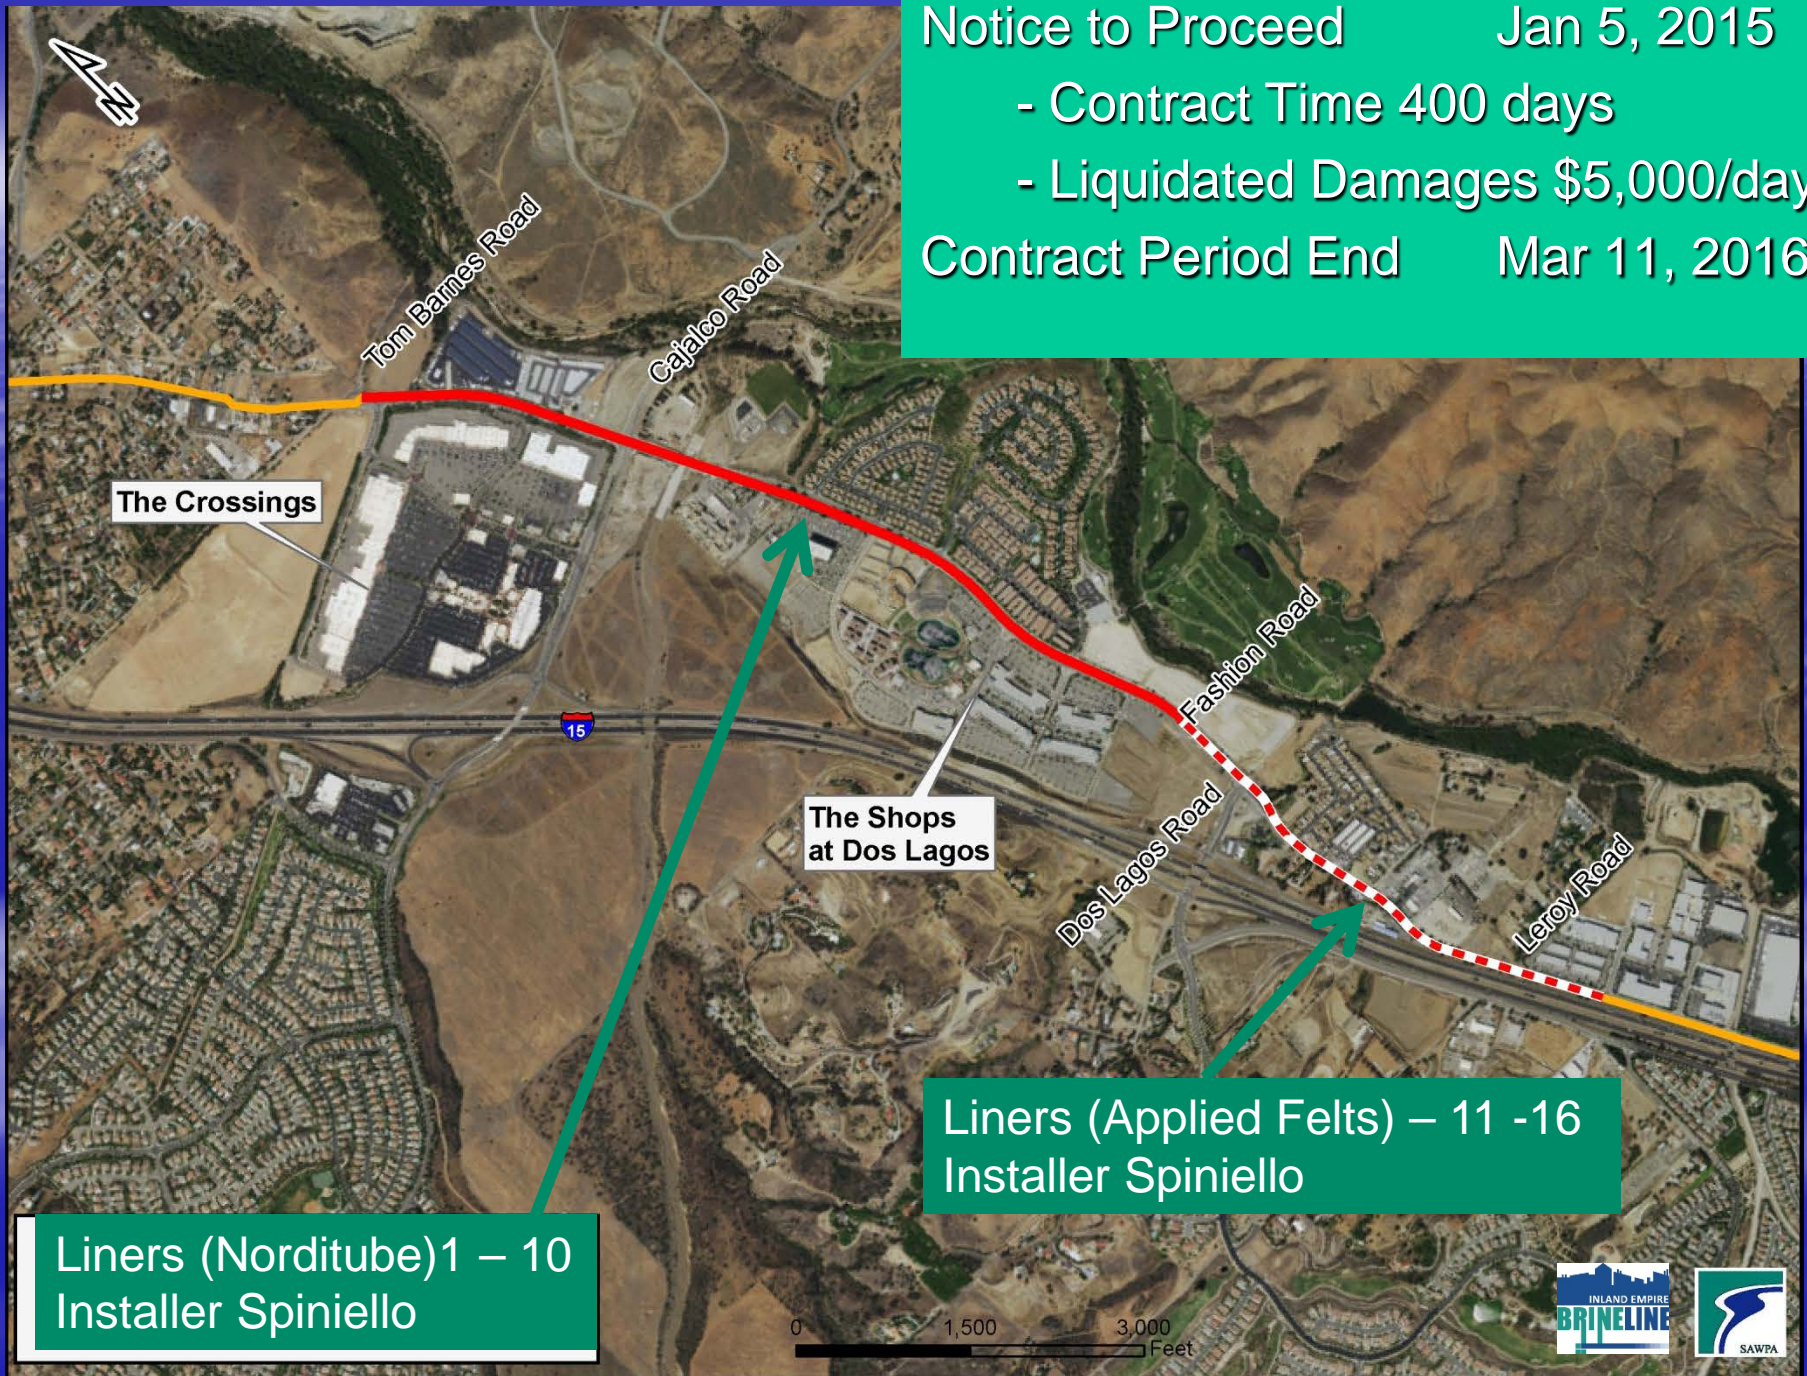
Liners (Norditube) 1 – 10
Installer Spiniello

Liners (Applied Felts) – 11 -16
Installer Spiniello

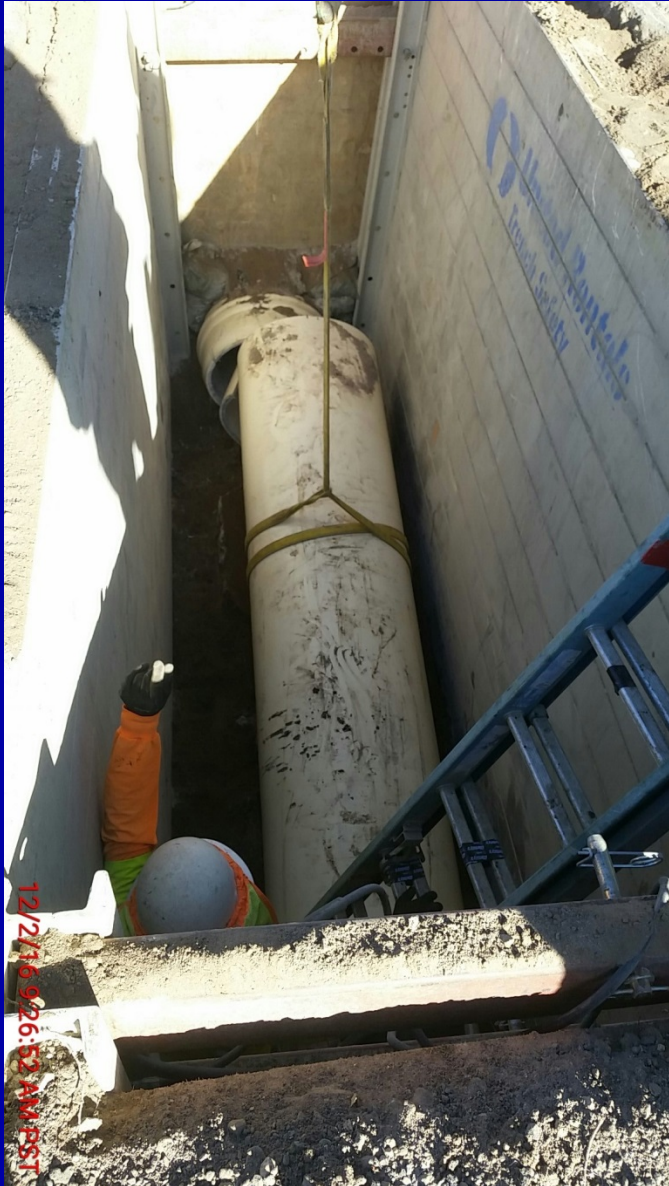
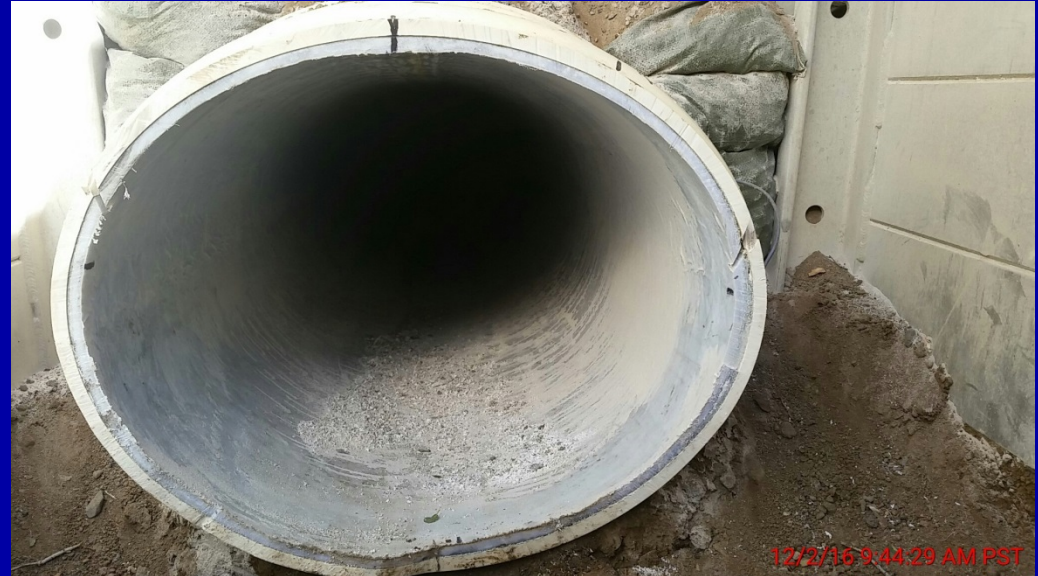
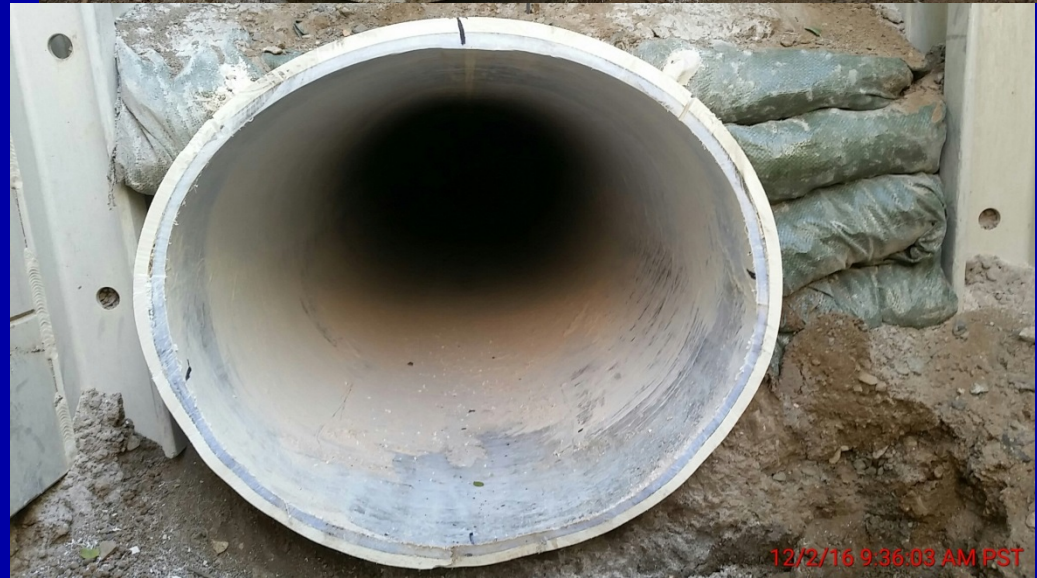
■ 14-1

North End 10.8%

South End 7.4%

11-1	4% - 8%
11-2	N/A - 7%
12-1	3% - 7%
12-2	4% - 4%
13-1	6% - 9%
13-2	4% - 5%
14-1	7% - 11%
14-2	5% - 6%
16-1	2% - 8%
16-2	2% - 6%

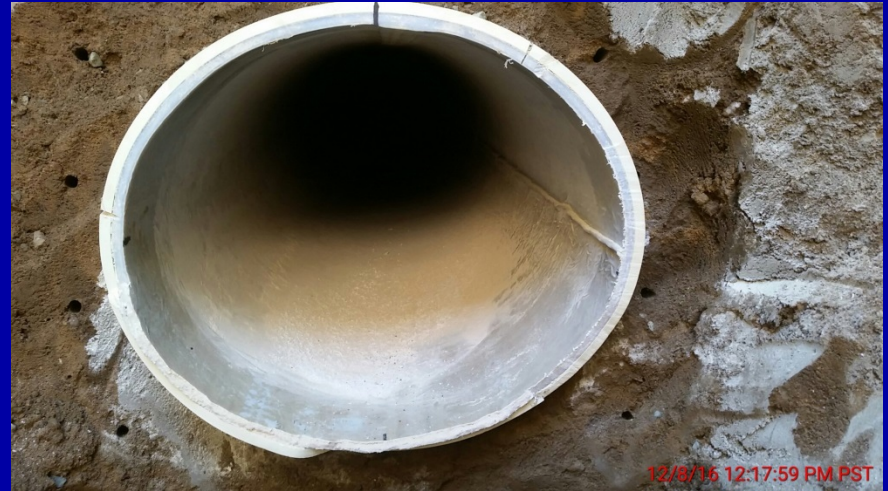
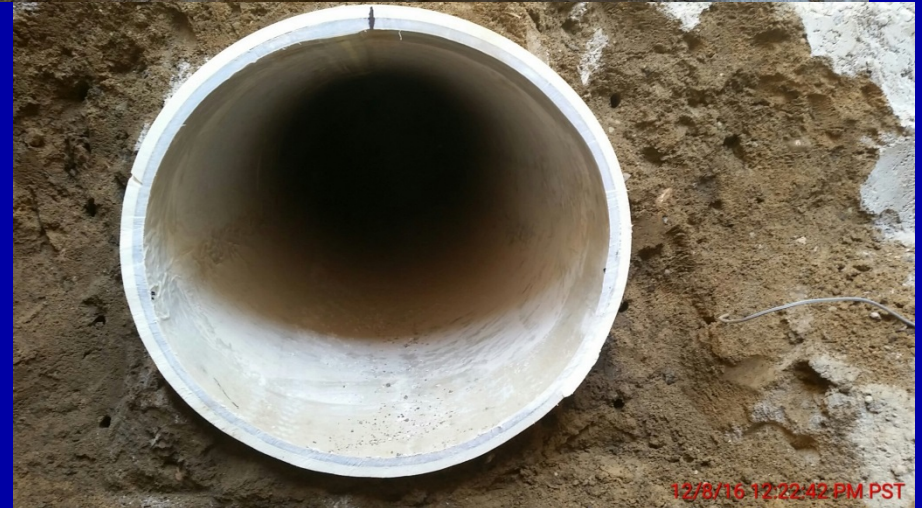
■ 16-2

South End 6.1%

North End 1.7%
