Technical Memorandum

To: Stormwater Quality Standards Task Force

Subject: Recreational Use Survey Data Report – Santa Ana Delhi Channel

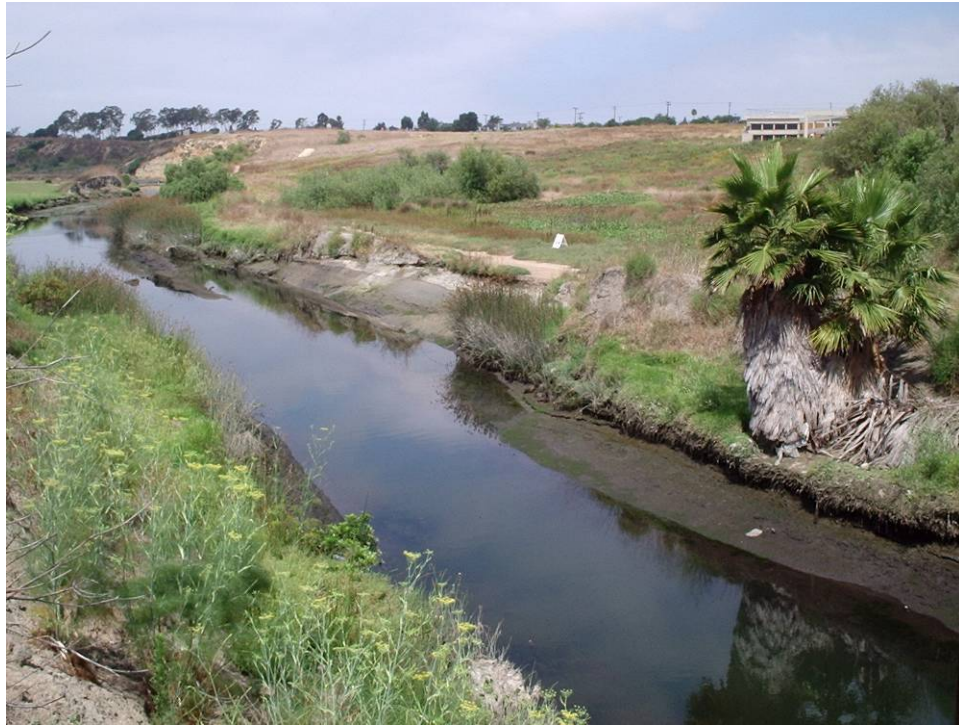
Figure 2a
Photo of the Santa Ana Delhi Channel at the Upper Newport Bay
Recreational Use Survey Location

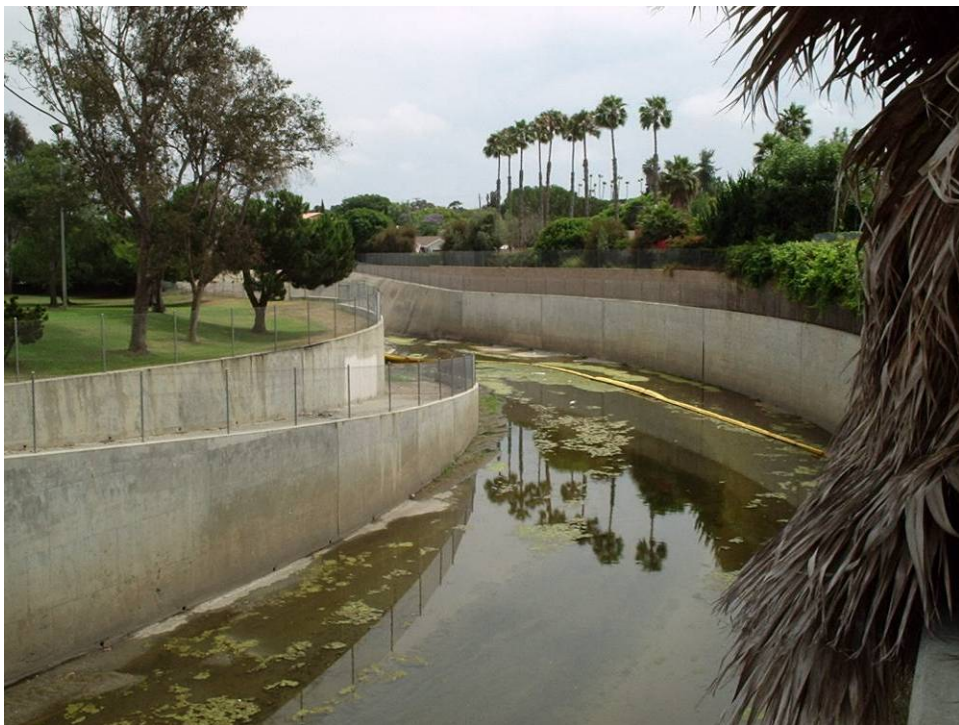
Figure 2b
Photo of the Santa Ana Delhi Channel at the Mesa Avenue
Recreational Use Survey Location

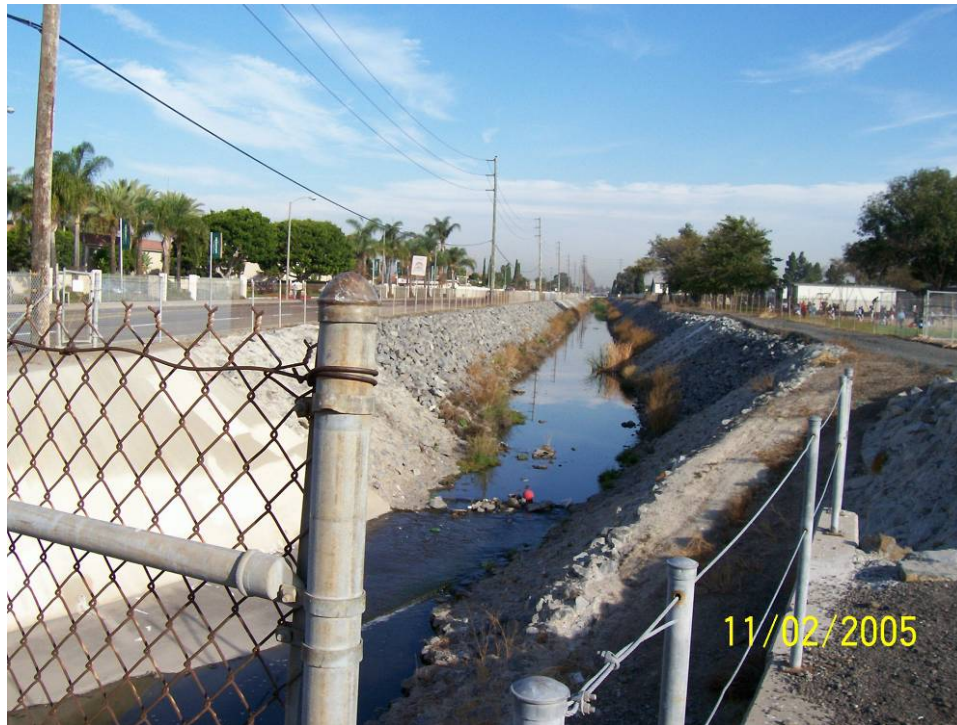
Figure 2c
Photo of the Santa Ana Delhi Channel at the Sunflower Avenue
Recreational Use Survey Location

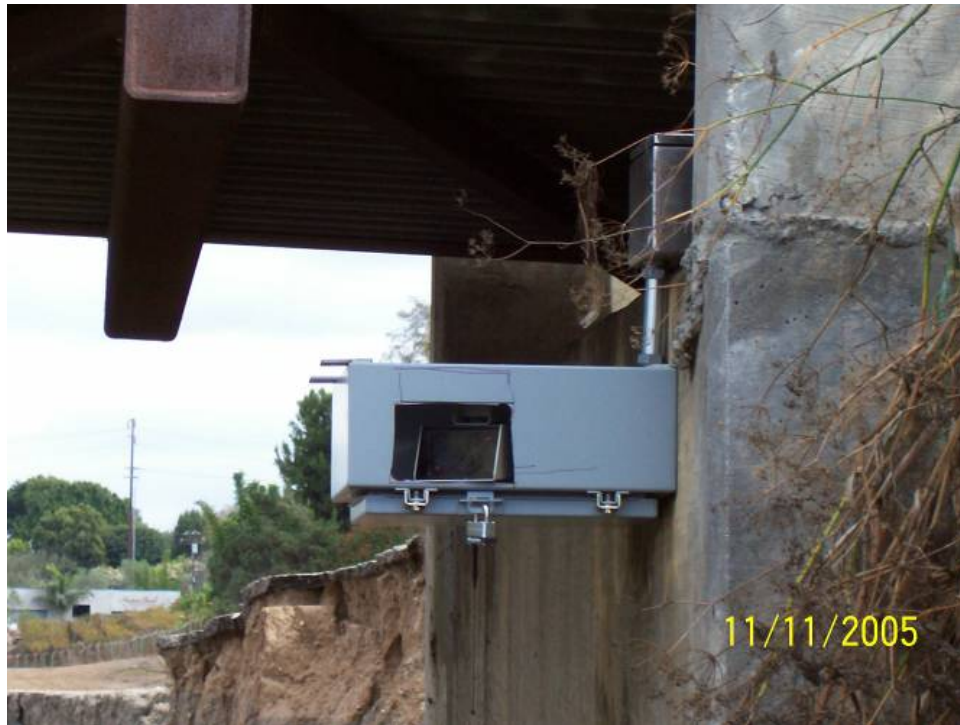
Figure 3a
Photo of the Santa Ana Delhi Channel at the Upper Newport Bay
Recreational Use Survey Camera Installation

Advanced digital cameras and data transfer technology, coupled with weekly on-location physical surveys were used to collect recreational use data at each location. Observer IV™ cameras were equipped with cellular data transmission equipment to collect an image at each location every fifteen minutes, and transfer the image to a secure data storage server via a file transfer protocol (FTP) site. Weekly site visits were conducted to log recreational use observations, and monitor and maintain the image collection equipment. This survey design was selected to provide unprecedented levels of data to characterize recreational use. Figure 3 shows the final camera installation at each of the recreational use survey locations.

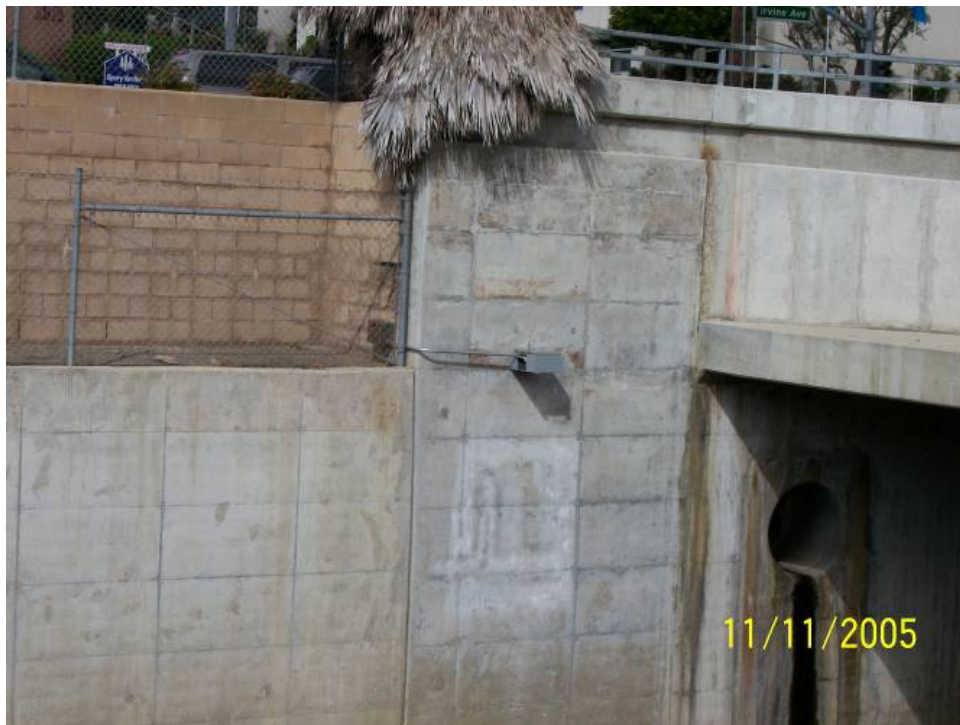
Figure 3b
Photo of the Santa Ana Delhi Channel at the Mesa Avenue Recreational Use
Survey Camera Installation

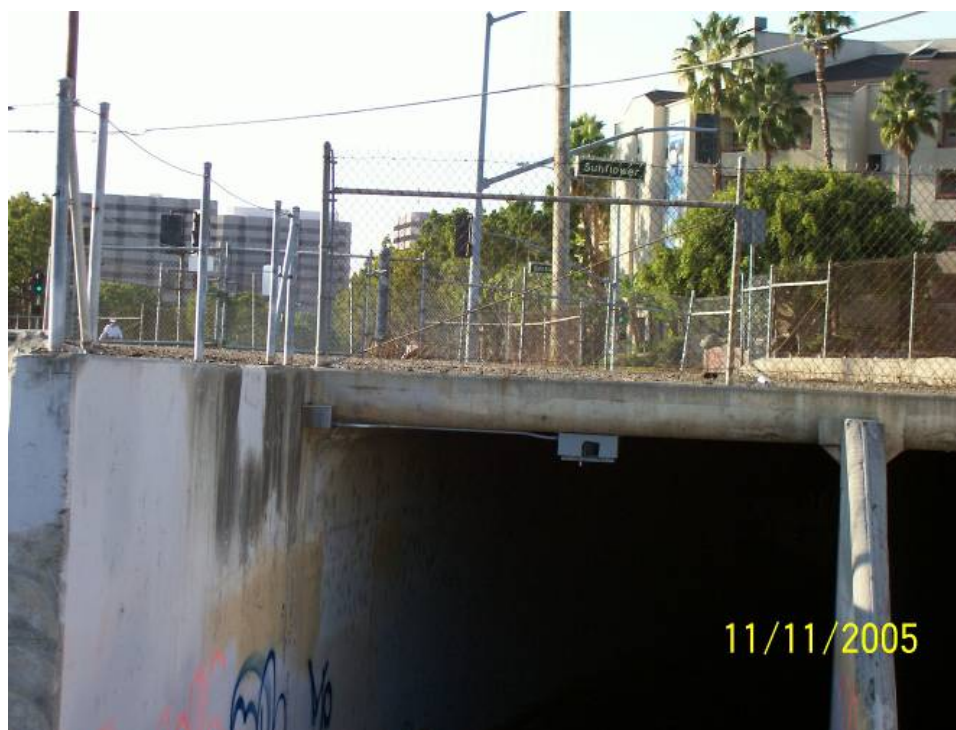
Figure 3c
Photo of the Santa Ana Delhi Channel at the Sunflower Avenue
Recreational Use Survey Camera Installation
