Technical Memorandum

То:	Stormwater Quality Standards Task Force				
From:	CDM				
Date:	November 24, 2006				
Subject:	Recreational Use Survey Data Report – Temescal Wash

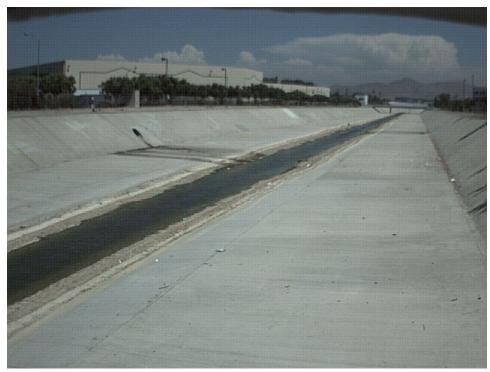
Figure 2a Photo of Temescal Wash at Main Street Location

The Main Street camera was vandalized beyond repair on the ninth day of operation. A replacement camera was subsequently installed upstream of Main Street at the WWTP location and the survey at the Main Street location was abandoned. The WWTP location was selected because it was more secure and had the same general physical channel characteristics as the Main Street location. Figure 1 illustrates these survey locations and depicts the physical characteristics at each location on Temescal Wash. Photos show the general conditions of Temescal Wash in the vicinity of the survey locations (Figure 2).

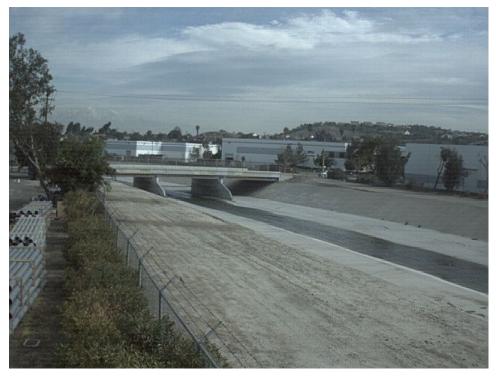
Figure 2b Photo of Temescal Wash at the City of Corona WWTP No. 2 Location

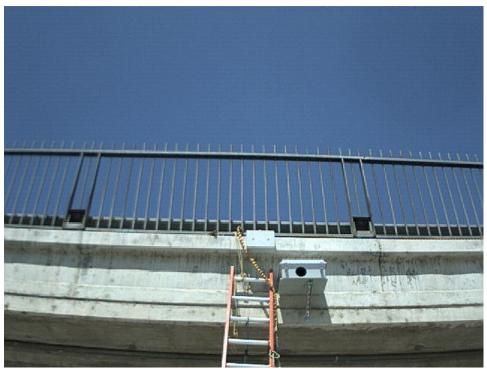
Figure 3a Photo of the Recreational Use Survey Camera Installation for Temescal Wash at Main Street

Advanced digital cameras and data transfer technology, coupled with weekly on-location physical surveys were used to collect recreational use data. Observer IV TM cameras were equipped with cellular data transmission equipment to collect an image every fifteen minutes, and transfer the image to a secure data storage server via a file transfer protocol (FTP) site. Weekly site visits were conducted to log recreational use observations, and to monitor and maintain the image collection equipment. This survey design was selected to provide unprecedented levels of data to characterize recreational use. Figure 3 shows the final camera installation at each of the recreational use survey locations.

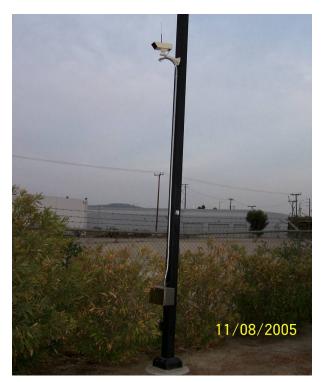
Figure 3b Photo of the Recreational Use Survey Camera Installation for Temescal Wash at WWTP

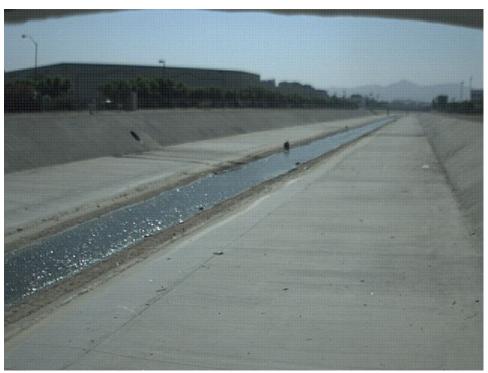
Contact Recreation: 7/27/2005 10:00

Table 3 Water Contact Recreation Events Recorded for Temescal Wash					
Location / Date	Lime Duration (min)		Magnitude of Contact	Image ID	
Temescal Wash at Main Street					
7/27/2005	10:00	< 30	Below Ankle	Temescal-05-07-27-10-00	
Temescal Wash at the City of Corona WWTP No. 2					
7/1/2006	13:30	< 30	Below Ankle	Temescal-06-07-01-13-30

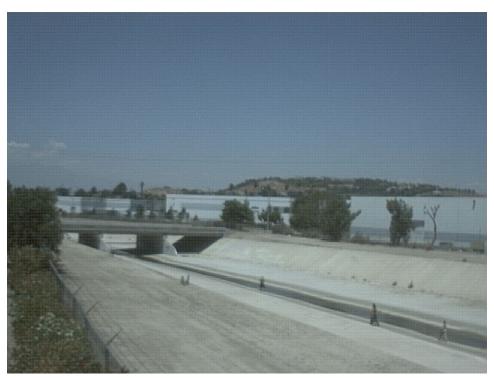
Contact Recreation: 7/1/2006 13:30
