Technical Memorandum

Subject: Recreational Use Survey Data Report – Demens Channel

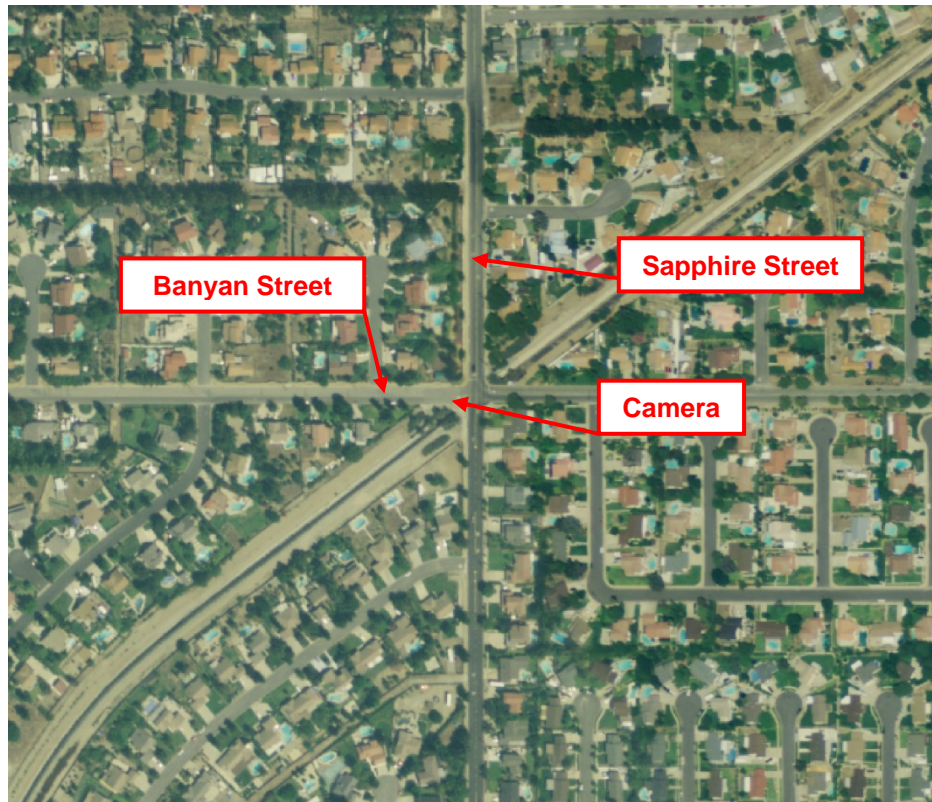
Figure 1
Demens Channel Survey Location

The location for this study was Demens Channel located downstream of the intersection of Banyan Street and Sapphire Street in the City of Rancho Cucamonga. Figure 1 presents an aerial photo of the survey location. The predominant land use immediately surrounding the survey location is residential. As shown in Figure 2, Demens Channel is a vertical walled, concrete lined channel in the vicinity of the survey location.

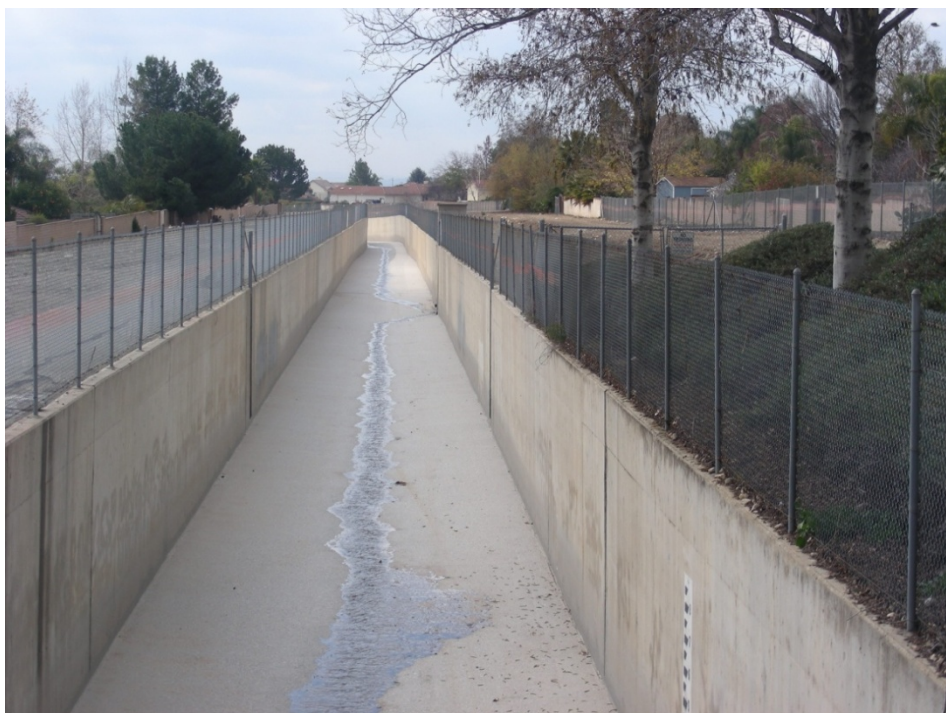
Figure 2
Photo of Demens Channel Survey Location

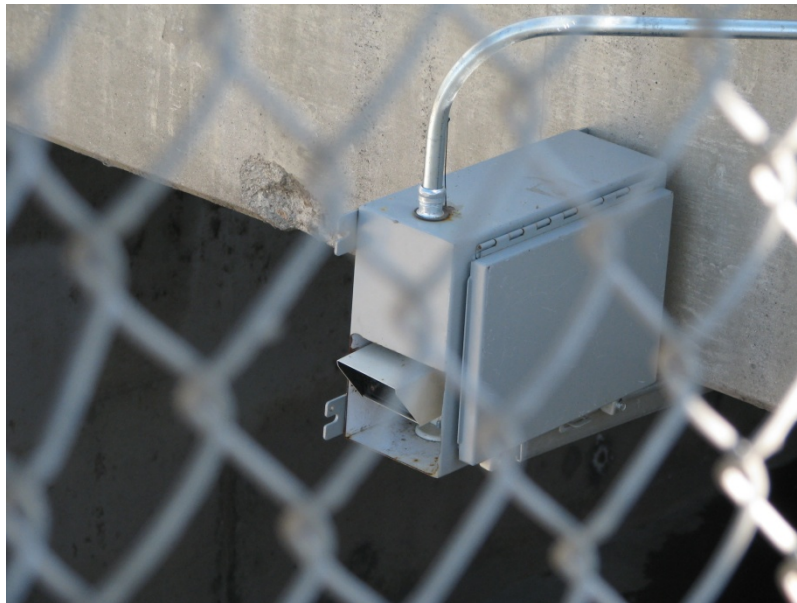
Figure 3
Photo of the Recreational Use Survey Camera Installation for Demens Channel

A camera was installed at the intersection of Banyan Street and Sapphire Street where the Sapphire Street bridge crosses over Demens Channel. Figure 3 shows the camera installation.
