# Technical Memorandum 3

## Flow and Water Quality Data Inventory and Characterization

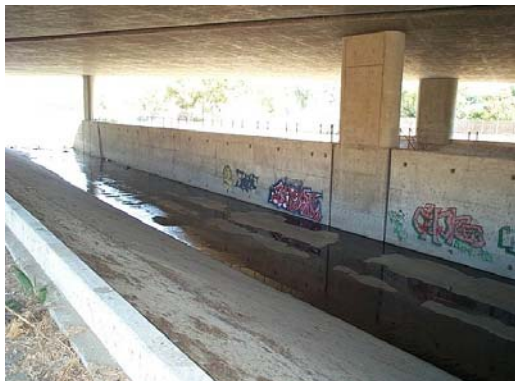
**Figure 26**  
**Graffiti in bottom of Chino Creek**

During the CDM site visit, the channel access gate was unlocked allowing easy access to the water. The gentle side slope of the channel would enable visitors to easily walk to the stream; and in fact the presence of graffiti and trash provided evidence that people had recently accessed this section of Chino Creek (Figure 26). This section of Chino Creek is located within a highly developed area of the city of Chino, with State Route 71 on the left bank and a shopping plaza on the right bank (Figure 27). With regards to the sites recreational appeal, the site generally received low scores (Figure 28).

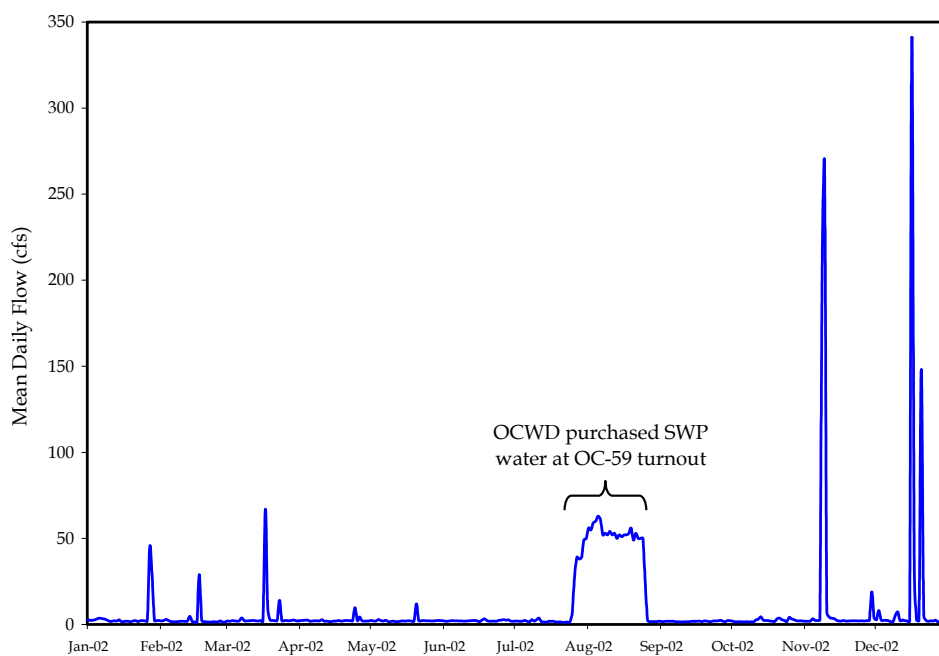
**Figure 30**  
**Mean Daily Flow in Chino Creek at Schaeffer Avenue during 2002**

However several instances of elevated flow occur without a corresponding rainfall event. During such periods, measured flow is elevated from typical dry weather baseflow (1 to 5 cfs) by one order of magnitude for about 30 days. Consultation with Orange County Water District (OCWD) indicated that these prolonged non-rainfall high flow events are the result of a water purchase from the State Water Project (SWP) or conveyed via Chino Creek to increase groundwater recharge downstream of Prado Dam in Orange County. A subset of the mean daily flow record provides an example of one of these water purchase events in August 2002 (Figure 30).

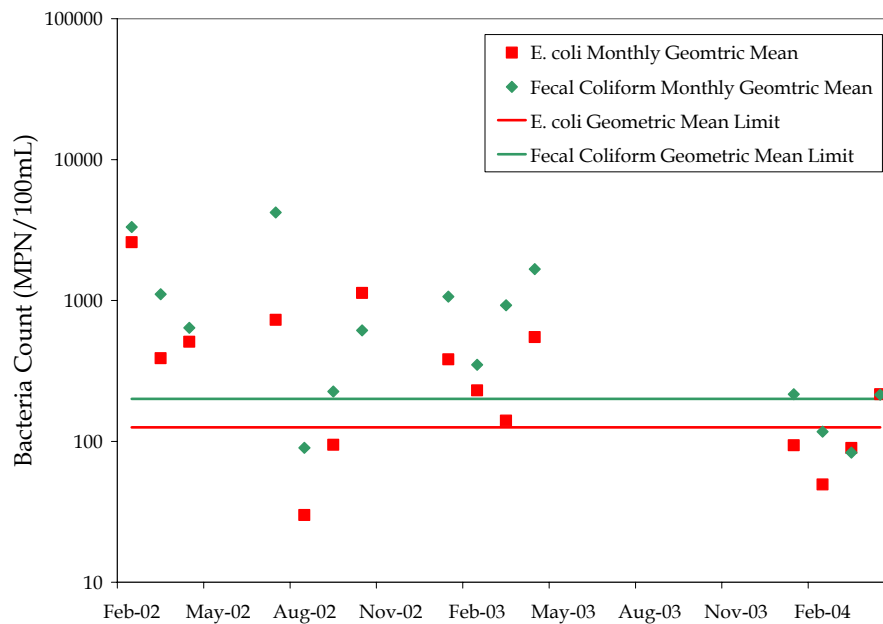
**Figure 36  
 Monthly Bacteria Geometric Mean Concentrations at Chino Creek at Schaeffer Avenue**

Month	E. coli Geometric Mean	Fecal Coliform Geometric Mean	Sample Size
Feb-02	2592	3318	5
Mar-02	390	1109	4
Apr-02	510	640	1
Jul-02	730	4219	4
Aug-02	30	90	1
Sep-02	95	226	3
Oct-02	1131	615	2
Jan-03	382	1063	4
Feb-03	230	350	1
Mar-03	140	925	3
Apr-03	550	1669	2
Jan-04	94	216	3
Feb-04	49	117	4
Mar-04	90	83	5
Apr-04	216	215	2

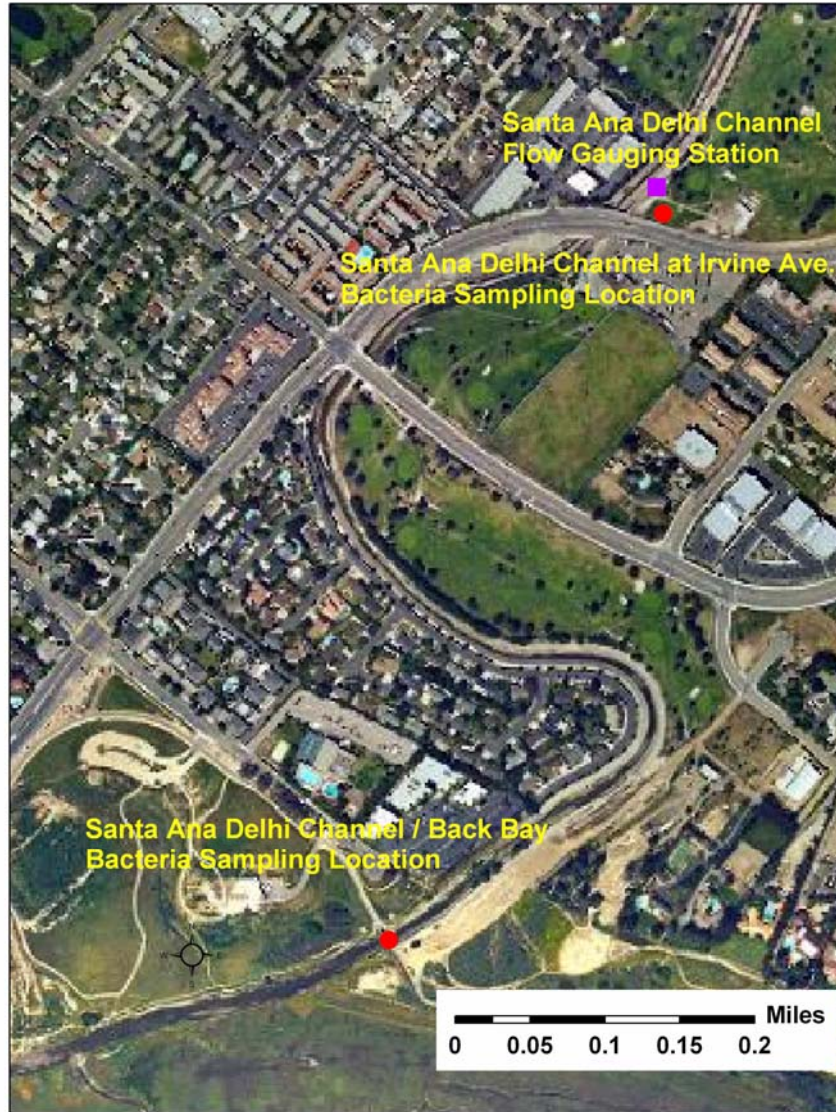
**Figure 39**  
**Aerial Photograph of the Santa Ana Delhi Channel Study Site**

The Santa Ana Delhi Channel (Figure 39) extends from the city of Santa Ana to Upper Newport Bay. At Irvine Avenue, the conveyance is a concrete lined rectangular channel with a 55 ft bottom width (Figure 40 and Figure 41). Channel attribute information was provided by Orange County Flood Control District and field verified during a site visit. The bed slope of the channel at this site is 2.5 percent.

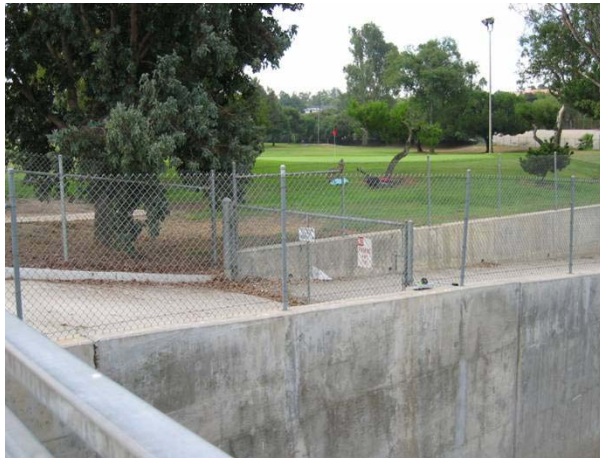
**Figure 45**  
**Fencing around Santa Ana Delhi Channel Prevents Access to Waterbody**

The steep side slopes, fencing, and restrictive signs minimize the likelihood of recreational use at this study site (Figure 45 and Figure 46). Although recreational use is not likely to occur within the Santa Ana Delhi Channel itself, the site is immediately upstream of Upper Newport Bay, an inland surface water that supports a diversity of REC-1 uses (Figure 47).

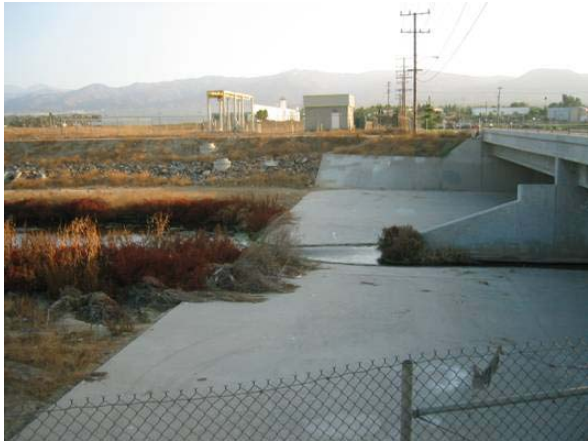
**Figure 59**  
**Temescal Creek transitions from concrete lined to natural below Lincoln Avenue Bridge**

Temescal Creek is a concrete lined trapezoidal channel upstream of Lincoln Avenue. Downstream of Lincoln Avenue the channel transitions from concrete lined to a more natural channel (Figure 58 through Figure 60). The concrete trapezoidal channel section has a 60 ft bottom width and 1.5:1 side slopes; the channel bed slope is 2.0 %. Flow is monitored in Temescal Creek near Main Street, approximately 1 mile upstream of the bacteria sampling location.

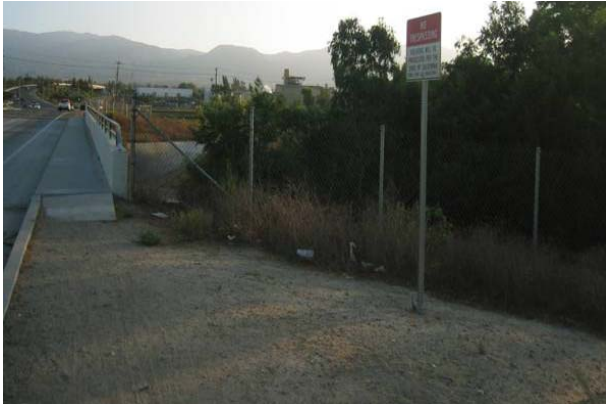
**Figure 64**  
Fencing and signs prohibiting access to Temescal Creek from the Lincoln Avenue Bridge

Two locations were evaluated for recreational appeal at the Temescal Creek study site, upstream and downstream of the Lincoln Avenue Bridge (Figure 63). At the Lincoln Avenue bridge, the site was fenced and signs were posted prohibiting trespassing; however, the fence could be easily bypassed (Figure 64). Upstream of the Lincoln Avenue Bridge, where Temescal Creek is concrete lined, no direct and little indirect evidence of recreation activity was observed. In the natural channel section downstream of the Lincoln Avenue Bridge, trails with recent footprints led from the road to the stream, indicating that people do access this reach of Temescal Creek (Figure 65). Upstream and downstream of Lincoln Avenue, the channel side slopes are gradual enough to provide easy access to the stream.

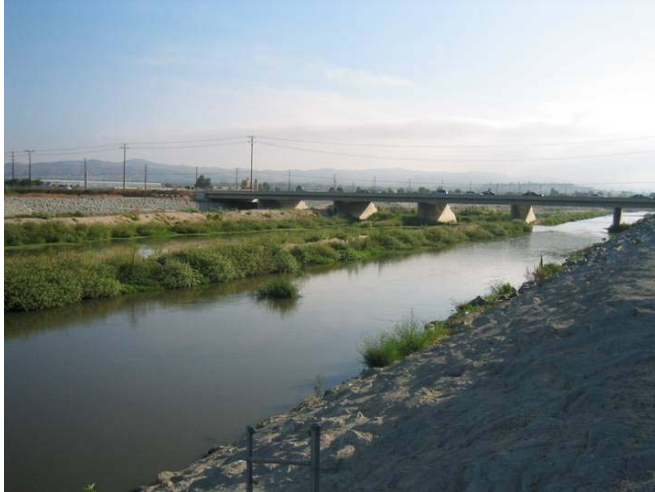
**Figure 76**  
**Santa Ana River downstream of Imperial Highway**

This reach of the Santa Ana River at Imperial Highway has a natural bottom and is about 200 ft wide (Figure 75 and Figure 76). The river banks, which have an approximately 1:1 side slope, are reinforced with riprap in some locations (Figure 77). The bed slope of the channel is 2.0 %.

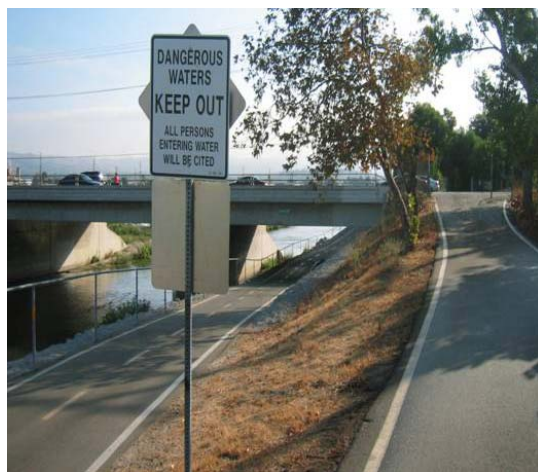
**Figure 79**  
**Signs prohibiting entrance into Santa Ana River at the Imperial Highway**

Evidence of the potential for recreational activity in the Santa Ana River at the Imperial Highway crossing was assessed during a site visit (Figure 78). This site was entirely fenced, and posted signs prohibited entrance to the river (Figure 79). Regardless, indirect evidence of recreational activity was observed, e.g., human footprints, trails that were traced to the waters edge, and trampled vegetation. In this reach, water depths were much greater than what was observed at most other sites due to continued releases from Prado Dam (Figure 80).

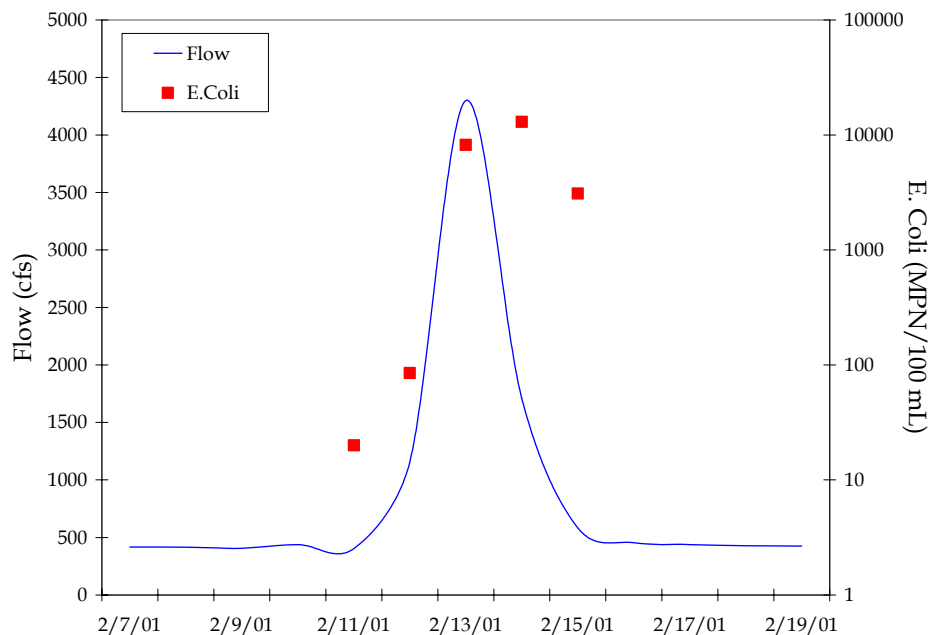
**Figure 85**  
**February 2001 Wet Weather E. coli Sampling Event**

Two separate high flow events (January 2001 & February 2001) were further analyzed with E. coli data to describe the relationship between wet weather flow and bacteria concentrations. Figure 84 and Figure 85 indicate that E. coli concentrations increased during the high flow event and then remained high for one to two days after the high flow event had ended. A recently completed study that characterized bacteria concentrations in the lower Santa Ana River during stormwater runoff events also observed this same pattern (Izbicki et al. 2004). Izbicki speculated that the elevated bacteria concentrations that persist for a few days after a wet weather event result from the re-suspension of bacteria in sediments.

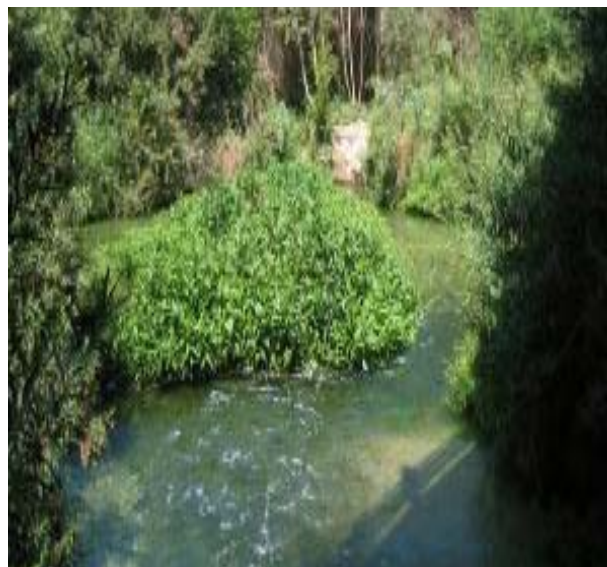
**Figure 90**  
**City of Riverside WWTP Effluent Channel**

This reach of the Santa Ana River exists within a predominantly naturally carved floodplain (Figure 89). Based on aerial photography it was estimated that the bankfull width of the Santa Ana River at MWD crossing is approximately 150 feet. Side slopes of 1:1 were estimated from field observations of the channel. The bed slope of the channel at this site is 2.0%. The study site is located upstream of the City of Riverside waste water treatment plant (WWTP) effluent channel (Figure 90)

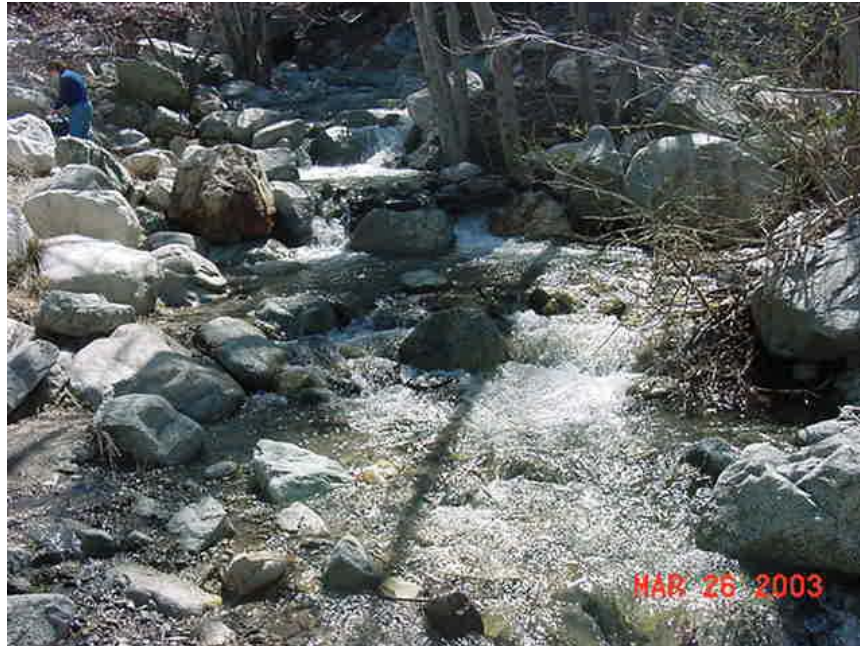
**Figure 104**  
**Icehouse Canyon Creek Study Site**

The Icehouse Canyon Creek study site is located in the Angeles National Forest at 5,100 feet above mean sea level at the Icehouse Canyon trailhead (Figure 103). The channel is a natural mountain stream about 10 feet wide with a bed slope that is significantly steeper than the other study site channels (Figure 104). This predominantly gravel bottom stream also includes large boulders and waterfalls in sections. Ambient water temperature is significantly lower than water temperatures in surface waters at lower elevations (Figure 105). These water temperatures were recorded at the time sample collection. The Icehouse Canyon Creek study site is included in the analysis to identify a background or naturally occurring bacteria condition.
