Technical Memorandum

To: Stormwater Quality Standards Task Force

From: CDM

Subject: Recreational Use Survey Data Report – Cucamonga Creek

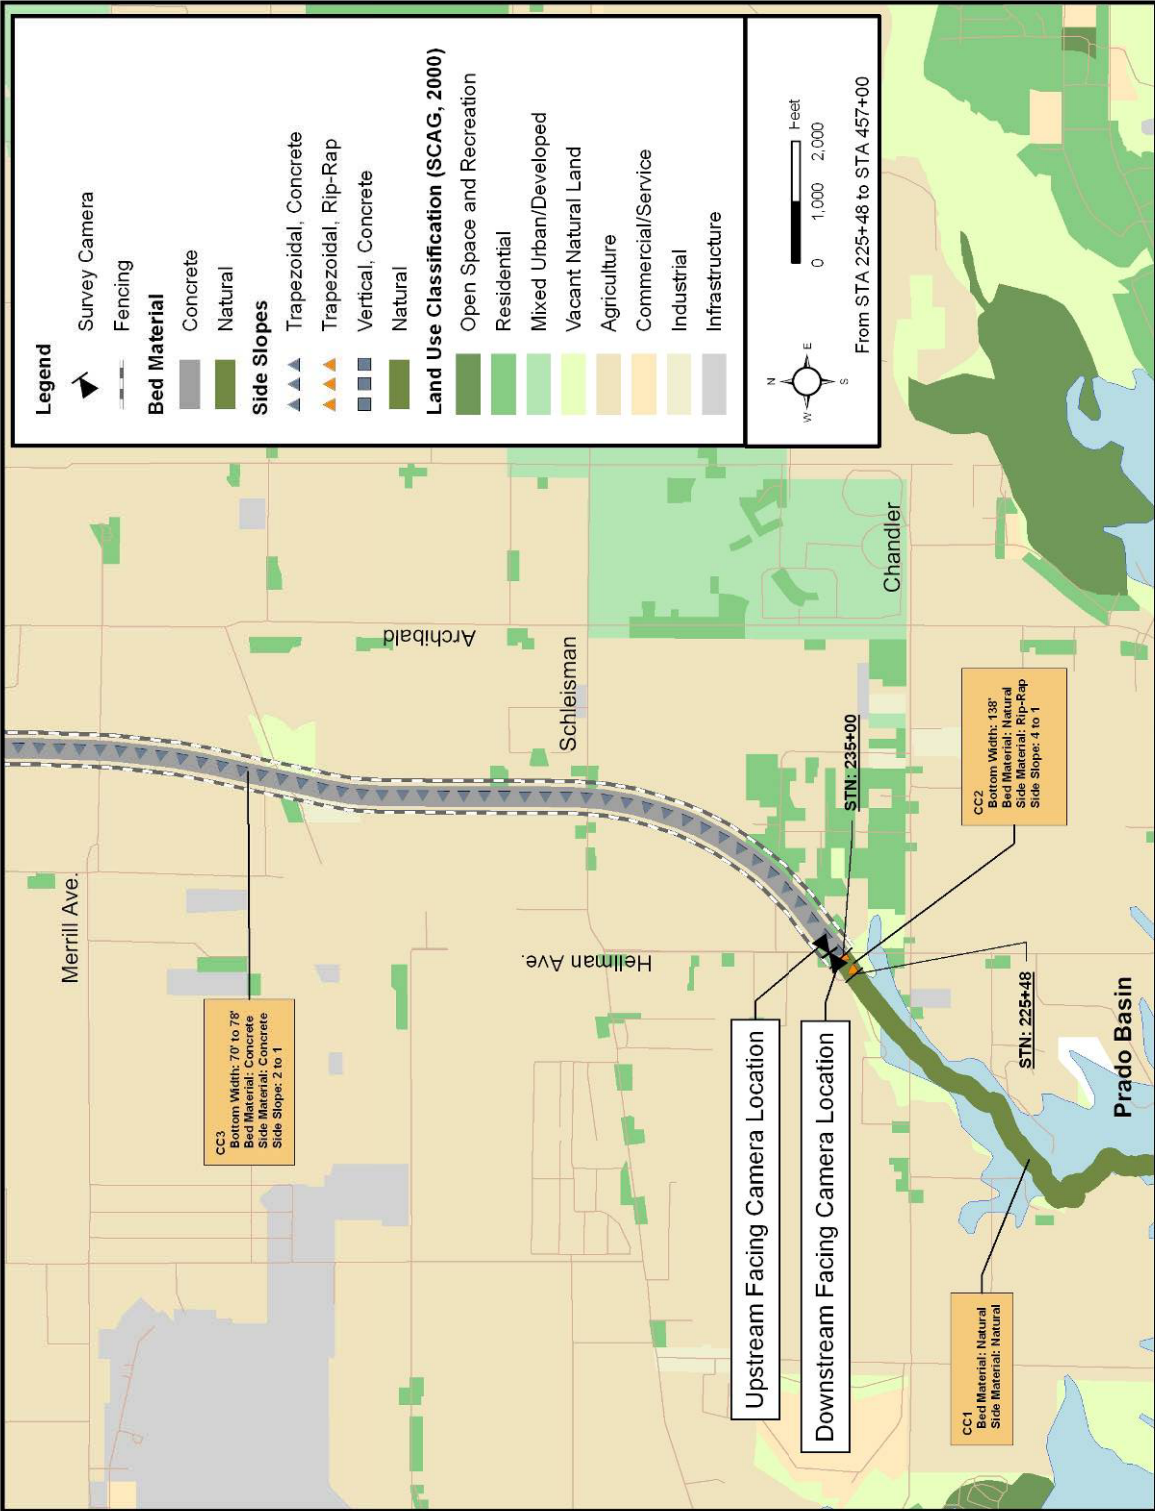
Figure 1
 Location of Recreational Use Surveys and Physical Characteristics for Cucamonga Creek

Cucamonga Creek at Hellman Avenue was selected as the survey location. Two cameras were installed at this bridge crossing, one facing upstream at a concrete lined section of the channel, and one facing downstream, where the channel transitions into a more natural condition prior to entering the Prado Basin.

Figure 1 illustrates the survey location and depicts the physical characteristics of Cucamonga Creek upstream and downstream of Hellman Avenue. Photos show the general conditions of Cucamonga Creek in the vicinity of the location (Figure 2).

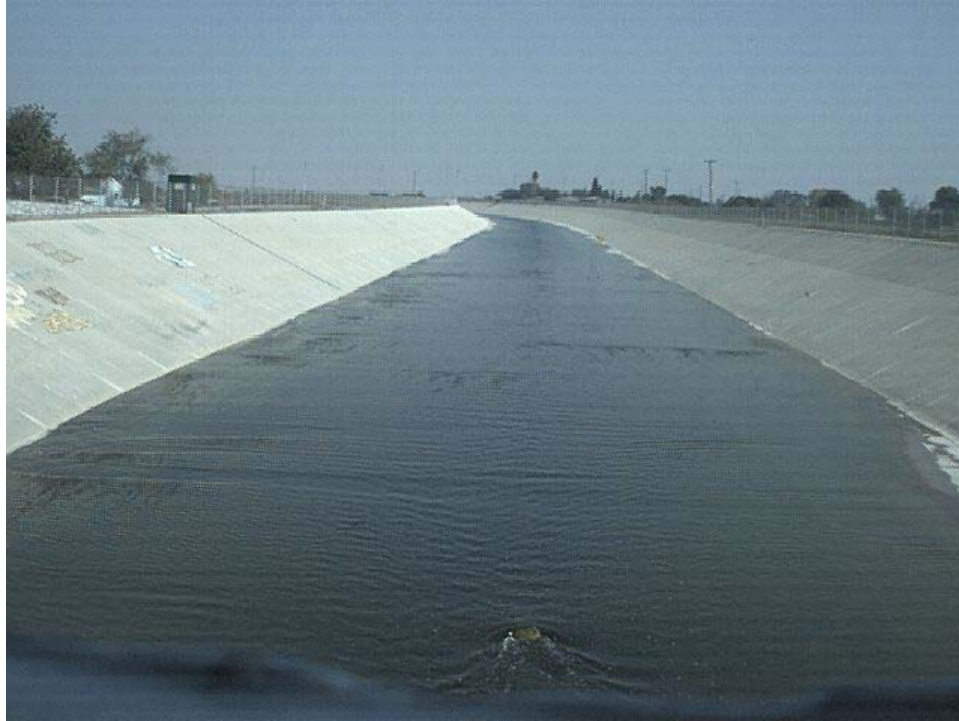
Figure 2a
Photo of Cucamonga Creek, Looking Upstream from Hellman Avenue

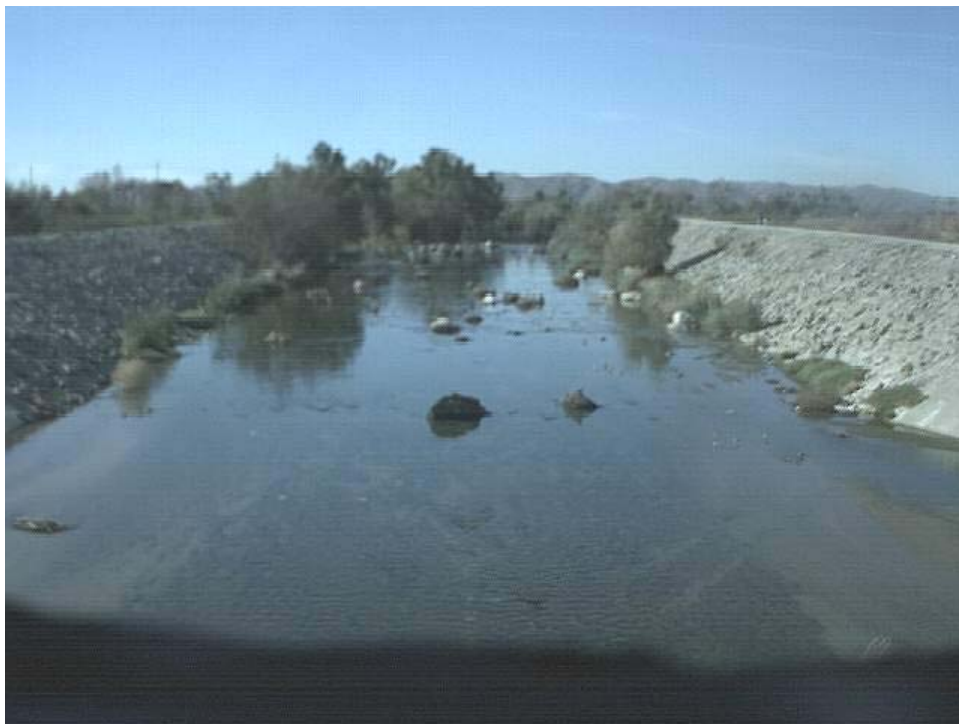
Figure 2b
Photo of Cucamonga Creek, Looking Downstream from Hellman Avenue

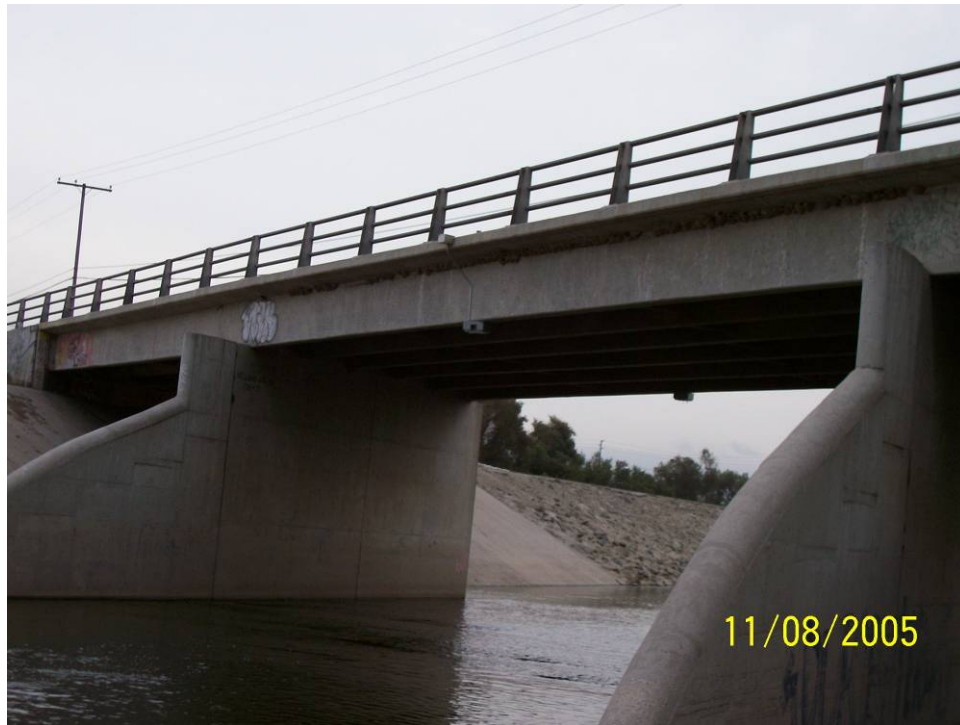
Figure 3a
Photo of the Recreational Use Survey Camera Installation Looking
Upstream at Hellman Avenue

Advanced digital cameras and data transfer technology, coupled with weekly on-location physical surveys were used to collect recreational use data at each location. Observer IV™ cameras were equipped with cellular data transmission equipment to collect an image at each location every fifteen minutes, and transfer the image to a secure data storage server via a file transfer protocol (FTP) site. Weekly site visits were conducted to log recreational use observations, and monitor and maintain the image collection equipment. This survey design was selected to provide unprecedented levels of data to characterize recreational use. Figure 3 shows the final camera installation at the recreational use survey location.

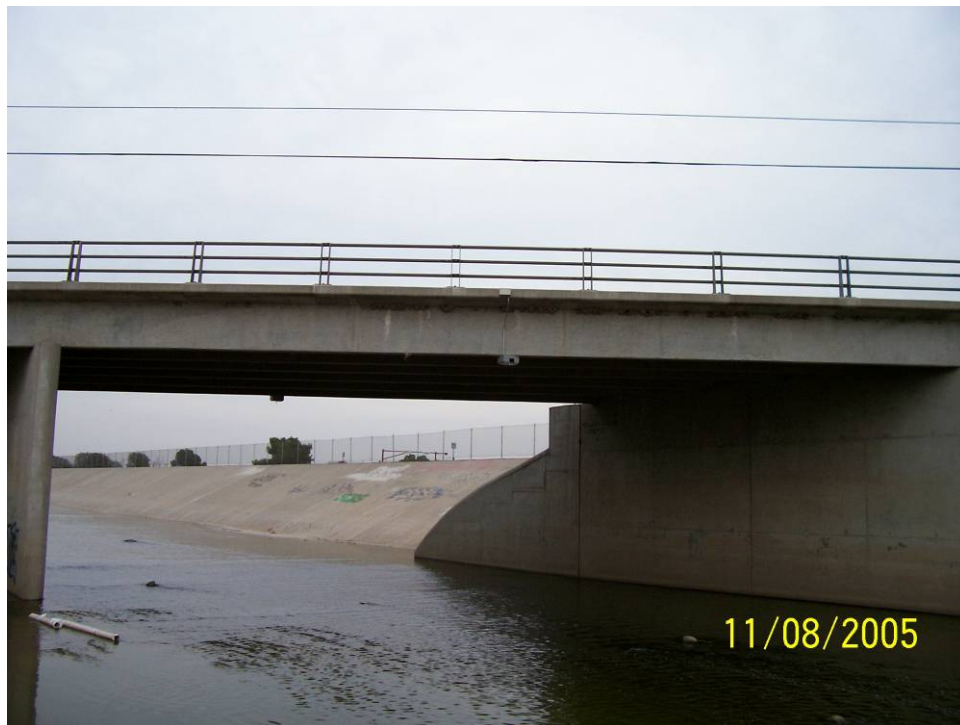
Figure 3b
Photo of the Recreational Use Survey Camera Installation Looking
Downstream at Hellman Avenue
