# SAWPA Brine Line Reach 4D Work Plan

Commission Meeting

October 16, 2018

# Reach 4D Contracts 1 and 2 System Overview

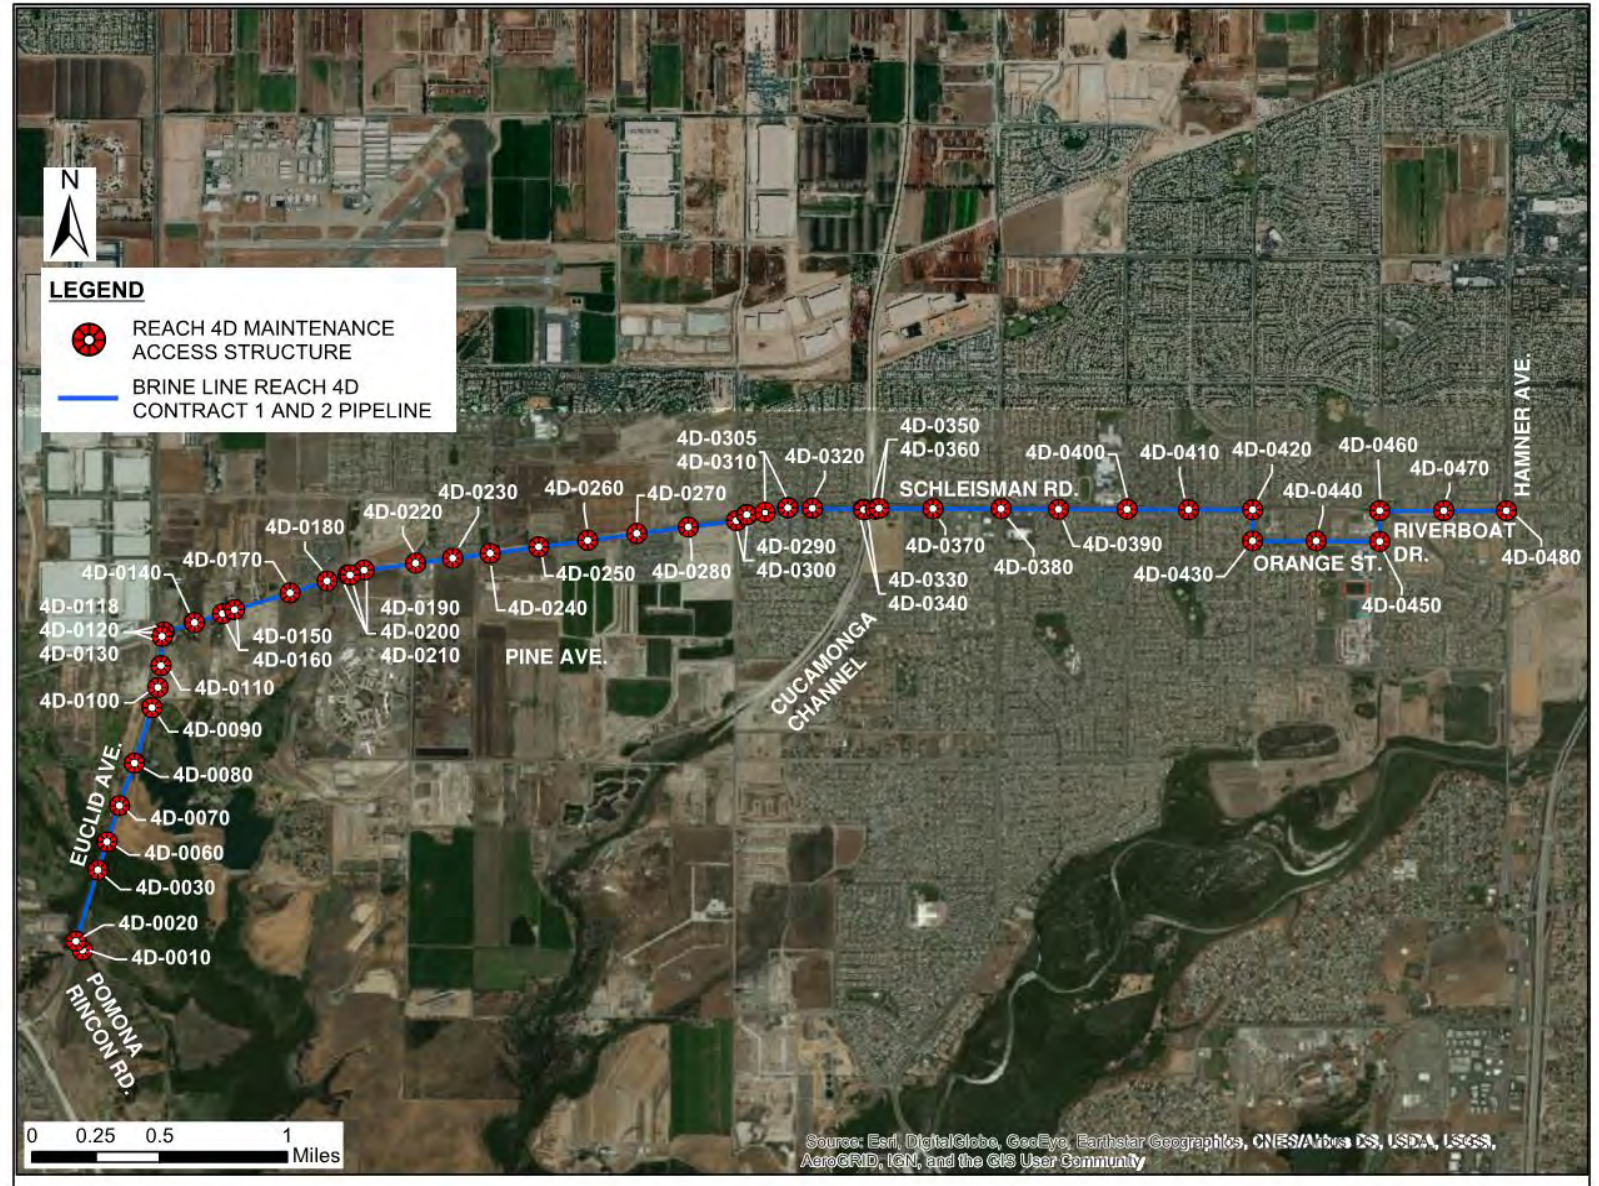
SAWPA BRINELINE REACH 4D

- 7 Miles long
- Within cities of Chino and Eastvale.
- 42" RCP with 270 degree T-Lock
- Built in 1990

**INSPECTION MANHOLES/MANHOLES RECOMMENDED FOR  
MAN-ENTRY PHYSICAL TESTING IN FIVE YEARS**

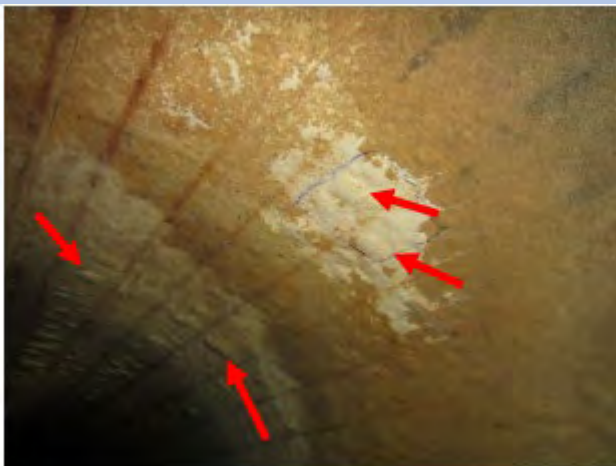
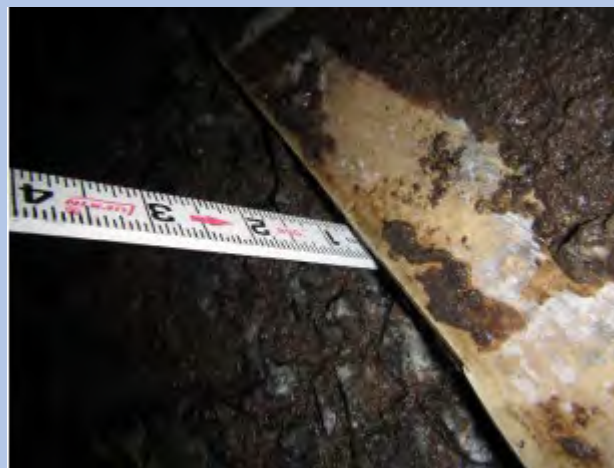
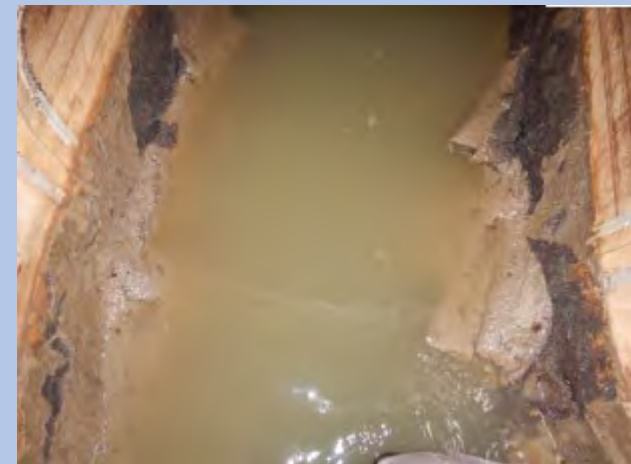
MH <sup>(a)</sup>	Liner				Concrete		General	
	Blisters / Bulges	Failed Weld Strips	Termination Undermined	Termination Unembedded	Exposed Aggregate	Exposed Rebar	Slime Layer	Debris
4D-0020	X	X	X				X	
4D-0118	X	X	X		X		X	X
4D-0150	X		X	X	X		X	X
4D-0470	X		X	X	X	X	X	
4D-0480							X

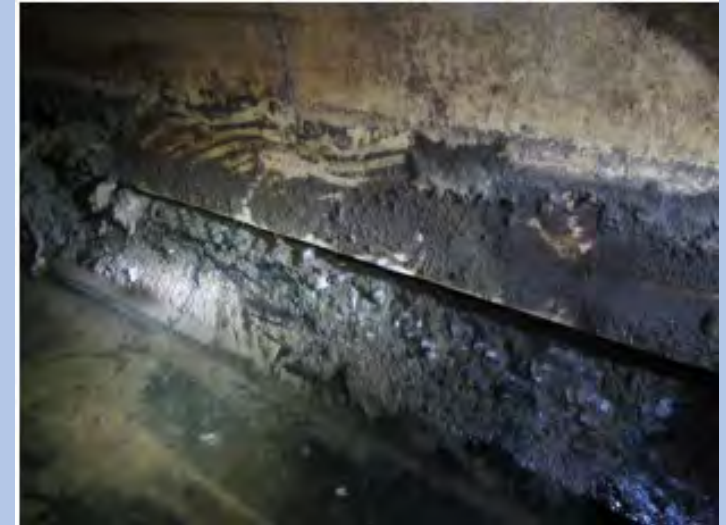
MH	D-Load Design Req. (psi) <sup>(a)</sup>	Assumed Pipe Class <sup>(b)</sup>	Assumed Wall Thickness (in.) <sup>(b)</sup>	Assumed Min. Concrete Cover (in.) <sup>(b)</sup>	Assumed Min. Circumferential Rebar Spacing (in.) <sup>(b)</sup>
4D-0020	3,500	V	5.25	1.00	3.94
4D-0118	2,250	IV			
4D-0150	2,800	IV			
4D-0470	1,700	III			
4D-0480	1,700	III

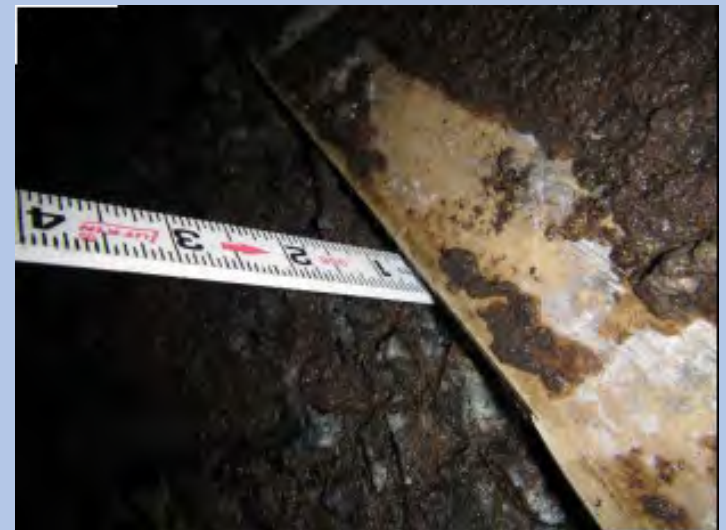
MH	Liner		Concrete	
	Termination Condition	Uplifted Liner Length (in.) <sup>(a)</sup>	Deterioration Depth (in.)	VANDA Rating
4D-0020	Embedded, yet undermined.	n/a	½	2
4D-0118	Embedded, yet undermined.	n/a	3/8	2
4D-0150	Uplifted and undermined.	1	½ – 1	3
4D-0470	Uplifted and undermined.	2	½ – 1	3
4D-0480	Embedded, yet undermined.	n/a	0	1

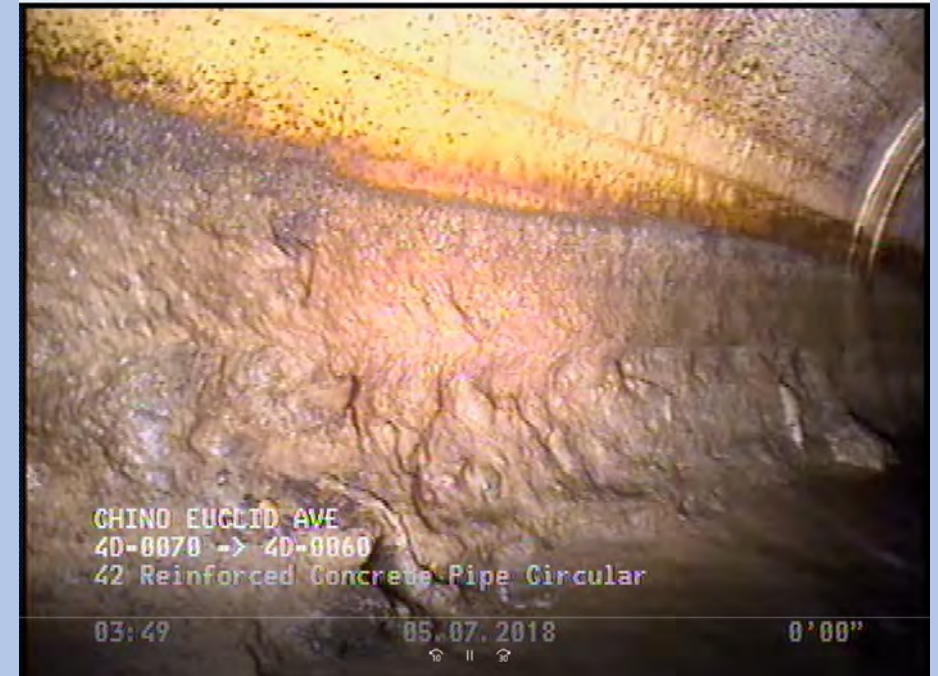
- ~26,500 feet of 42-inch brine line inspected out of ~35,200 feet of total brine line in Reach 4D. (75%)
- Liner/pipe interface visible in ~6,500 feet of pipe.
- 19% of the total length of Reach 4D was visible during CCTV inspections.
- Reason?:
  - Major reason: Slime layer
  - Minor reason: High flows
- Detailed summary available.

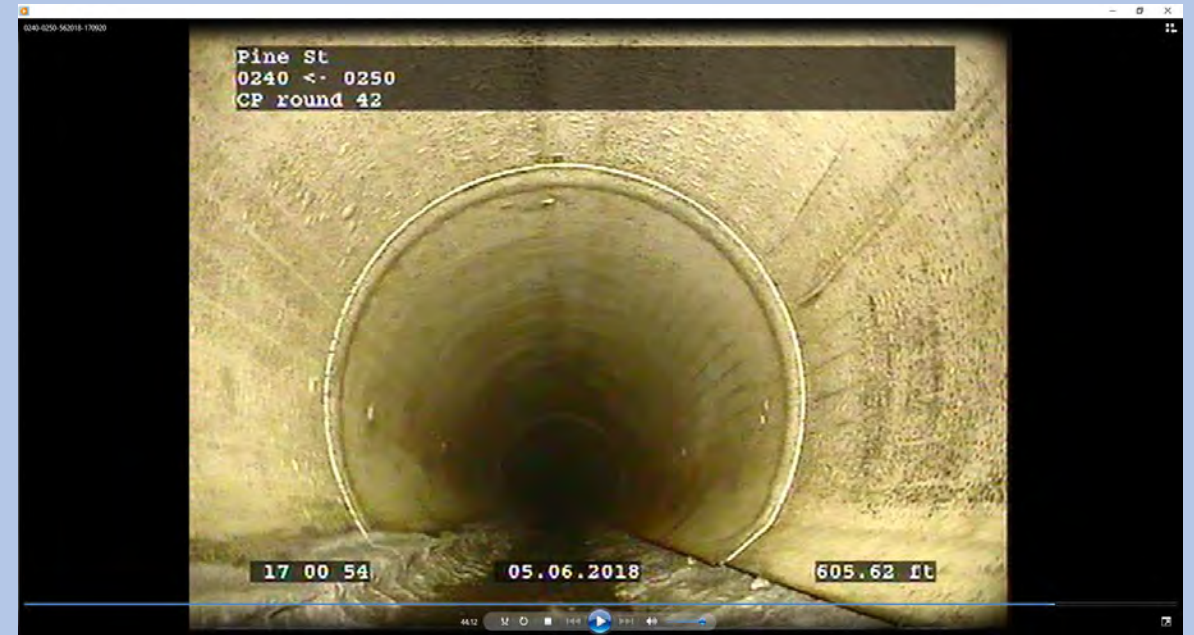
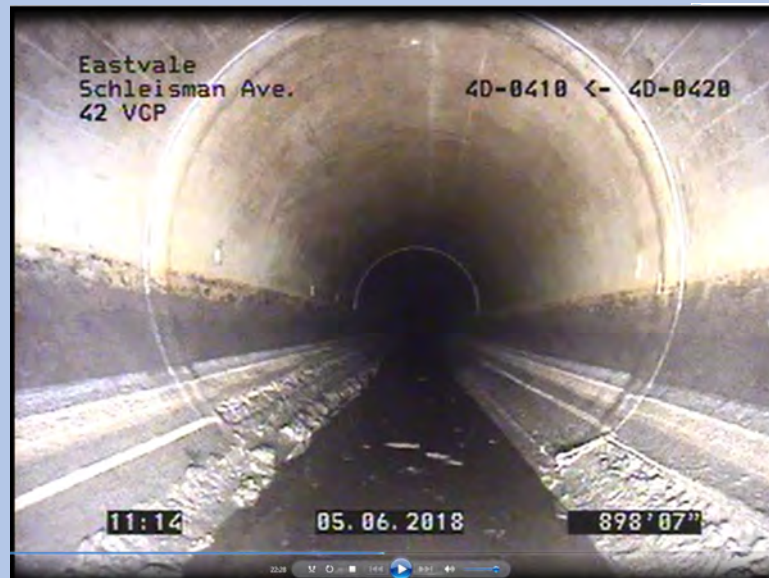
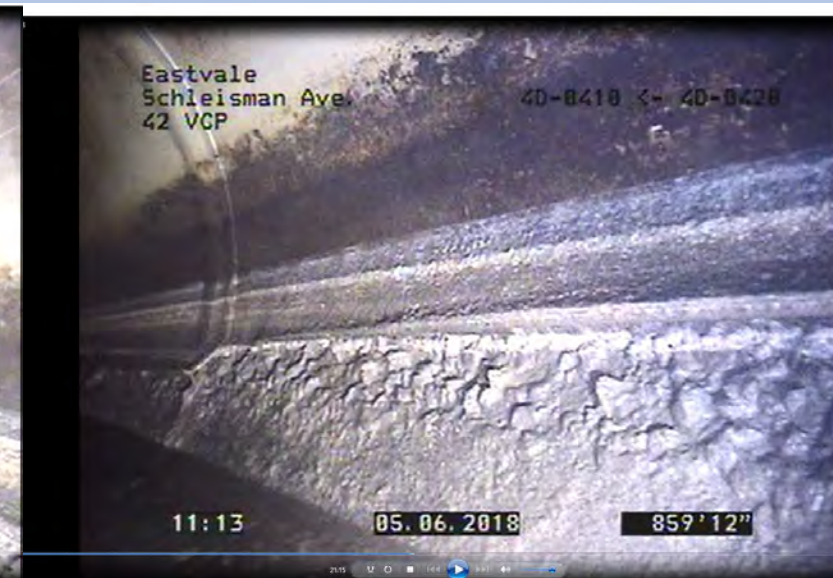
- More uniformity in conditions than man-entry inspections.
- Rotated liner present in 7 reaches. Rotation varies from 1-6 inches. Corrosion not consistent at 3 O'clock and 9 O'clock positions.
- Minor concrete loss with visible aggregate (groove) along much of liner/concrete interface where visible.

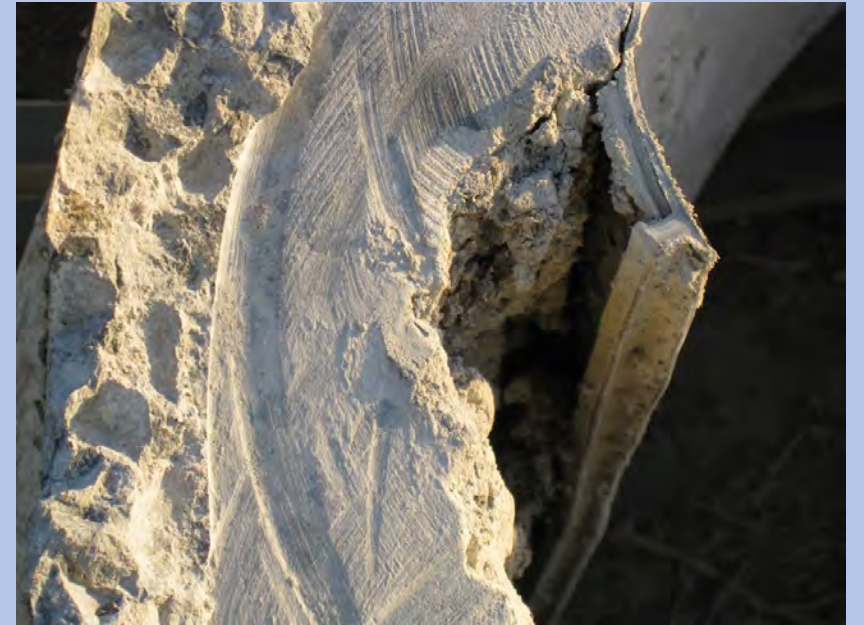
- When first installed, low flow level exposed unlined concrete to sulfuric acid causing corrosion at the interface of lined and unlined concrete.

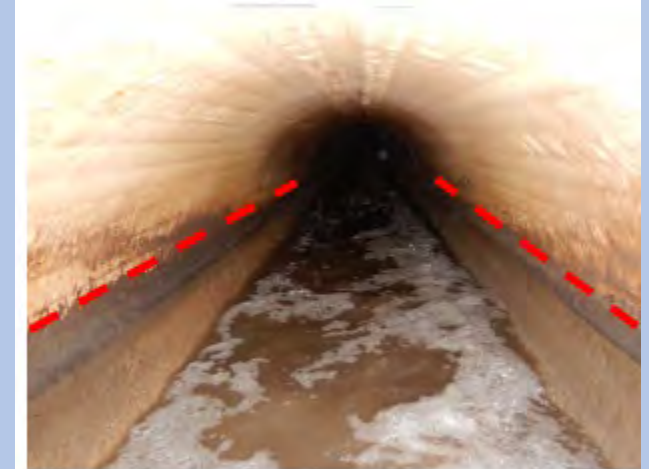
Photo 3-5. Typical water level indicated by slime layer (red dashed line).

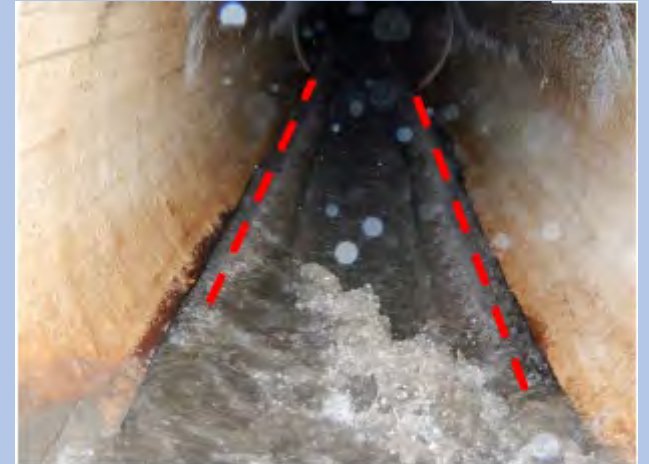
Photo 3-6. Steep slope for Manhole 4D-0150 influent pipe. Apparent typical water level indicated by red
