Lake Elsinore and Canyon Lake TMDL Water Quality

Pre-Post Holy Fire Runoff In-lake Monitoring
Watershed Monitoring Summary

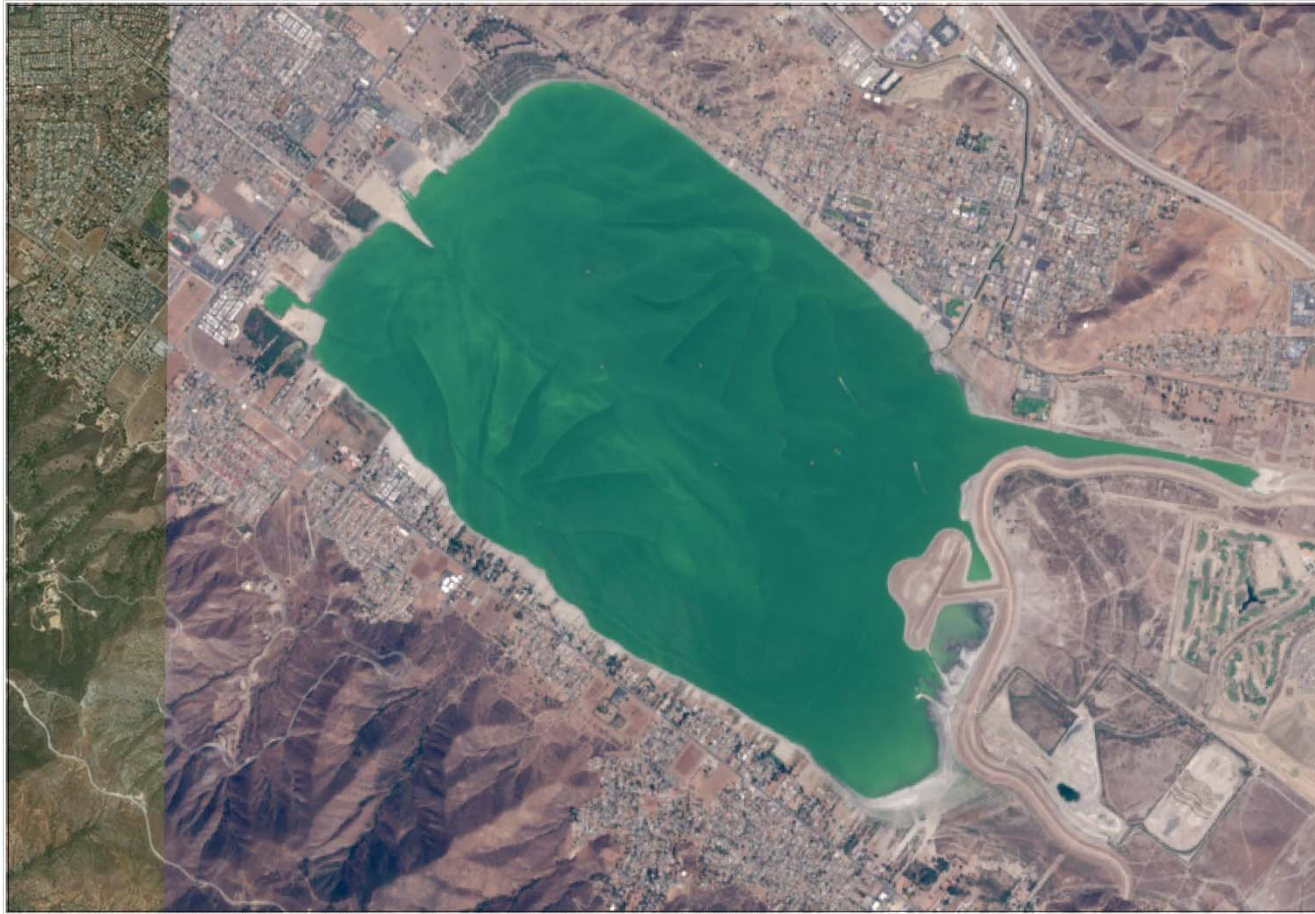
Satellite Imagery
Lake Elsinore
September 11, 2018 Satellite Flyover Event

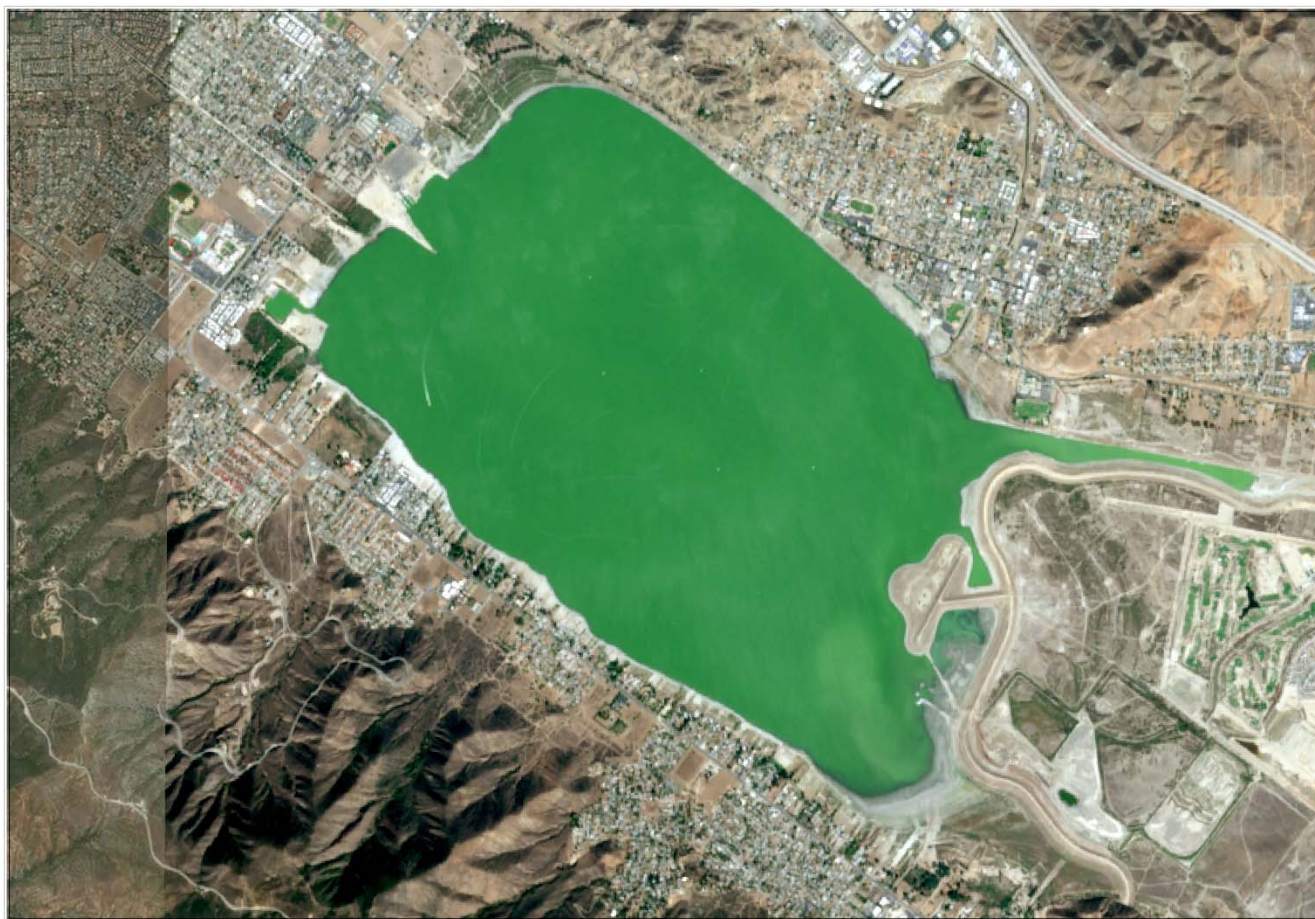
Satellite Imagery
Lake Elsinore
October 16, 2018 Satellite Flyover Event

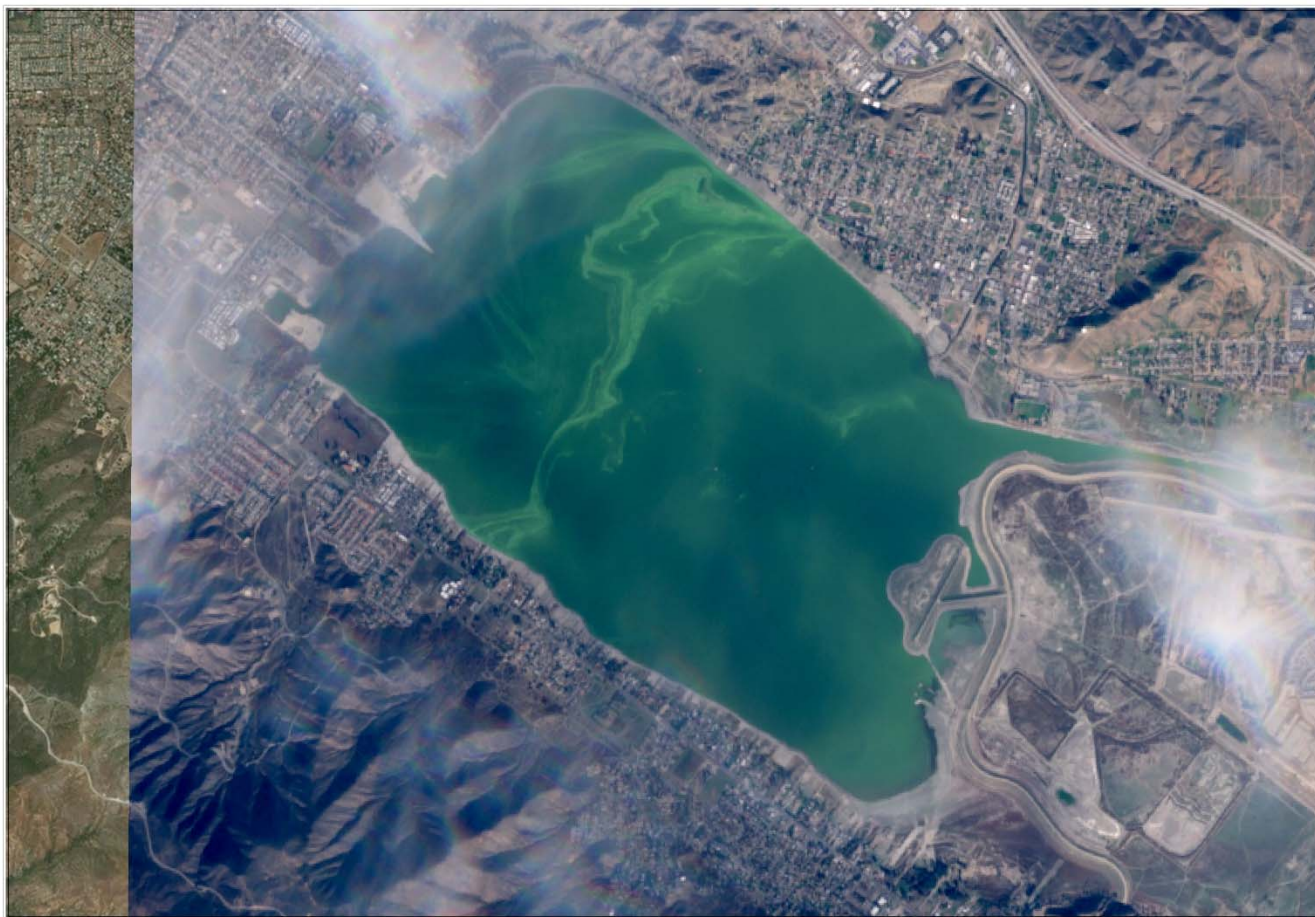
Satellite Imagery
Lake Elsinore
December 20, 2018 Satellite Flyover Event

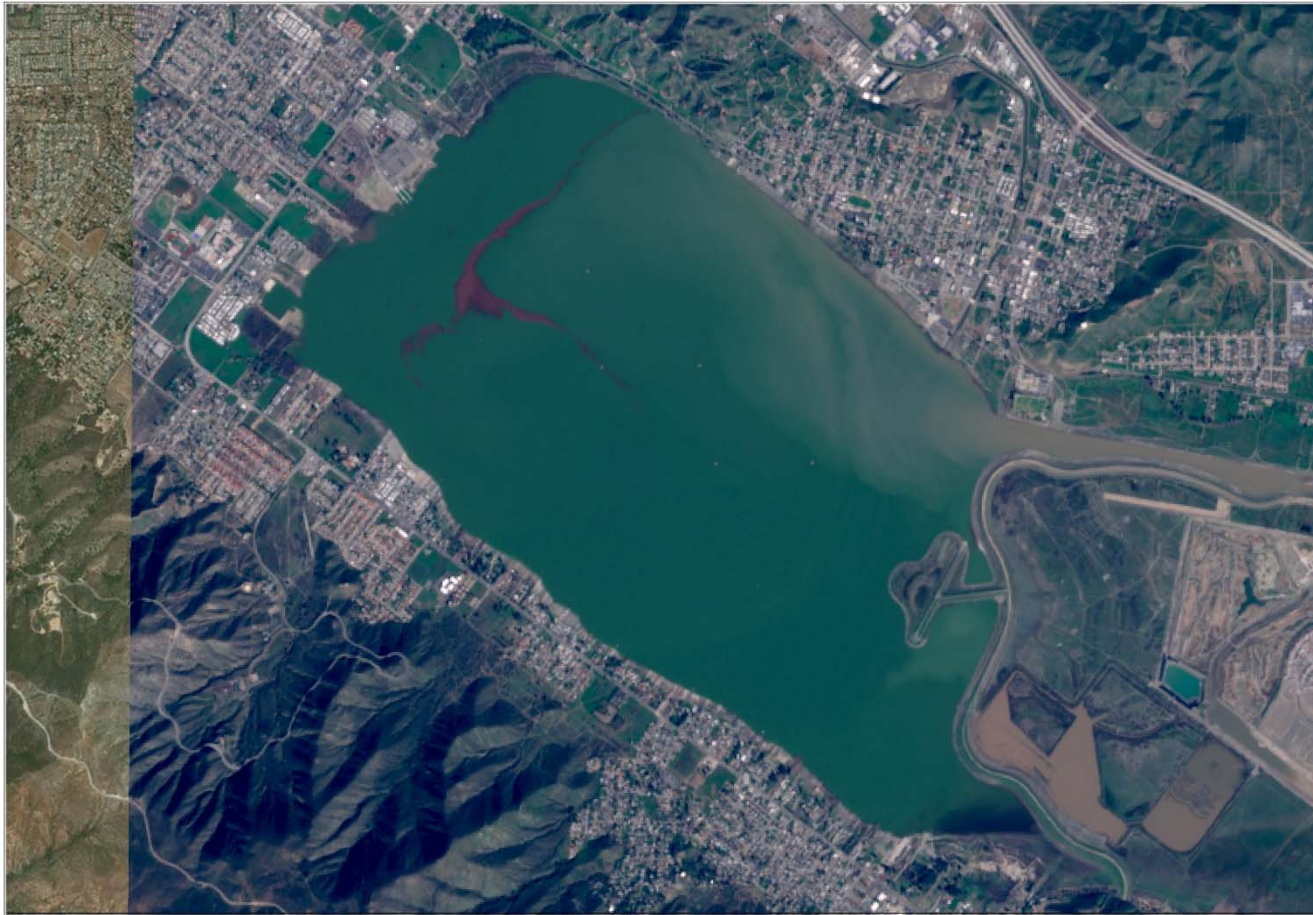
Satellite Imagery
Lake Elsinore
February 19, 2019 Satellite Flyover Event

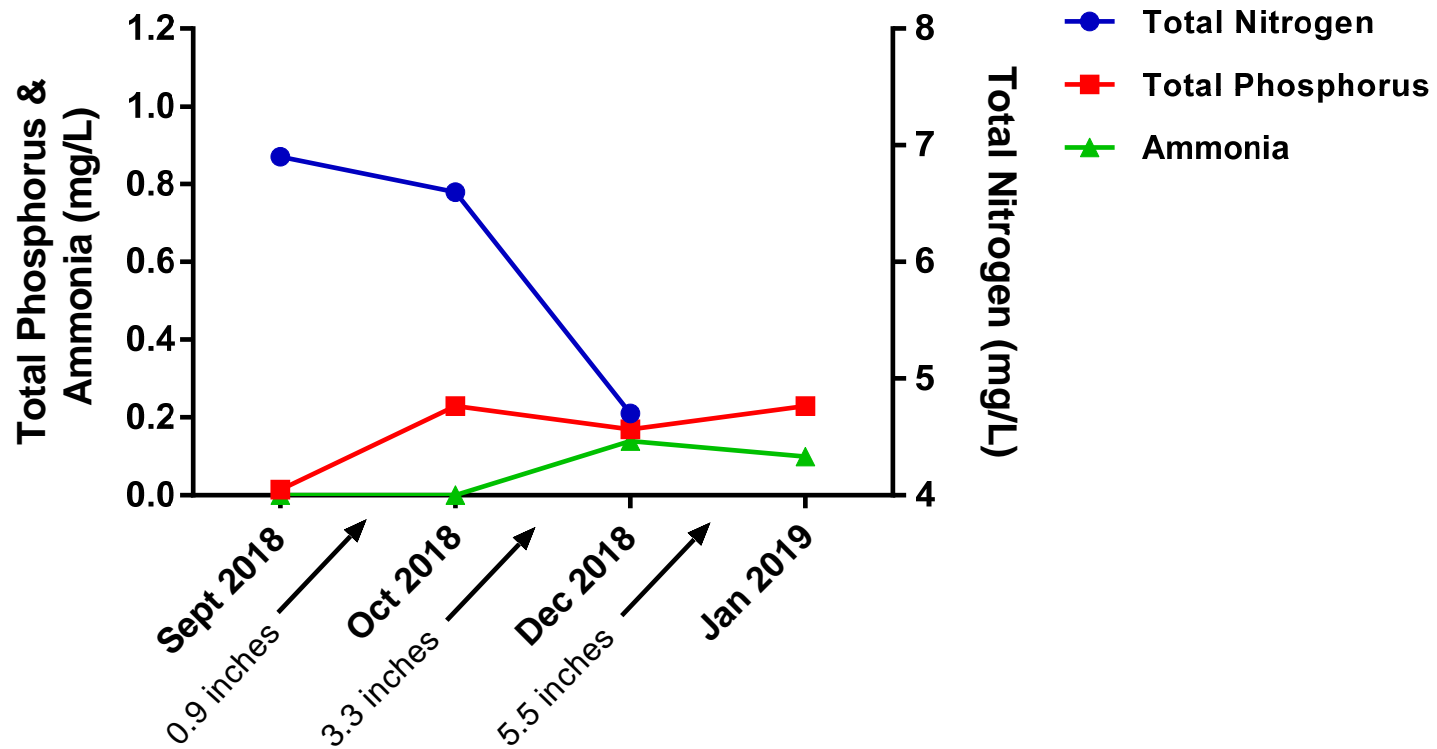
In-lake Sampling Pre-Post Holy Fire Runoff

Nutrients

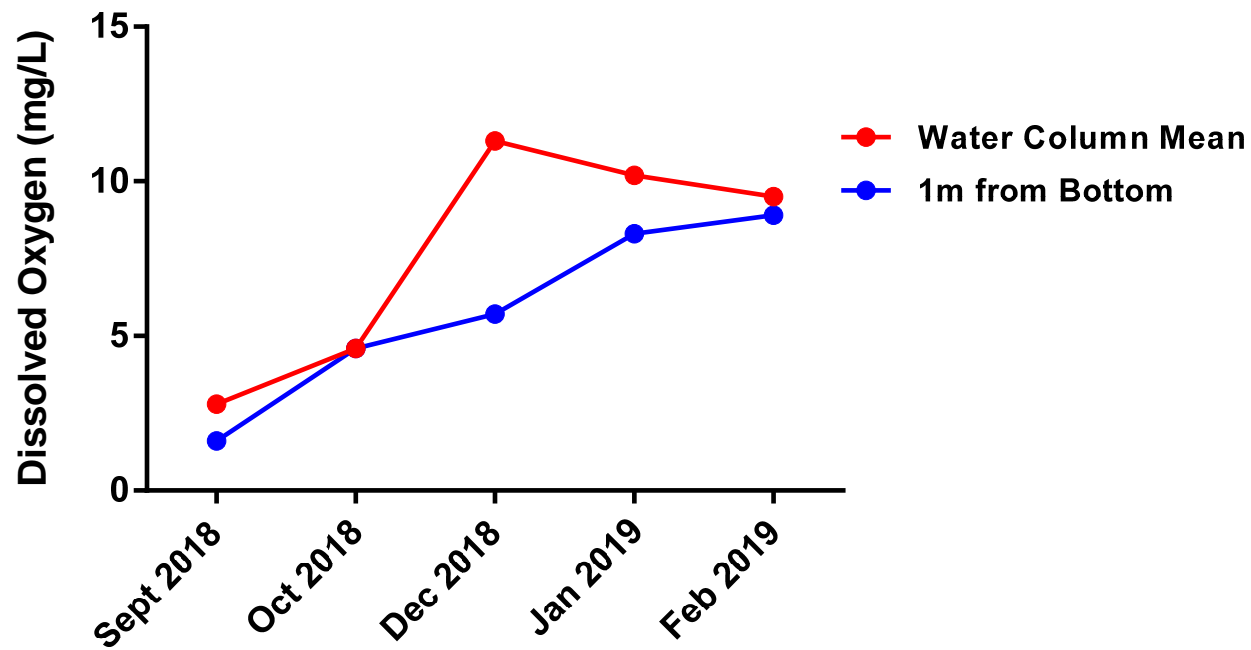
In-lake Sampling Pre-Post Holy Fire Runoff

Dissolved Oxygen

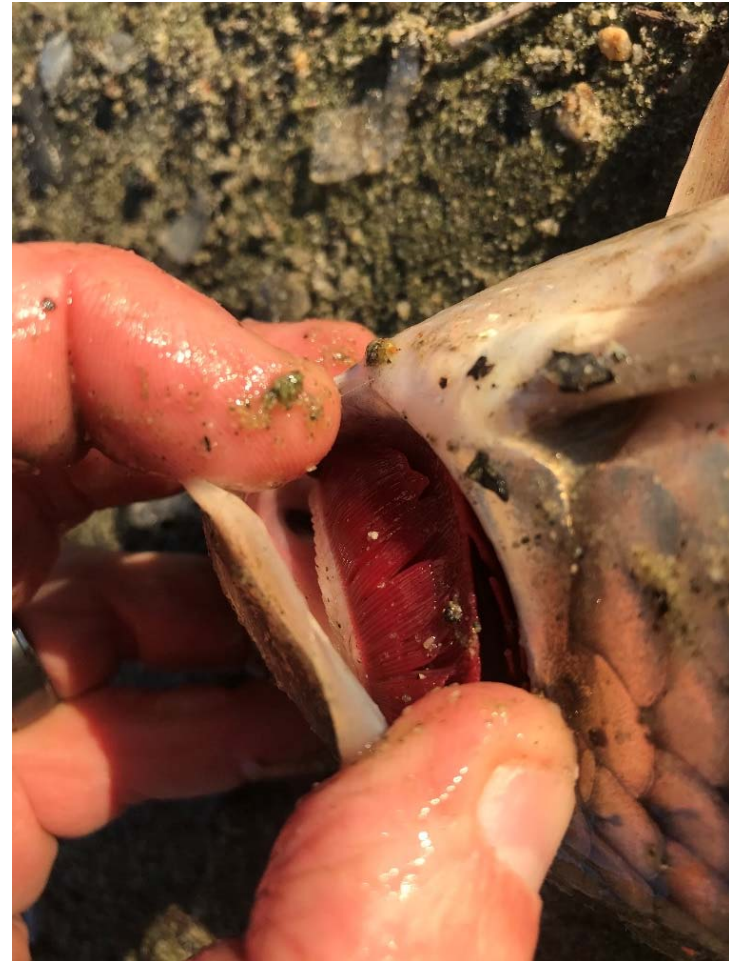
Hyper-red gills of carp, with fin hemorrhaging

Golden Algae likely cause of die off based on multiple lines of evidence

- High levels of *Prymnesium parvum*
- Fish behaviour – gasping, swimming in circles
- Hyper-red gills
- Fin hemorrhaging
- Actively moving towards toxin-free water

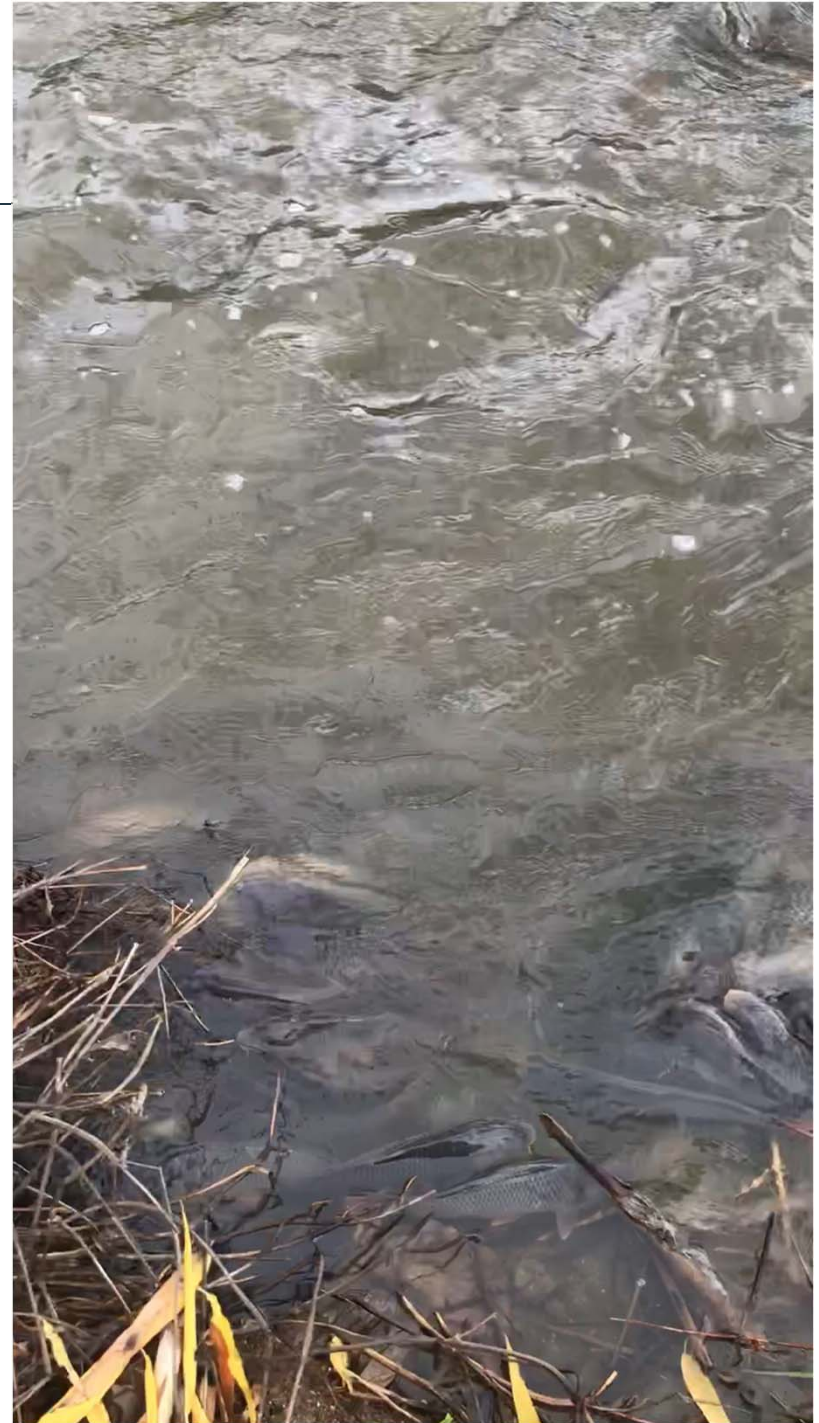
January 16 - Carp swimming up the EVMWD recycled water input to Lake Elsinore (see video)

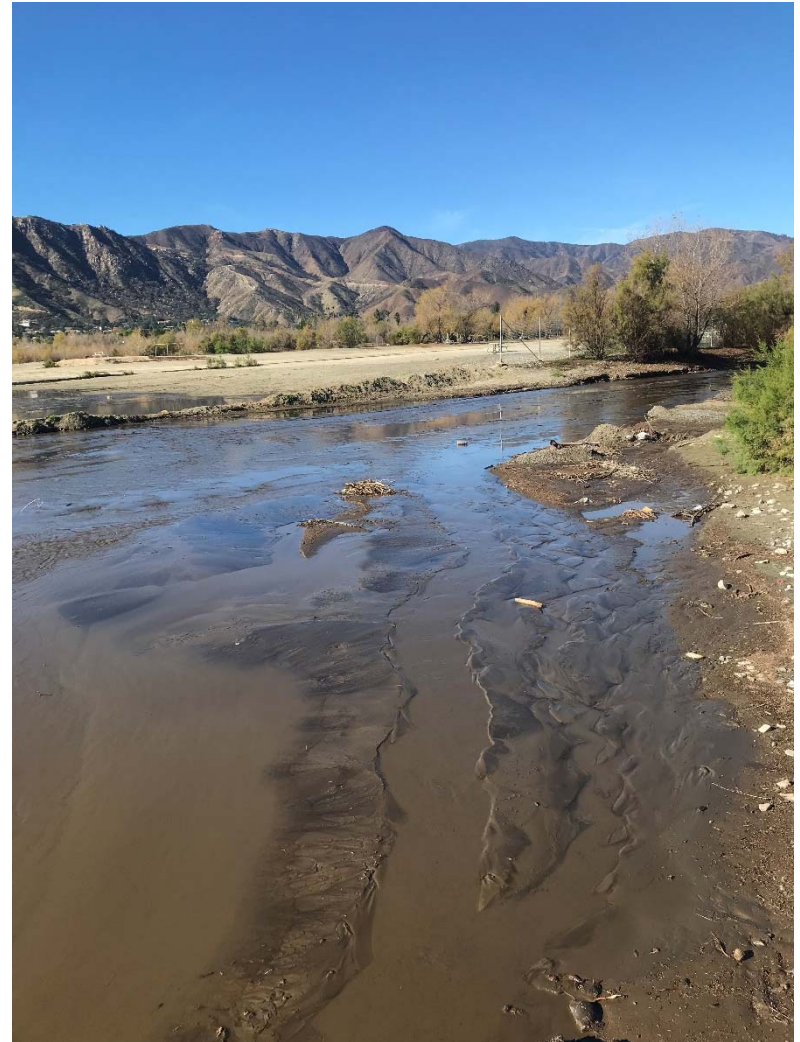
- Decreased densities of Golden Algae (12th most abundant) mid-lake
- La Laguna Boat Ramp Water
 - Low cyanotoxin concentration
 - Acutely toxic (Minnow 12% survival)
- Water from Holy Fire Delta
 - Not toxic (Minnow 100% survival)
 - Nutrients
 - TN = 14 mg/L
 - TP = 7.4 mg/L
 - PAHs – ND
 - Metals (ug/L)
 - Arsenic 87 (T), 3.4 (D)
 - Cadmium 28 (T), ND (D)
 - Copper 520 (T), 1.7 (D)
 - Lead 190 (T), ND (D)
 - Zinc 2300 (T), ND (D)

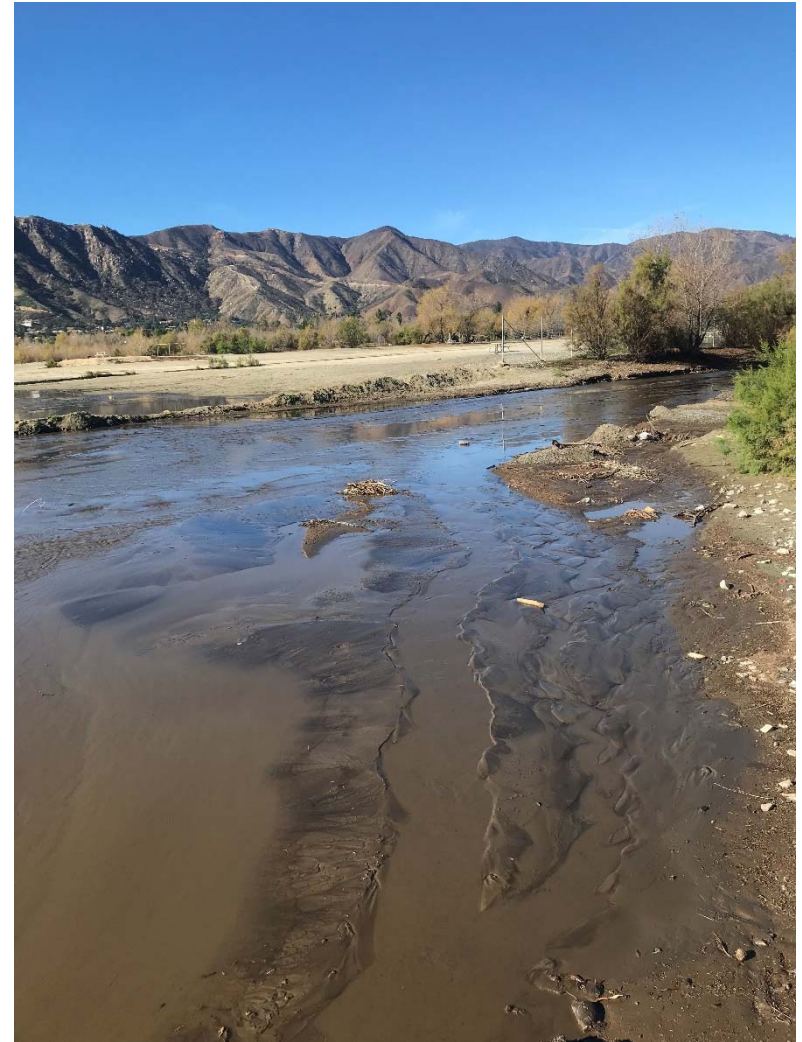
- Water from beach just west of La Laguna Boat Ramp
 - Nutrients
 - TN = 4.2 mg/L
 - TP = 0.62 mg/L
 - PAHs – ND
 - Metals (ug/L)
 - Arsenic 23 (T), 15 (D)
 - Cadmium ND (T), ND (D)
 - Copper 3.0 (T), 1.6 (D)
 - Lead ND (T), ND (D)
 - Zinc 6.8 (T), 2.0 (D)
- Sediment from Holy Fire Delta
 - Not toxic to (*Hyaella* 91% survival)
 - Grain size = 93% silt/clay
 - Waiting on other chemistry results
