Lake Elsinore and Canyon Lake TMDL Water Quality Monitoring Update – 2018-19 Summary

September 25, 2019

Watershed
Monitoring

In-Lake
Monitoring

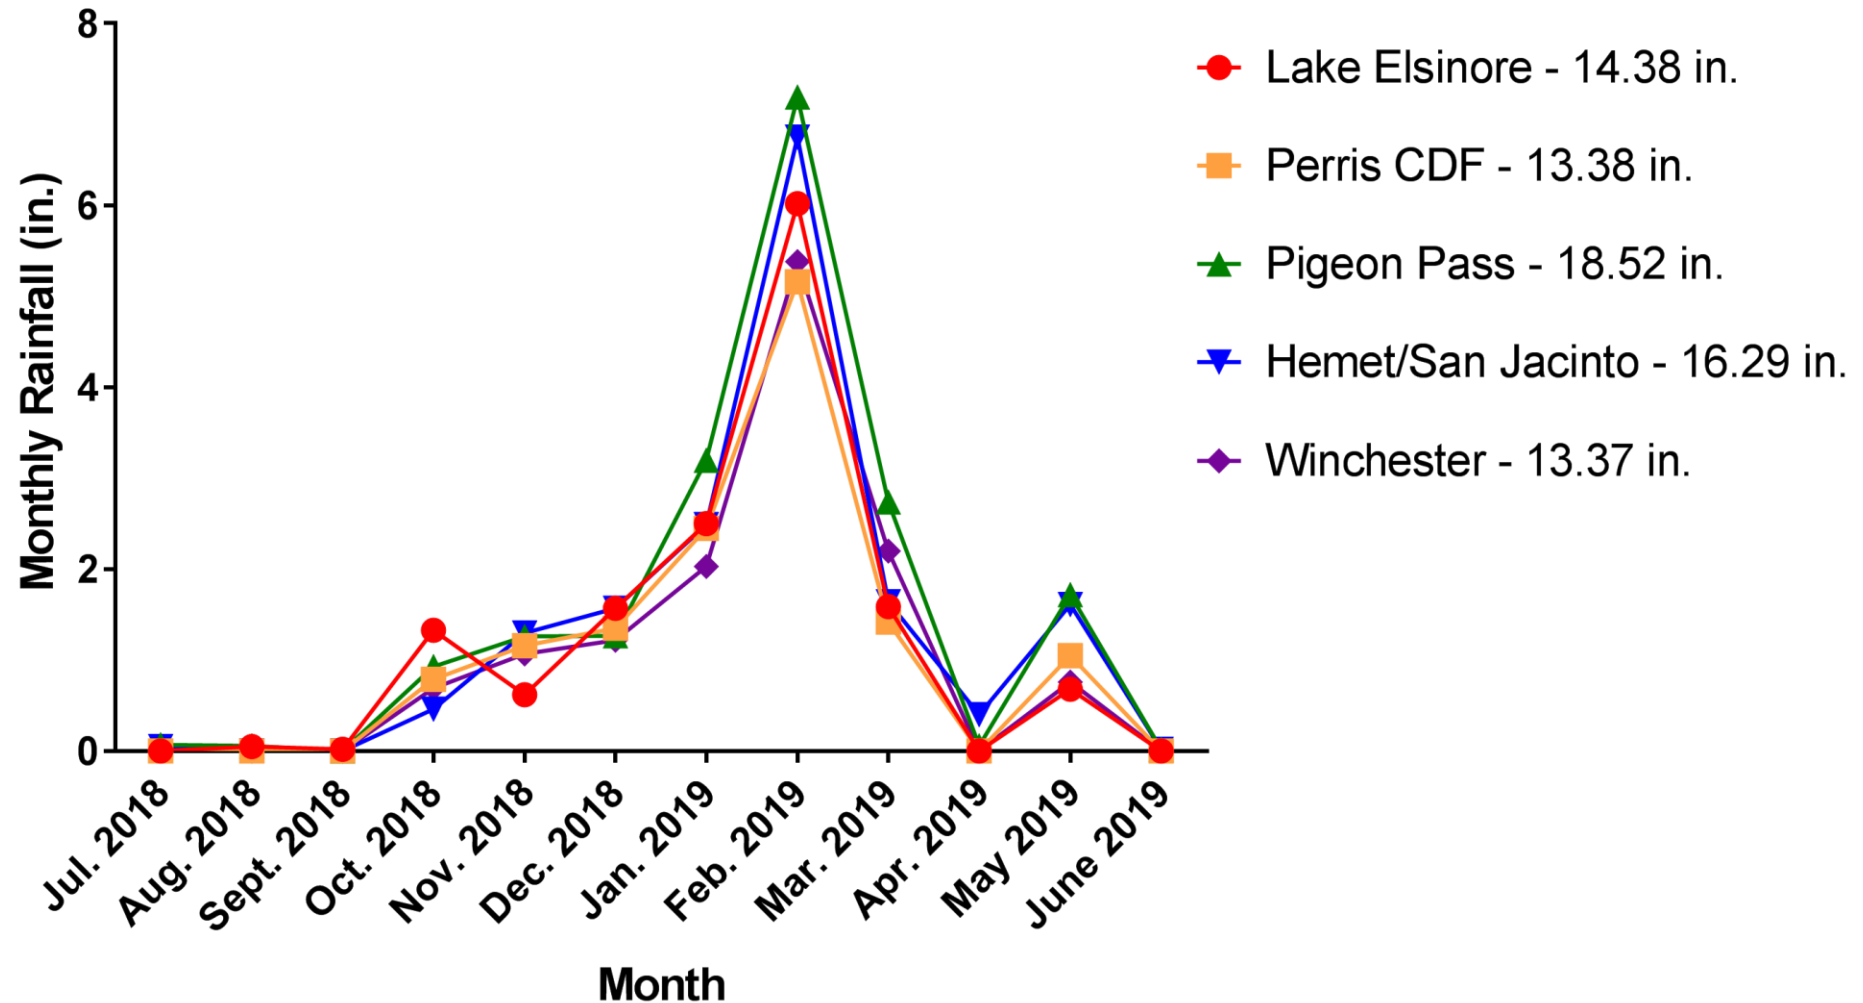
Summary of 2018-2019 Rainfall

Summary of 2018-2019 Rainfall

2018-2019 Monthly Rainfall (inches)	Lake Elsinore	Perris CDF	Pigeon Pass	Hemet / San Jacinto	Winchester
Jul	0.00	0.00	0.07	0.05	0.02
Aug	0.05	0.00	0.06	0.00	0.00
Sep	0.02	0.00	0.00	0.00	0.00
Oct	1.33	0.79	0.93	0.46	0.69
Nov	0.62	1.16	1.26	1.30	1.07
Dec	1.57	1.35	1.27	1.57	1.22
Jan	2.50	2.45	3.20	2.49	2.03
Feb	6.02	5.16	7.19	6.75	5.38
Mar	1.59	1.42	2.74	1.64	2.20
Apr	0.00	0.00	0.06	0.40	0.00
May	0.68	1.05	1.72	1.61	0.76
Jun	0.00	0.00	0.02	0.02	0.00
Annual Rainfall (Inches)	14.38	13.38	18.52	16.29	13.37

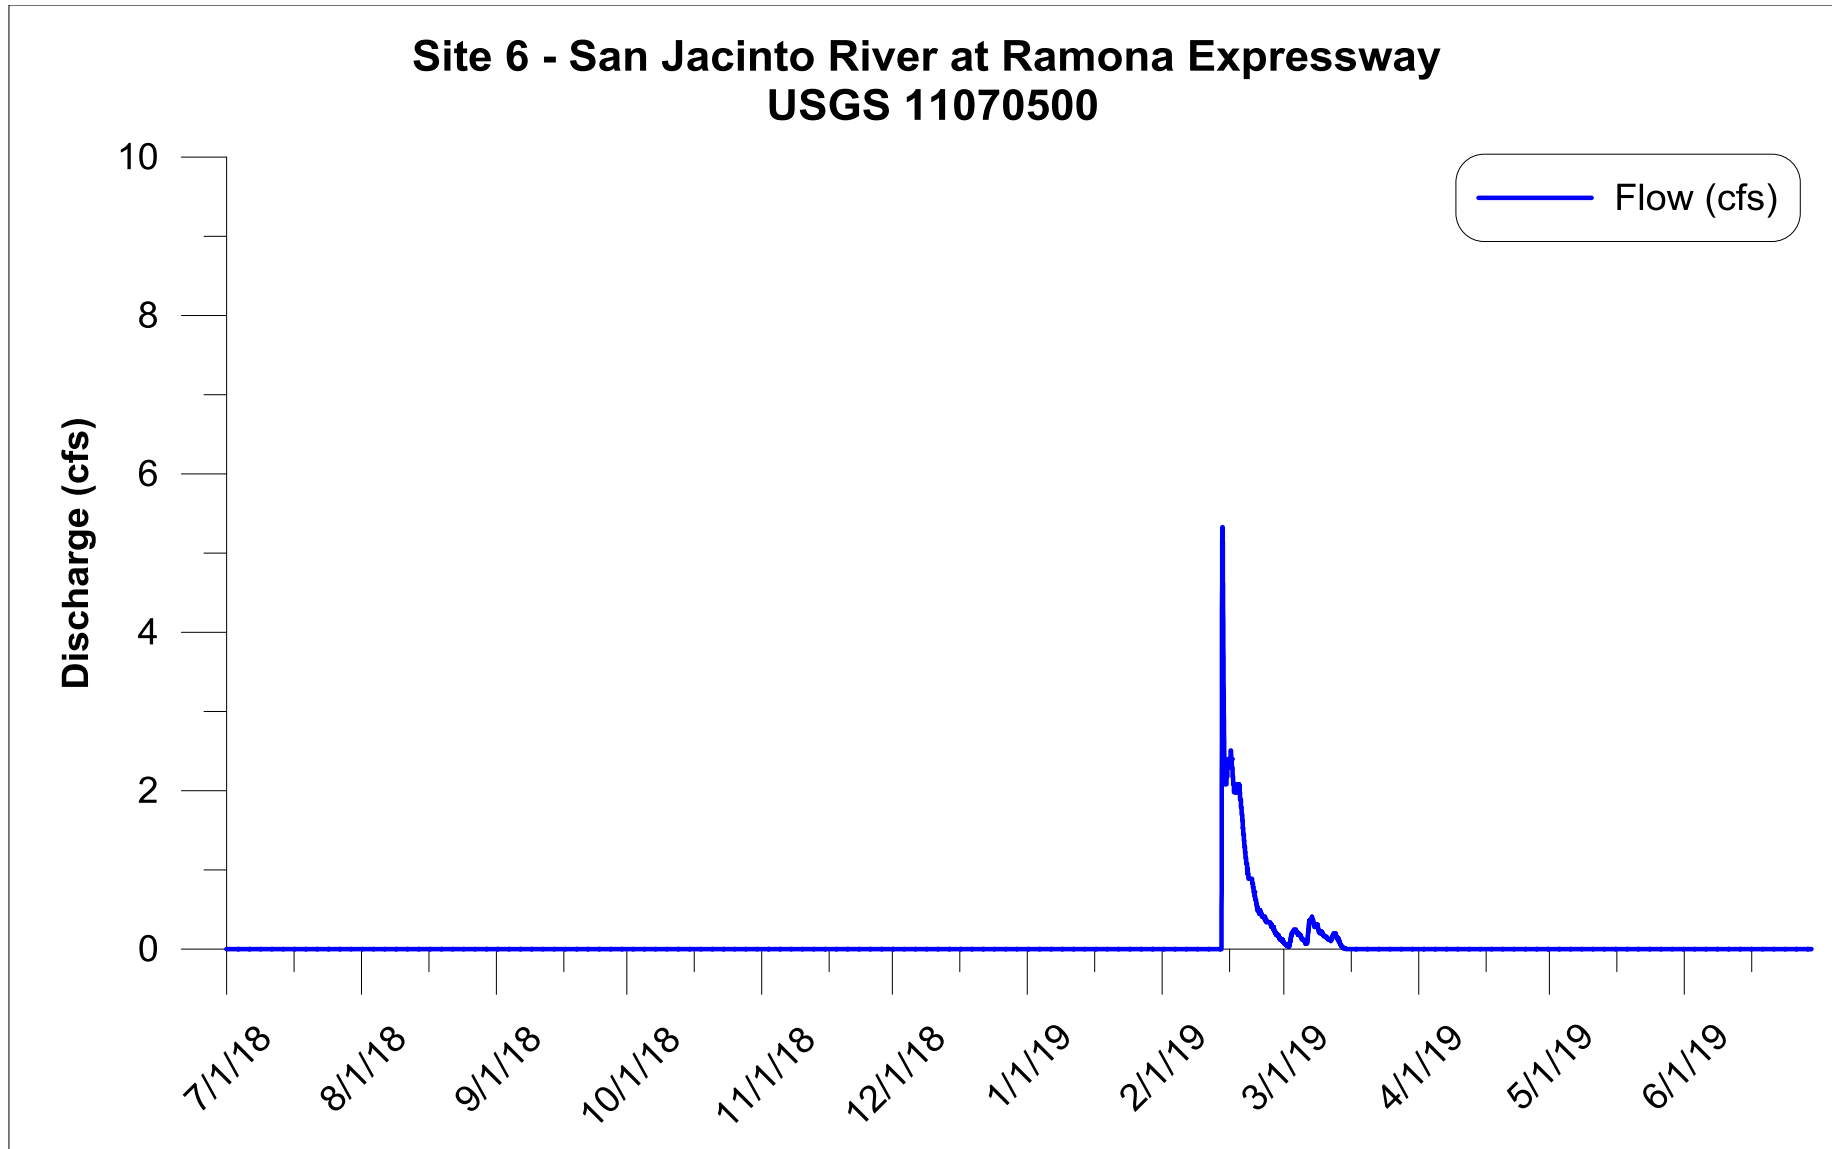
2018-2019 Annual Hydrograph

Site 6 - San Jacinto River at Ramona Expressway
USGS 11070500

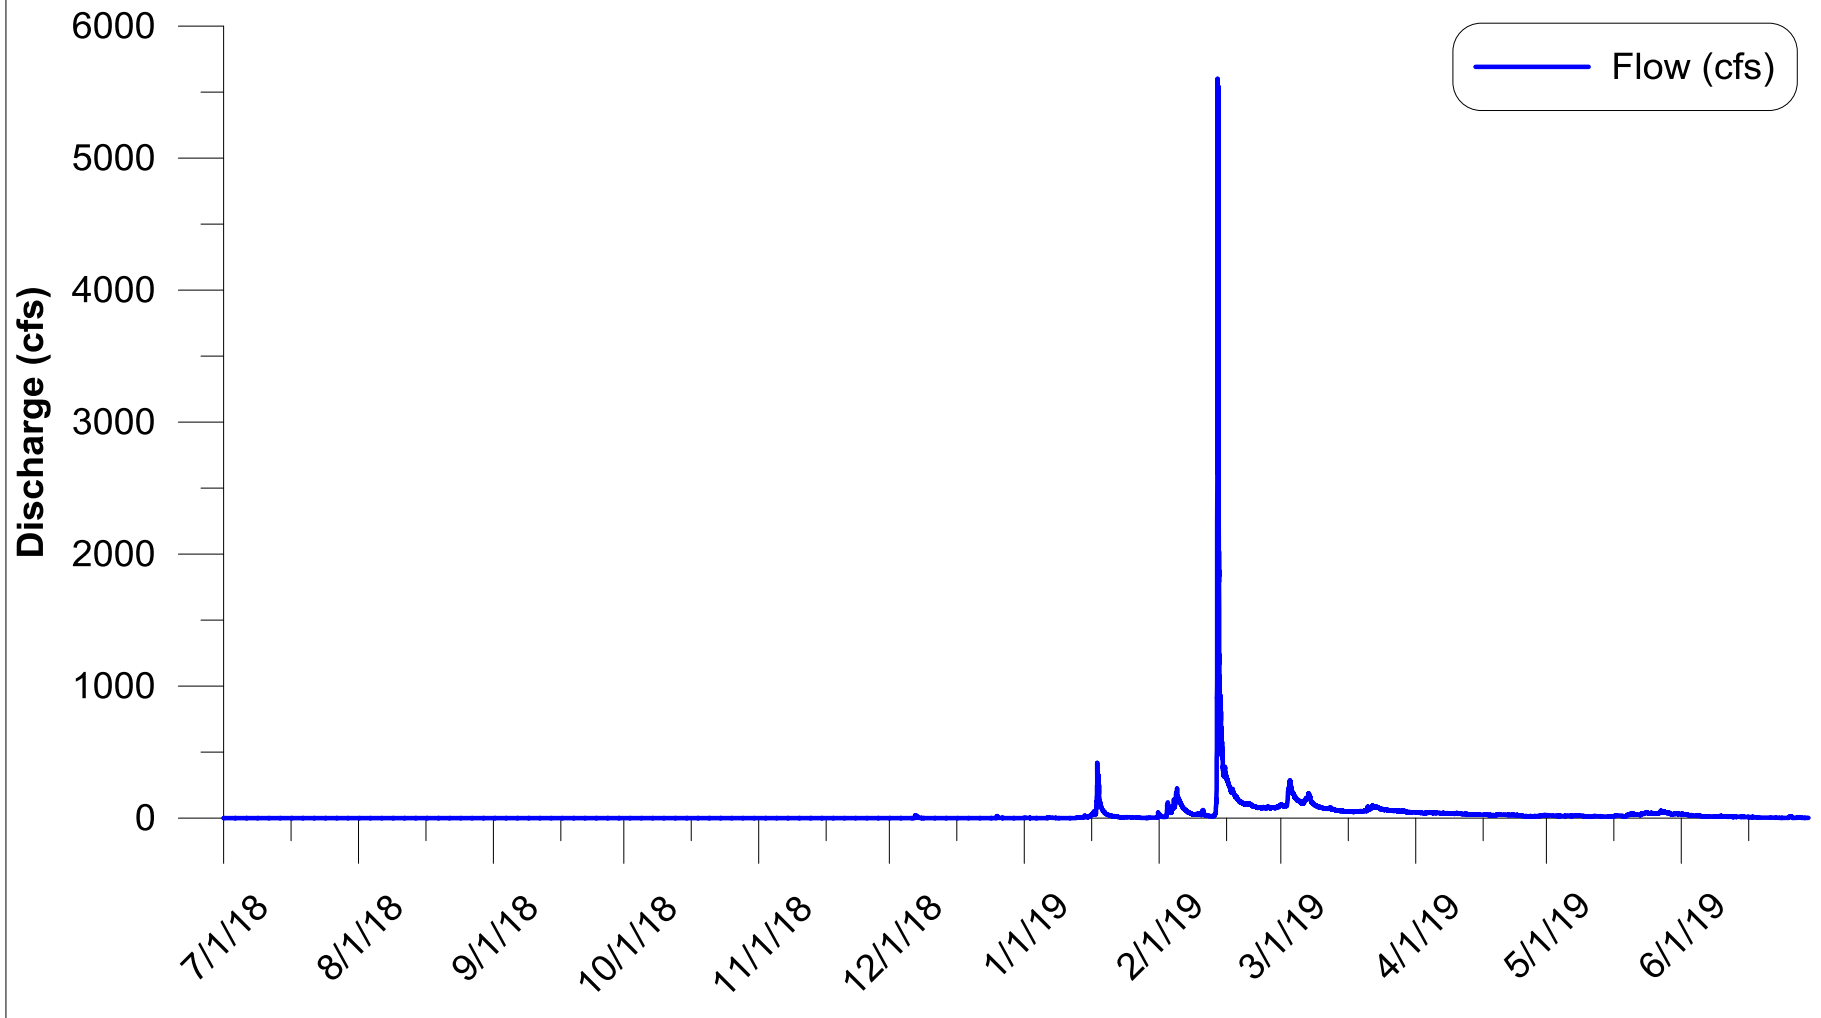
2018-2019 Annual Hydrograph

**Site 1 - San Jacinto River at Cranston Guard Station
USGS 11069500**

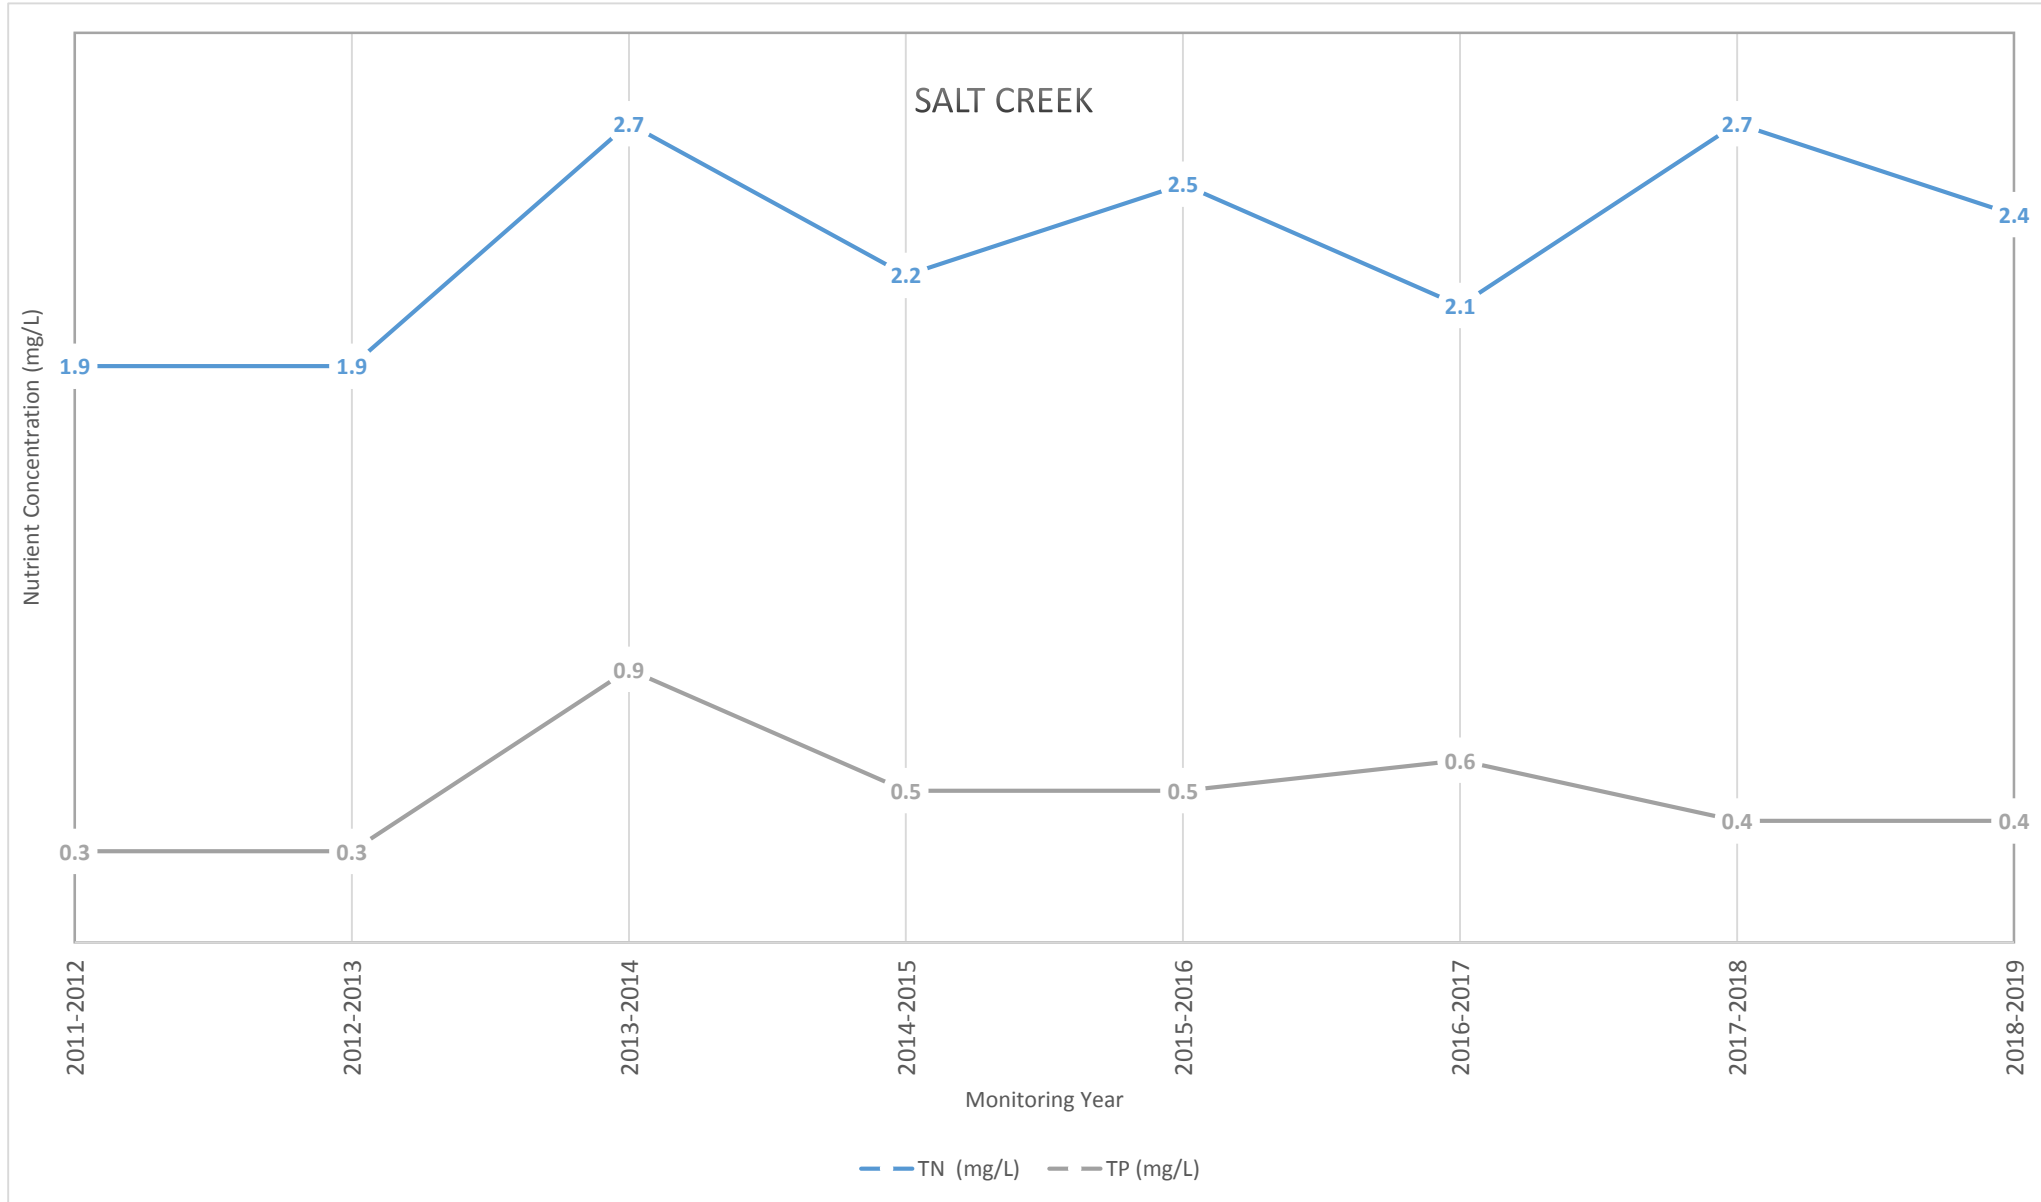
Salt Creek Historic Nutrient Concentrations

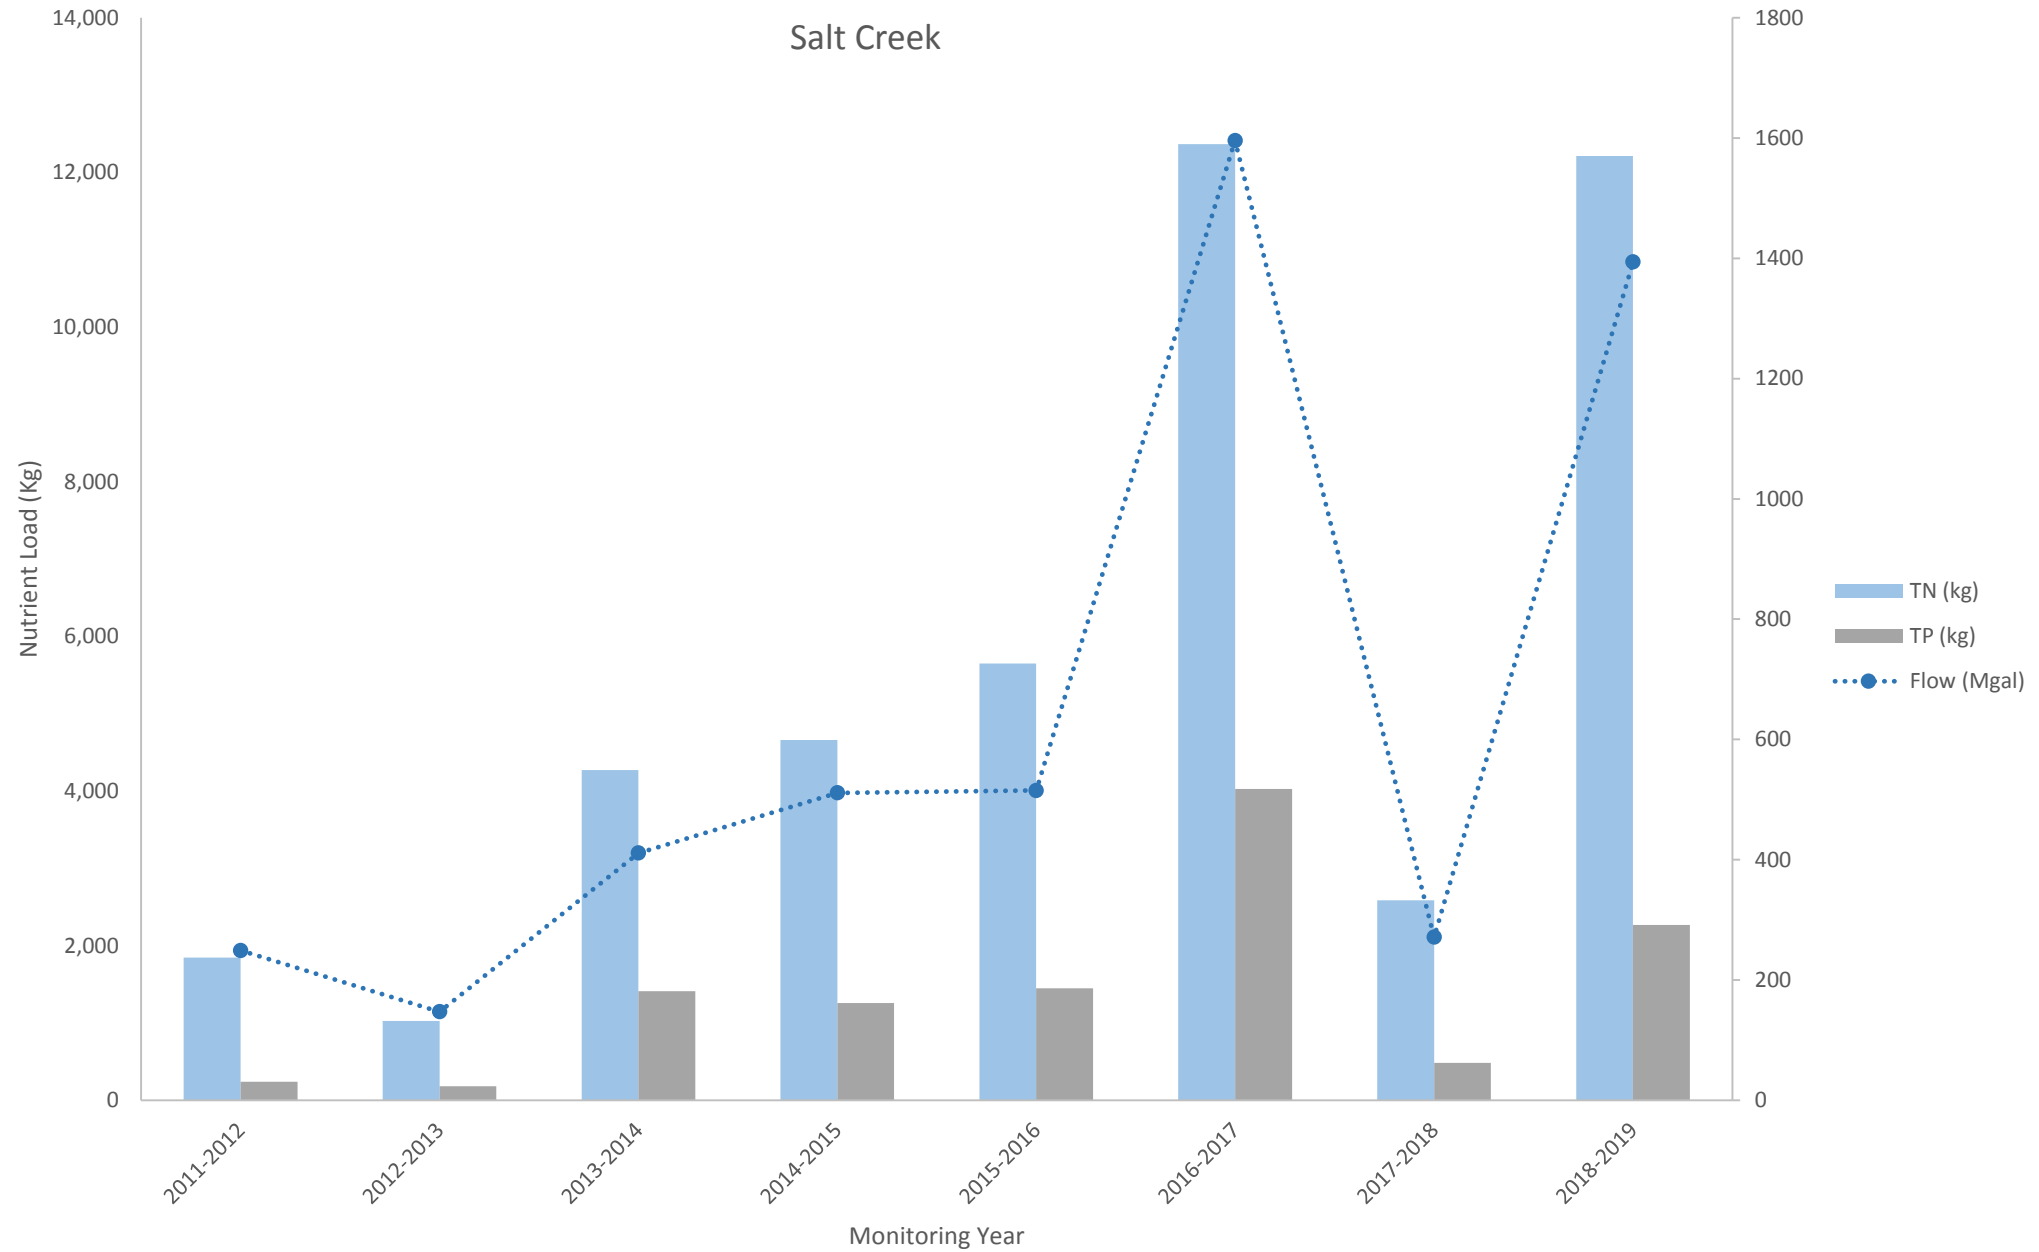
Salt Creek Historic Nutrient Loads

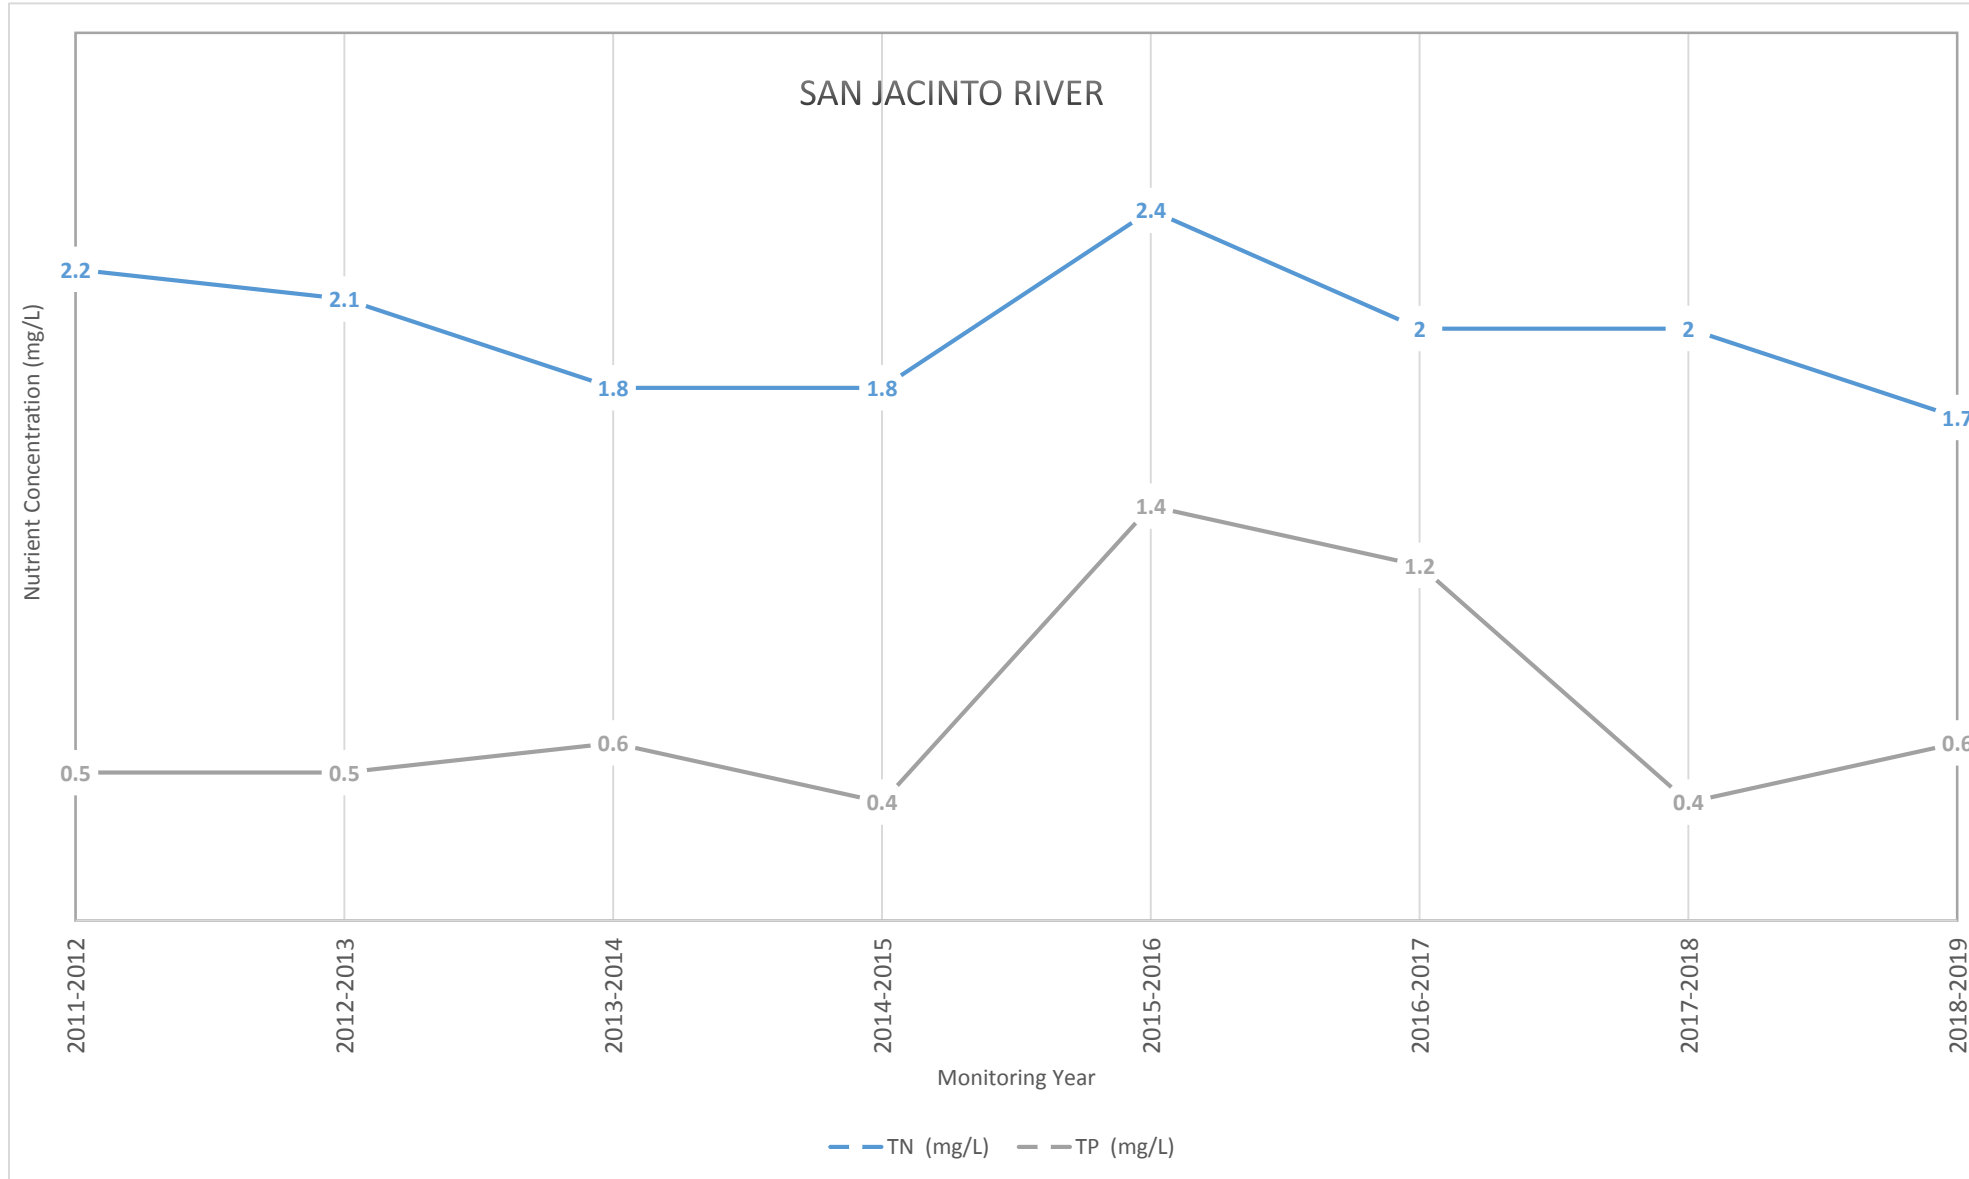
San Jacinto Historic Nutrient Concentrations

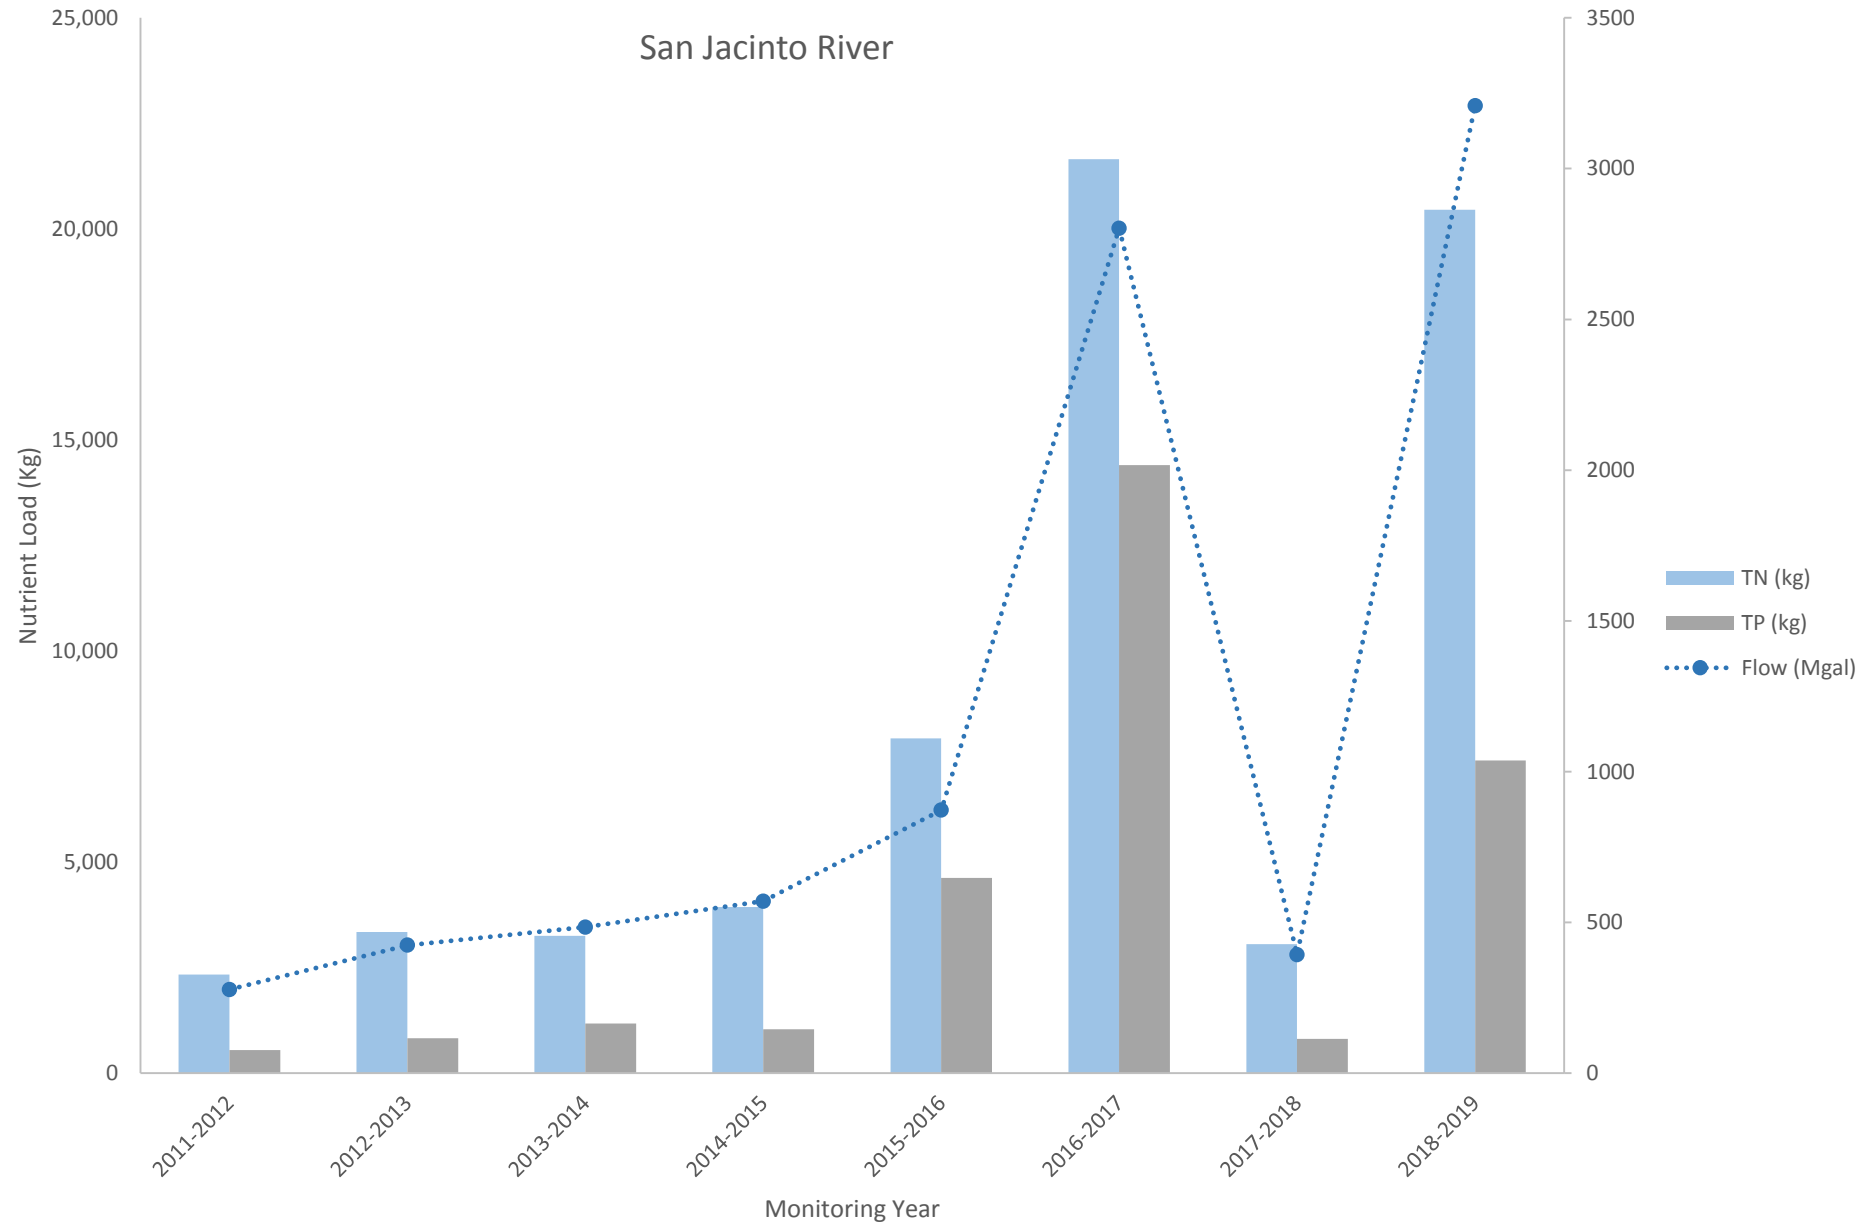
San Jacinto Historic Nutrient Loads

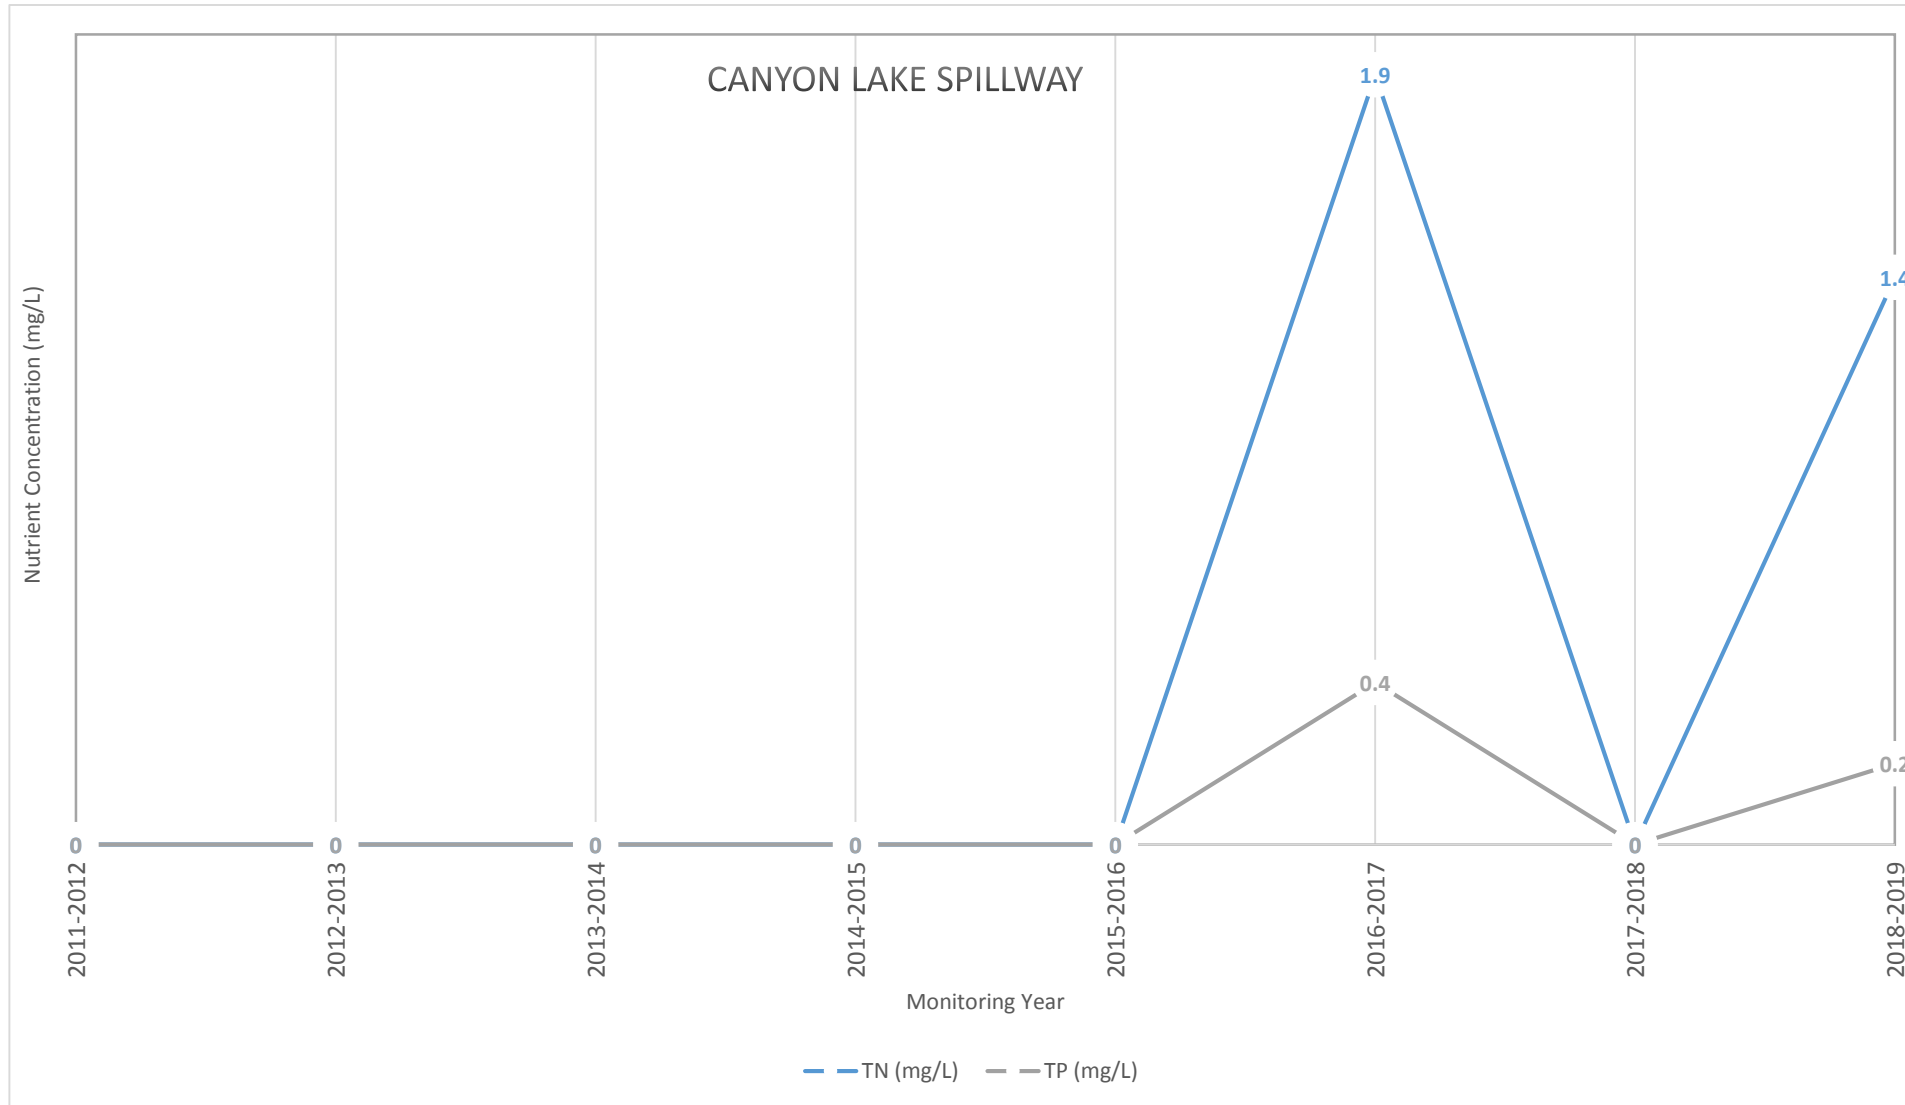
Canyon Lake Spillway Historic Nutrient Concentrations

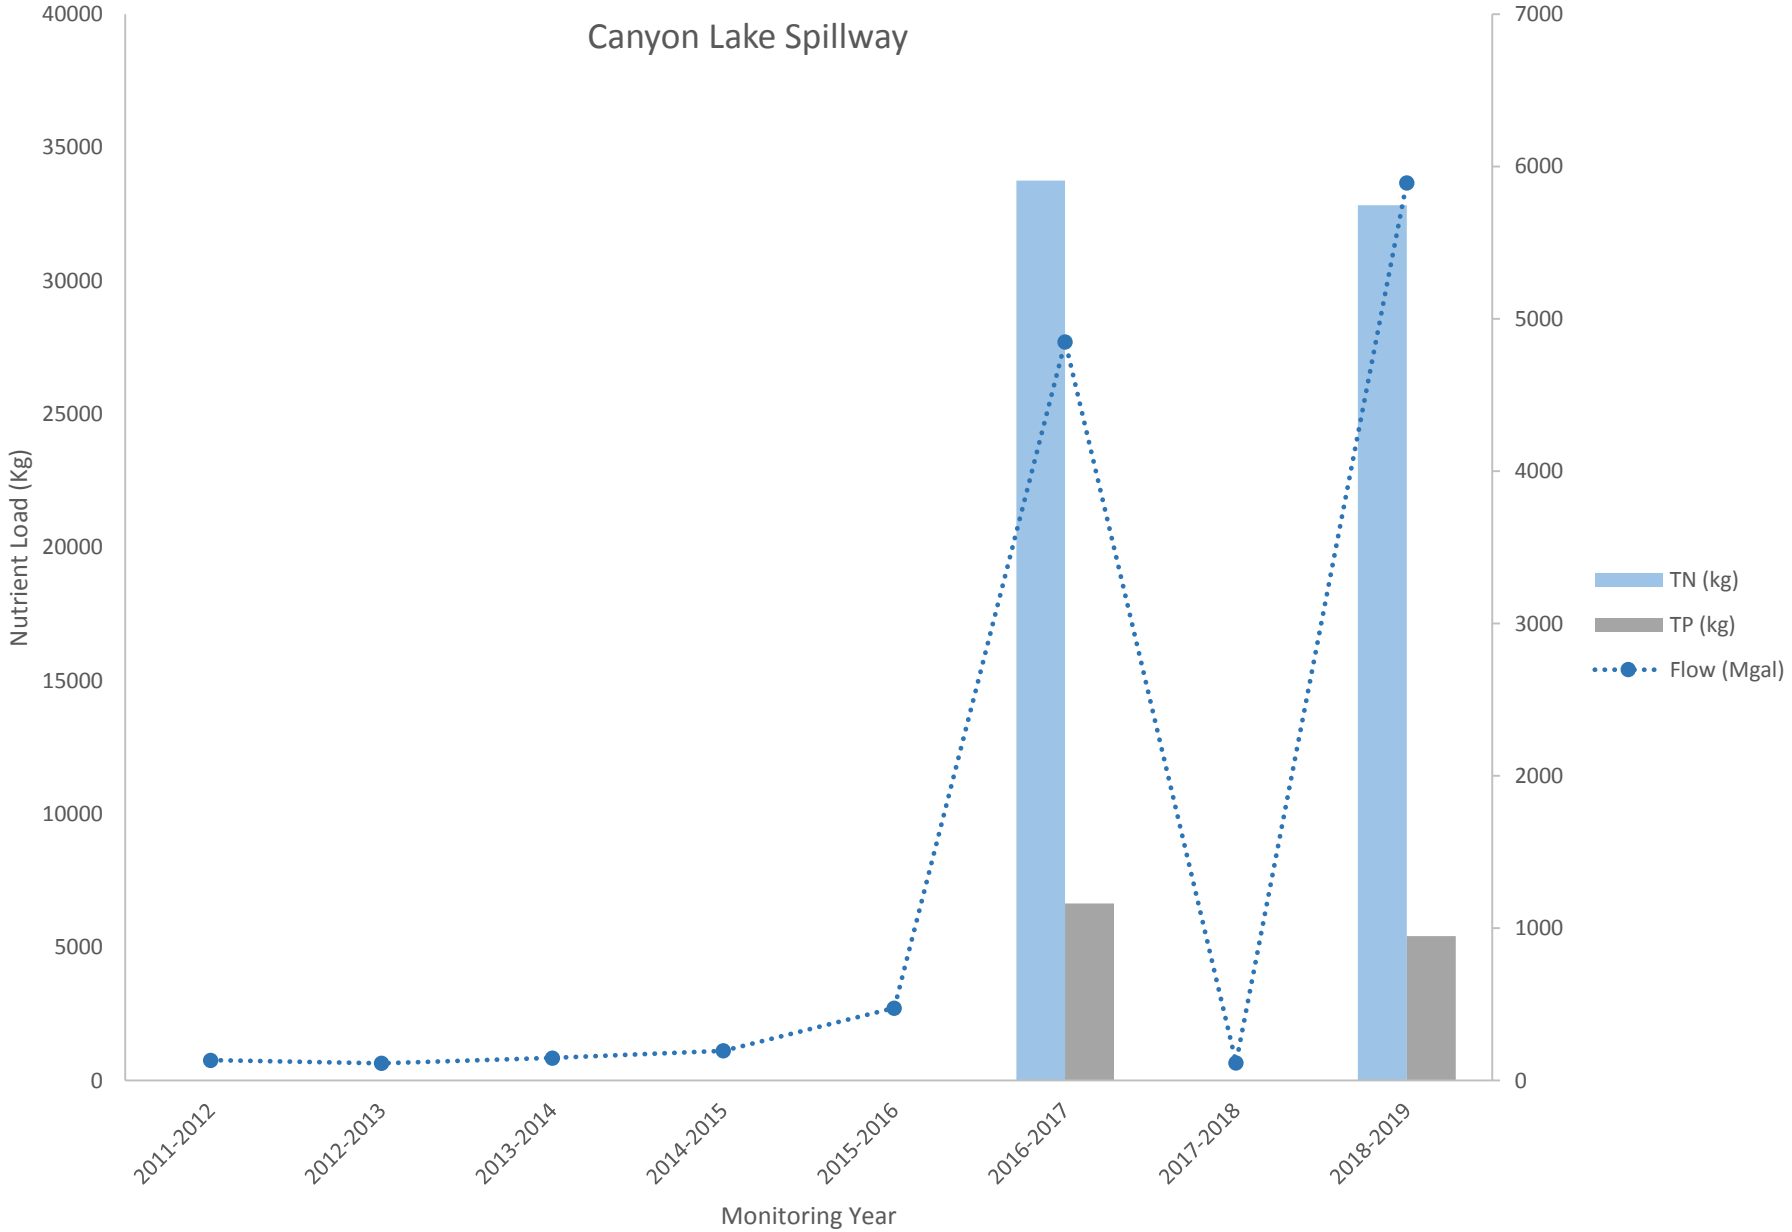
Canyon Lake Spillway Historic Nutrient Loads

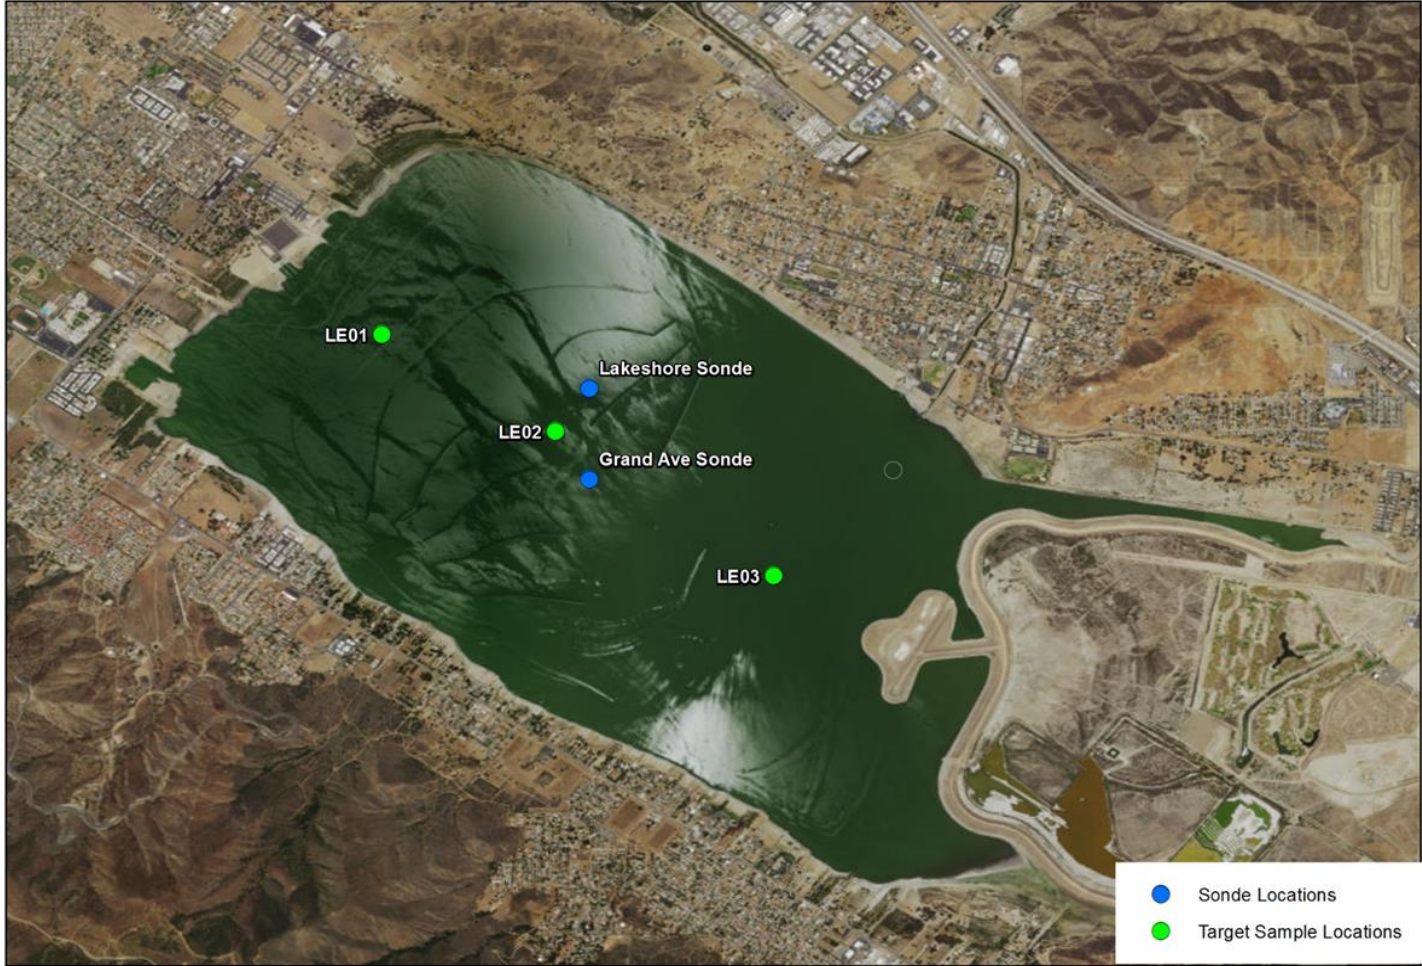
Station Locations – Lake Elsinore

Sample Locations and Water Quality Data Sondes For Lake Elsinore

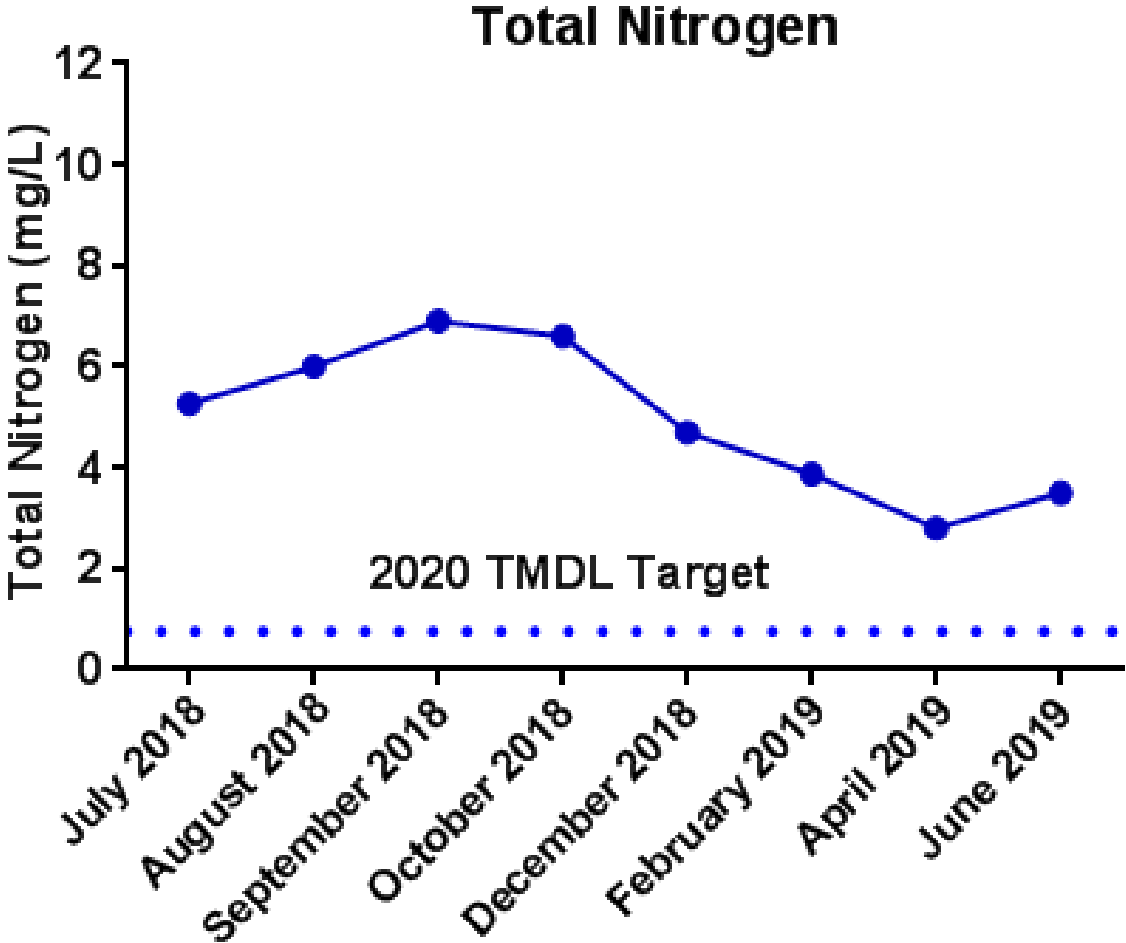
Total Nitrogen – Lake Elsinore 2018-2019
