Lake Elsinore and Canyon Lake TMDL Water Quality Monitoring Update – 2018-19 Summary

September 25, 2019

Watershed
Monitoring

In-Lake
Monitoring

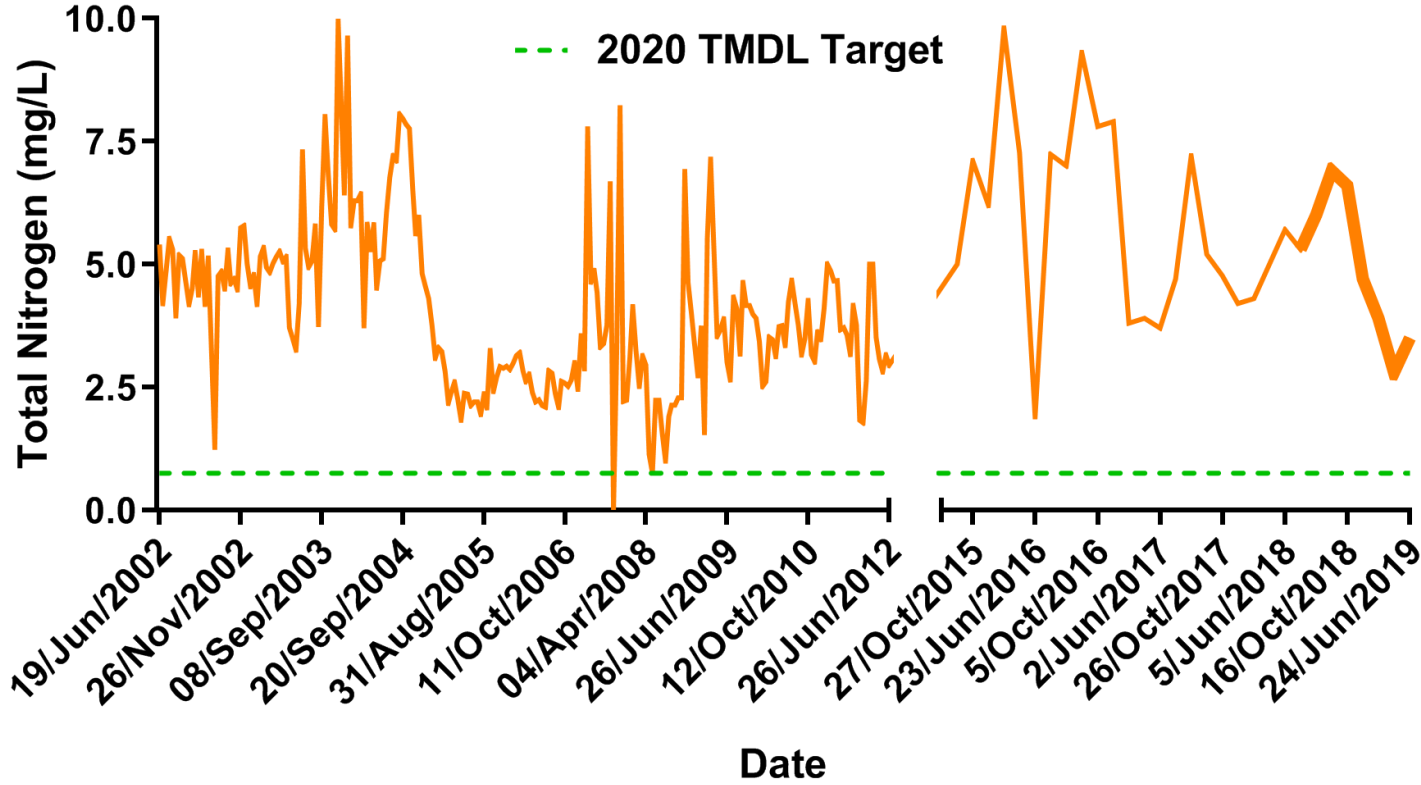
Total Nitrogen – Lake Elsinore Historic Data

No data available from June 2012-July2015
 TMDL target of 0.75 mg/L is annual average to be attained by 2020
Bold represents current monitoring year July 2018-June 2019

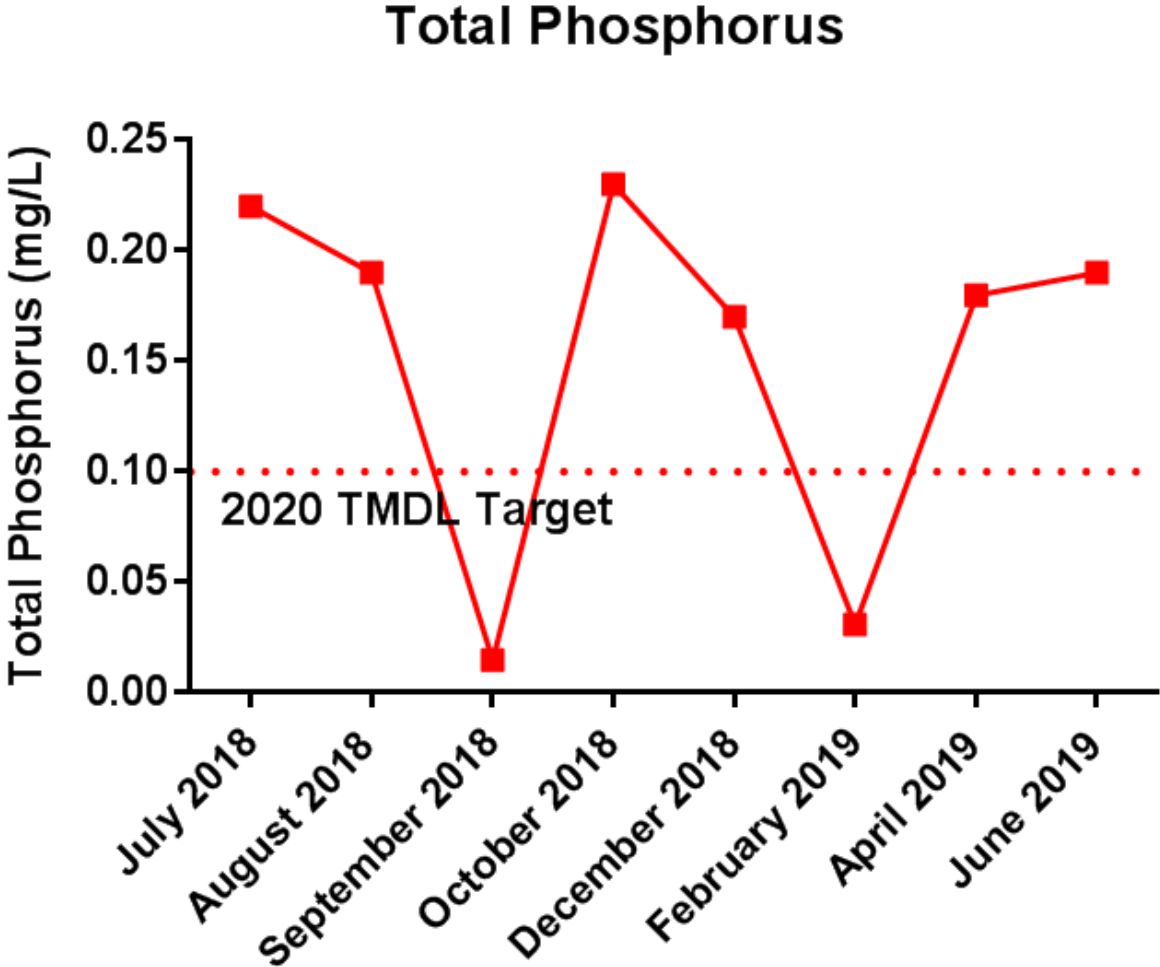
Total Phosphorus – Lake Elsinore 2018-2019

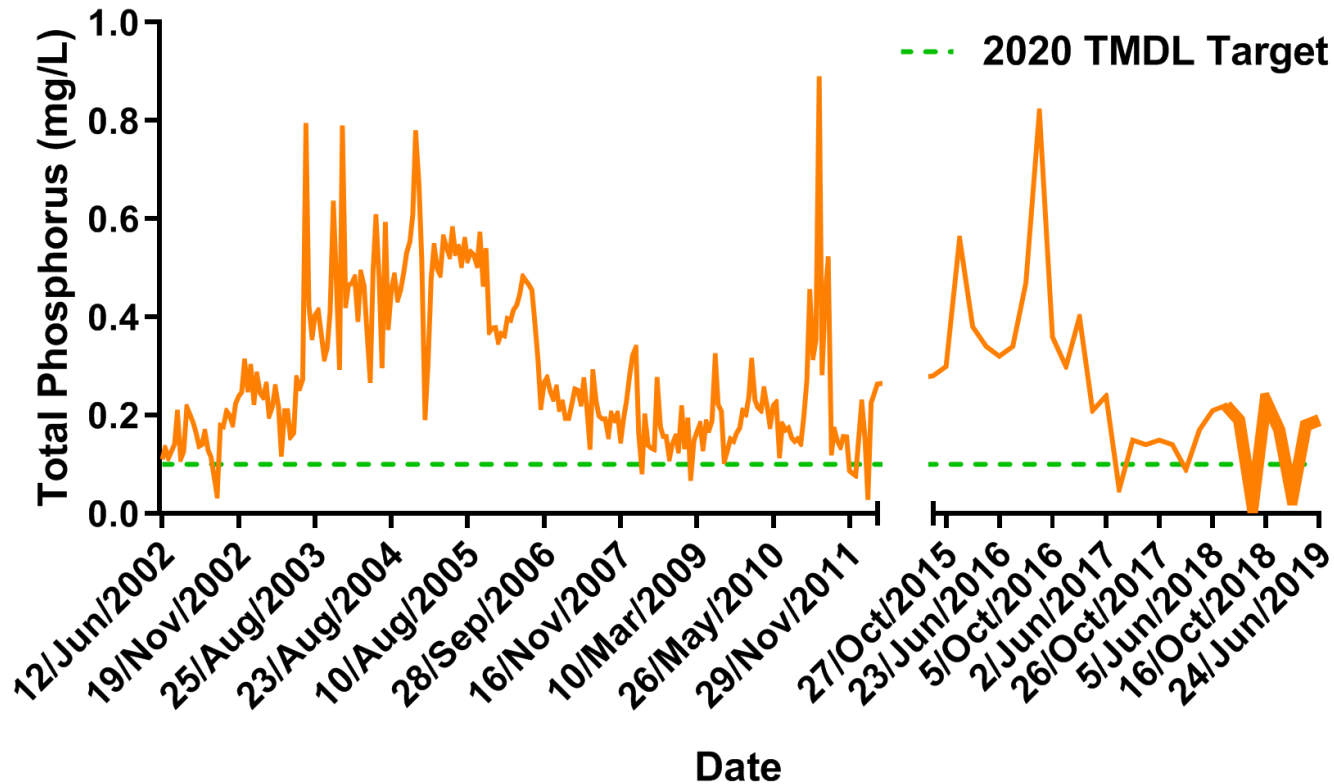
Total Phosphorus – Lake Elsinore Historic Data

No data available from June 2012-July 2015

TMDL target of 0.75 mg/L is annual average to be attained by 2020

Bold represents current monitoring year July 2018-June 2019

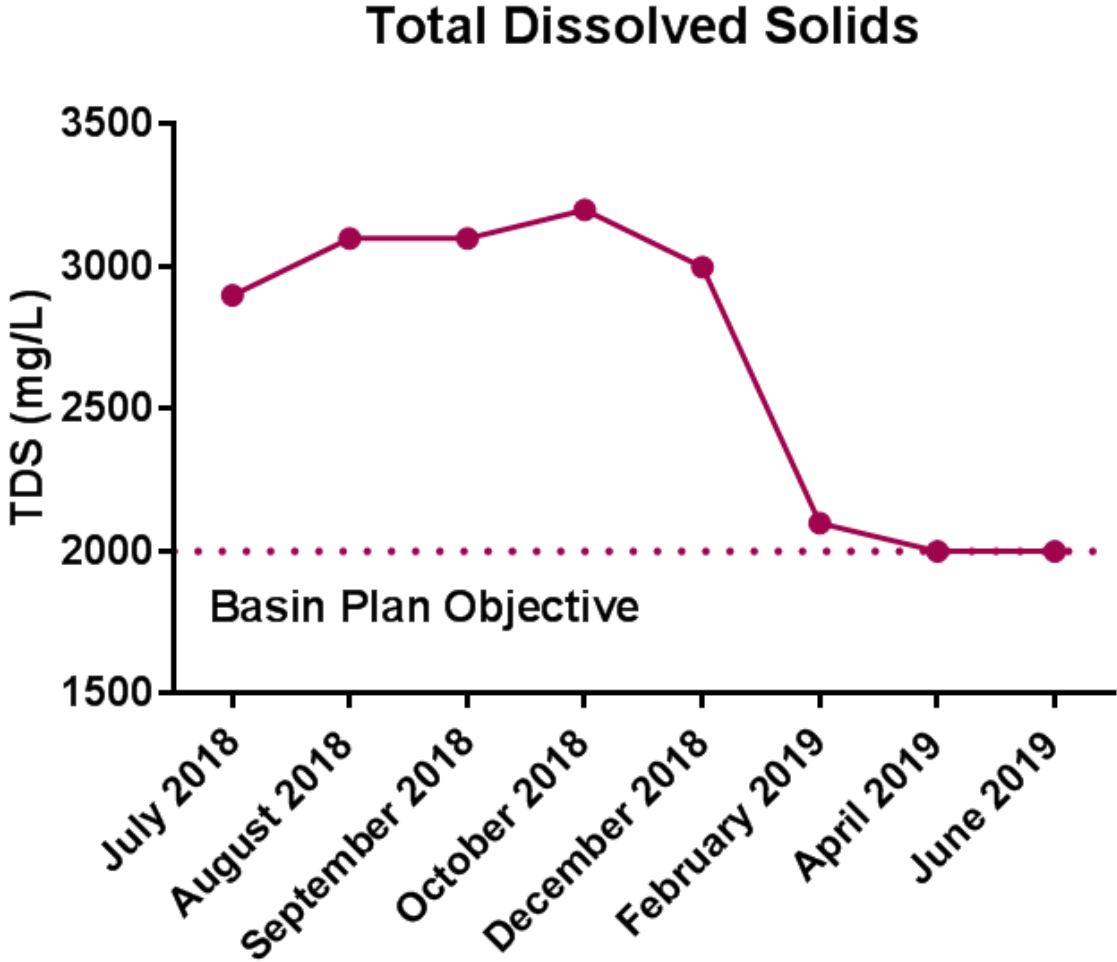
Total Dissolved Solids– Lake Elsinore 2018-2019

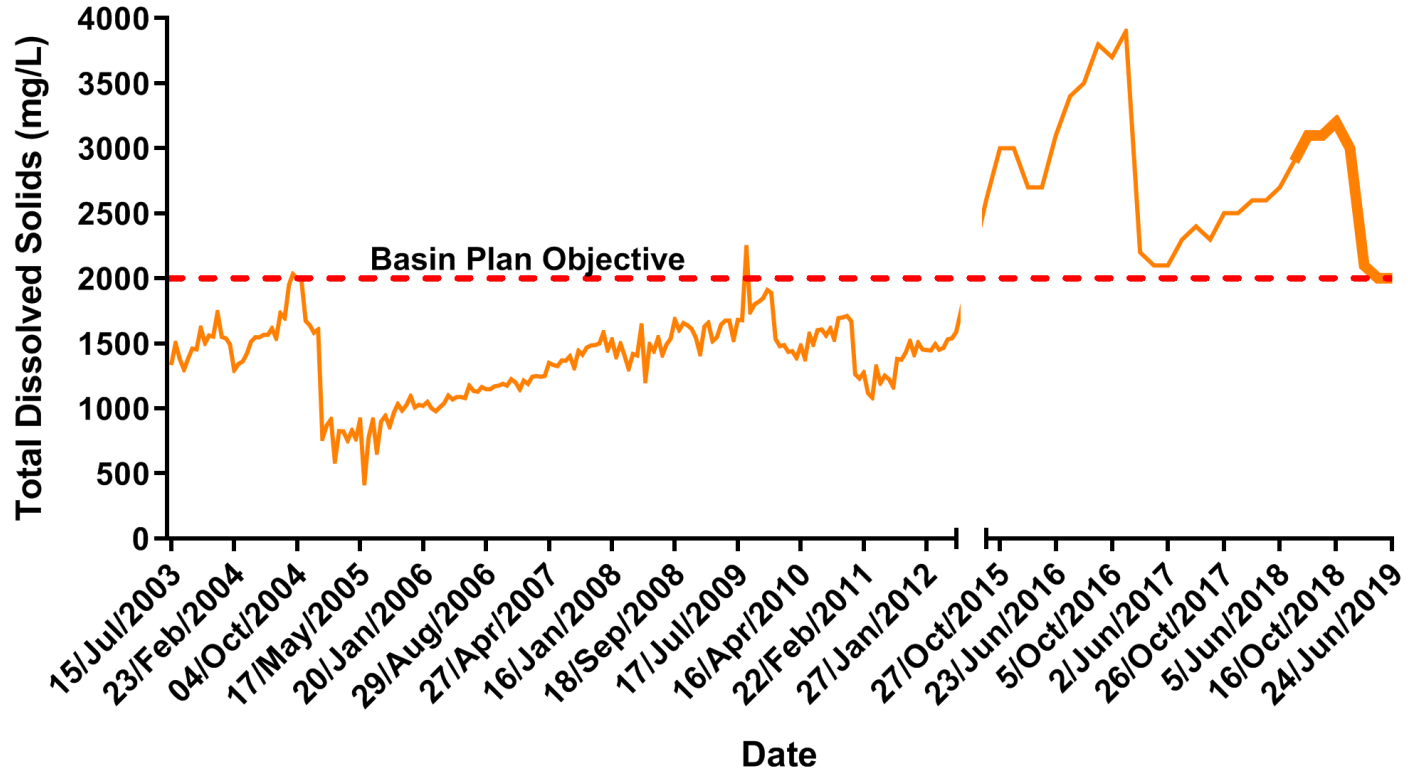
Total Dissolved Solids– Lake Elsinore Historic Data

No data available from June 2012-July 2015

Bold represents current monitoring year July 2018-June 2019

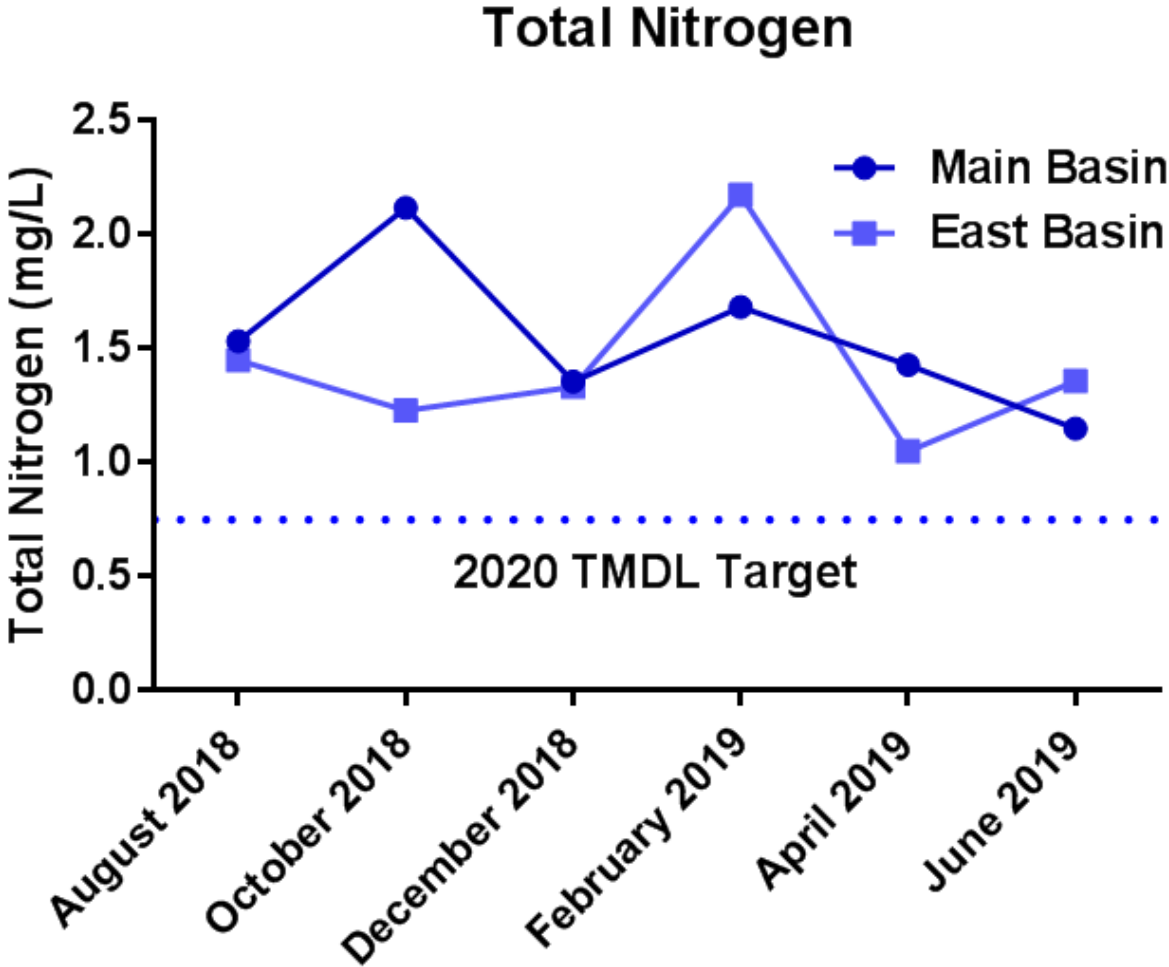
Total Nitrogen – Canyon Lake 2018-2019

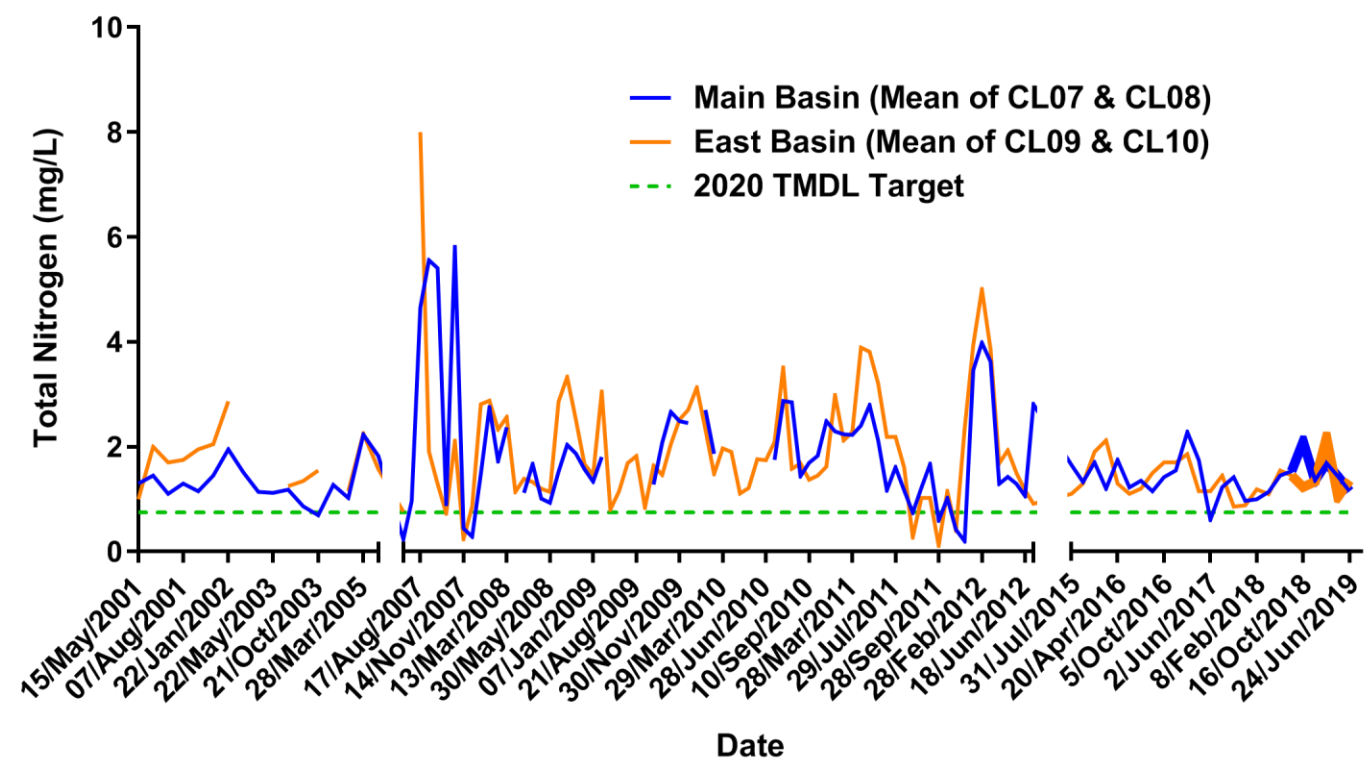
Total Nitrogen – Canyon Lake Historic Data

No data available from May 2005-July 2007; June 2012-July2015
TMDL target of 0.75 mg/L is annual average to be attained by 2020
Bold represents current monitoring year July 2018-June 2019

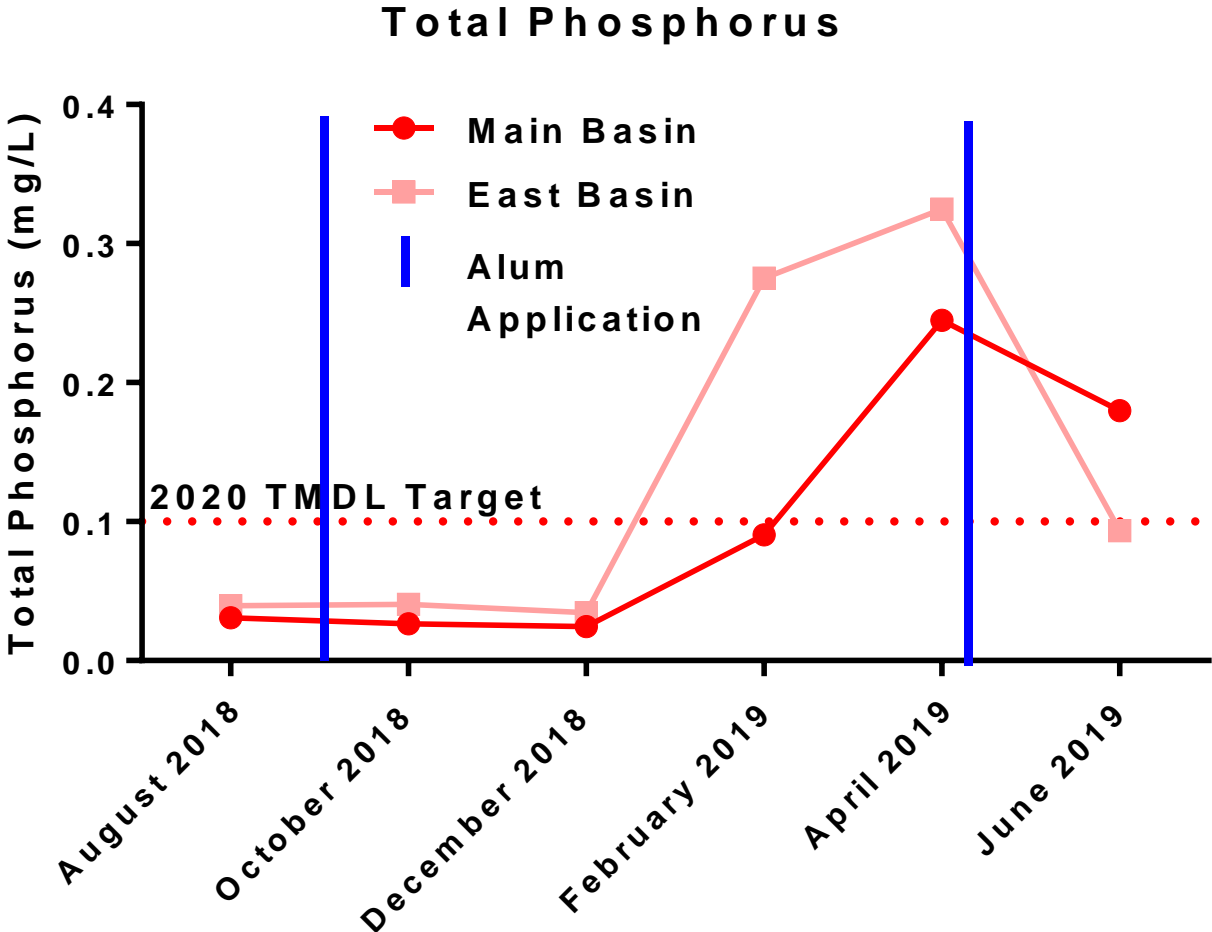
Total Phosphorus – Canyon Lake 2018-2019

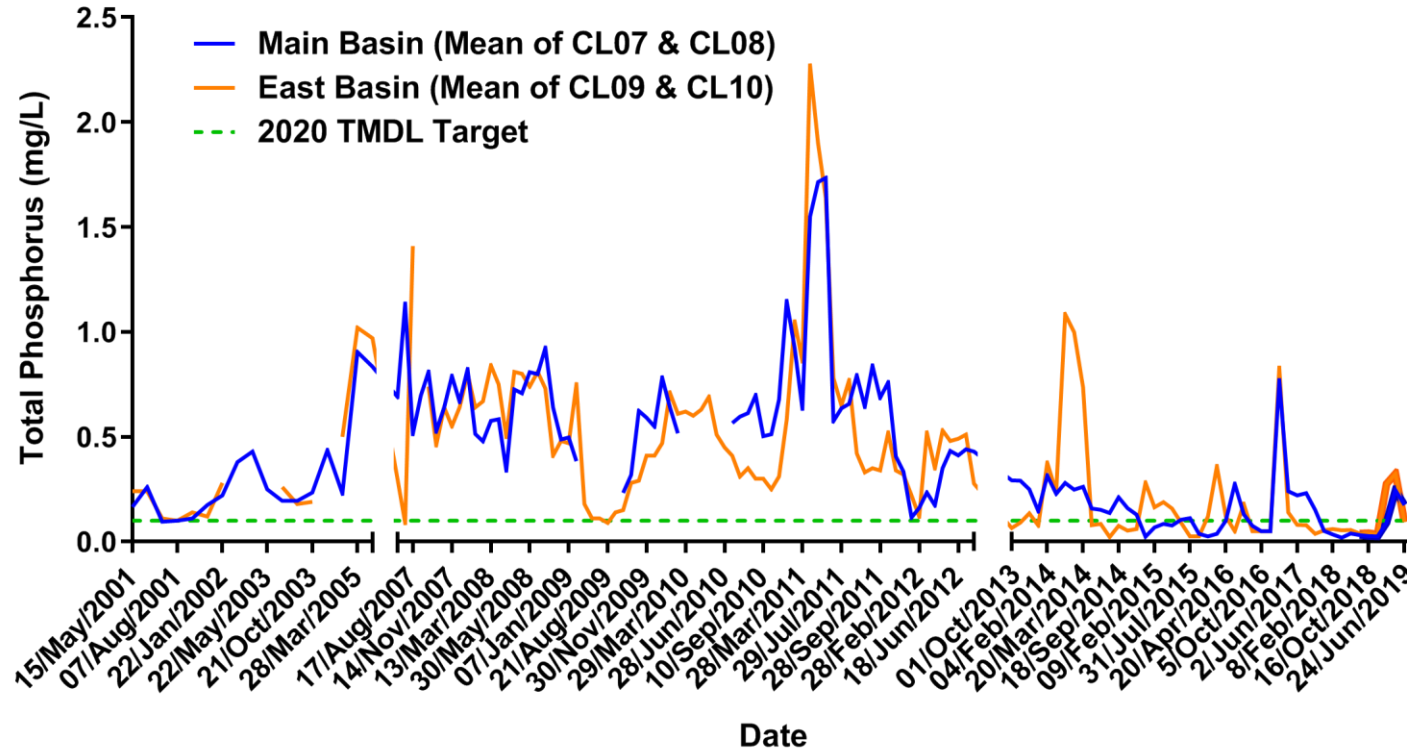
Total Phosphorus – Canyon Lake Historic Data

No data available from May 2005-July 2007; June 2012-Sept 2013
TMDL target of 0.75 mg/L is annual average to be attained by 2020
Bold represents current monitoring year July 2018-June 2019

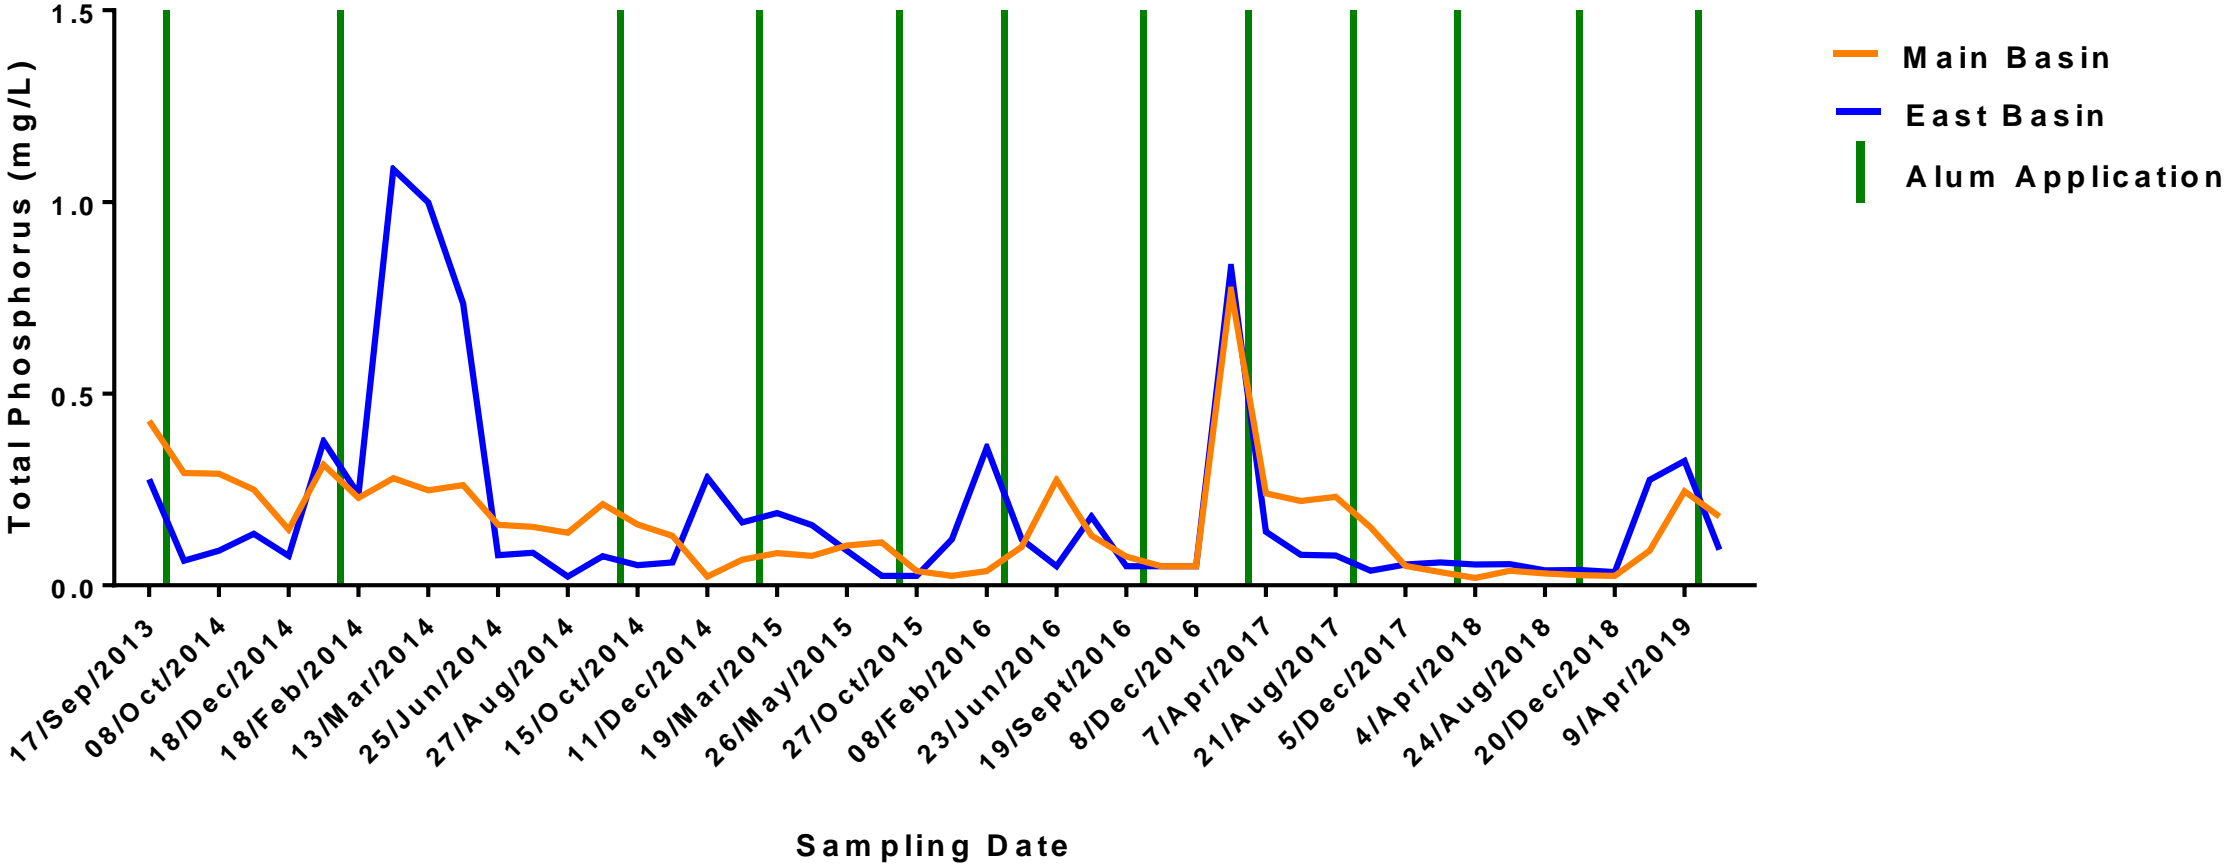
Alum Effectiveness – Canyon Lake Total Phosphorus

* All samples labels not included on x-axis

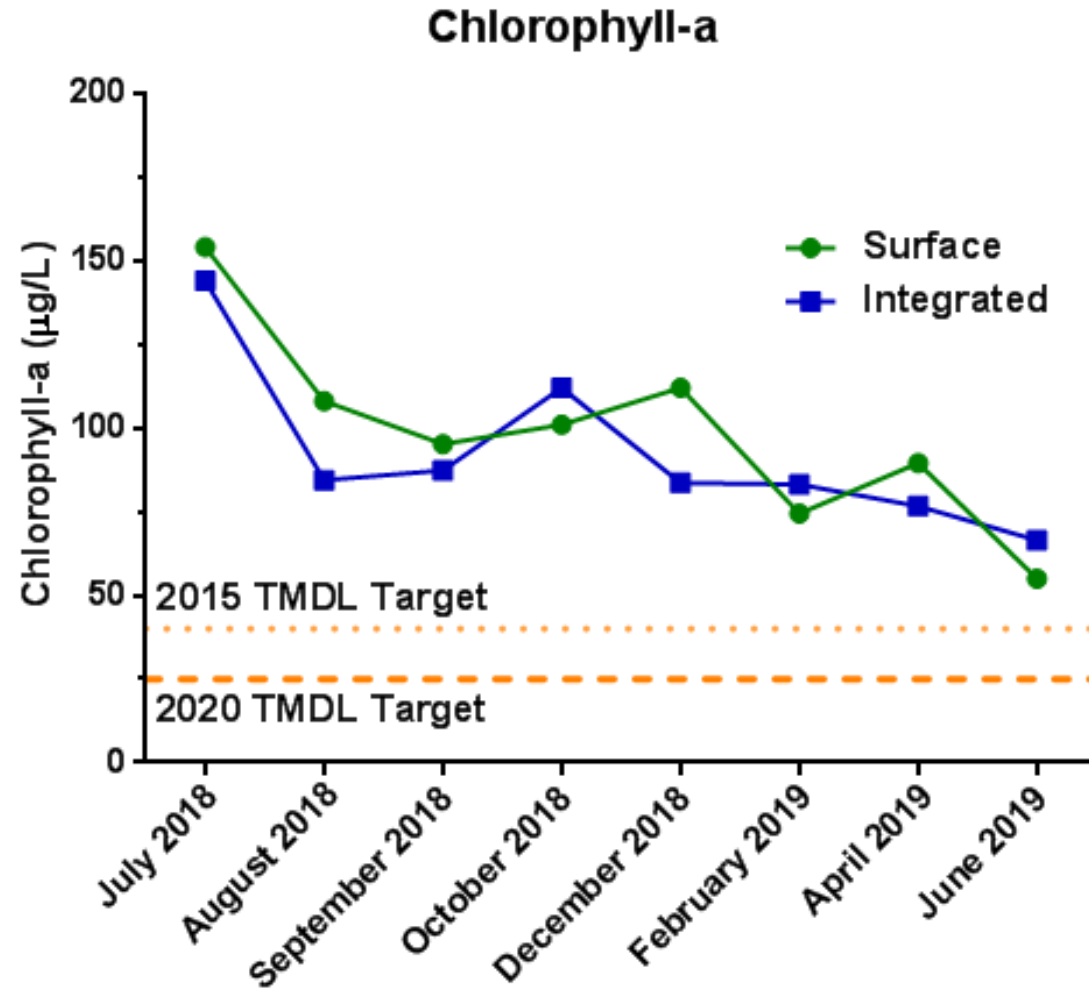
Lake Elsinore Chlorophyll – 2018-2019

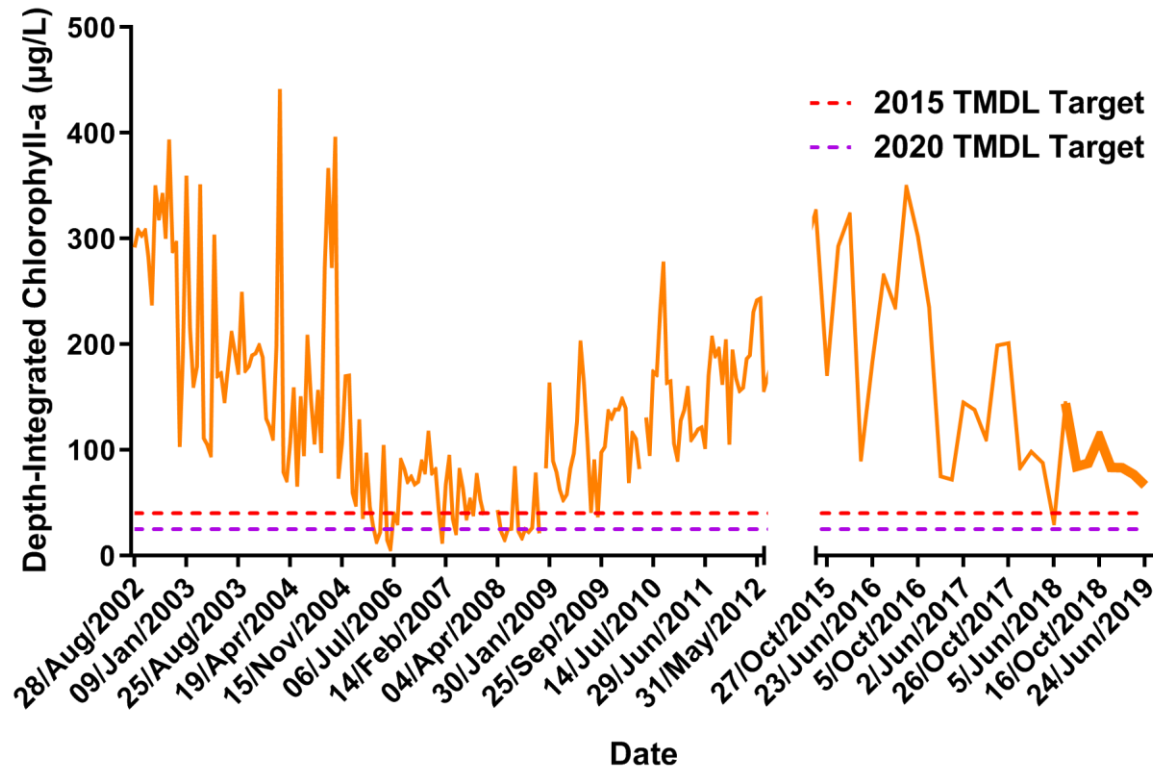
Lake Elsinore Chlorophyll – Integrated Historic Data

No data available from June 2012-July 2015
2015 TMDL target of 40 µg/L is annual average to be attained by 2015
2020 TMDL target of 25 µg/L is annual average to be attained by 2020
Bold represents current monitoring year July 2018-June 2019

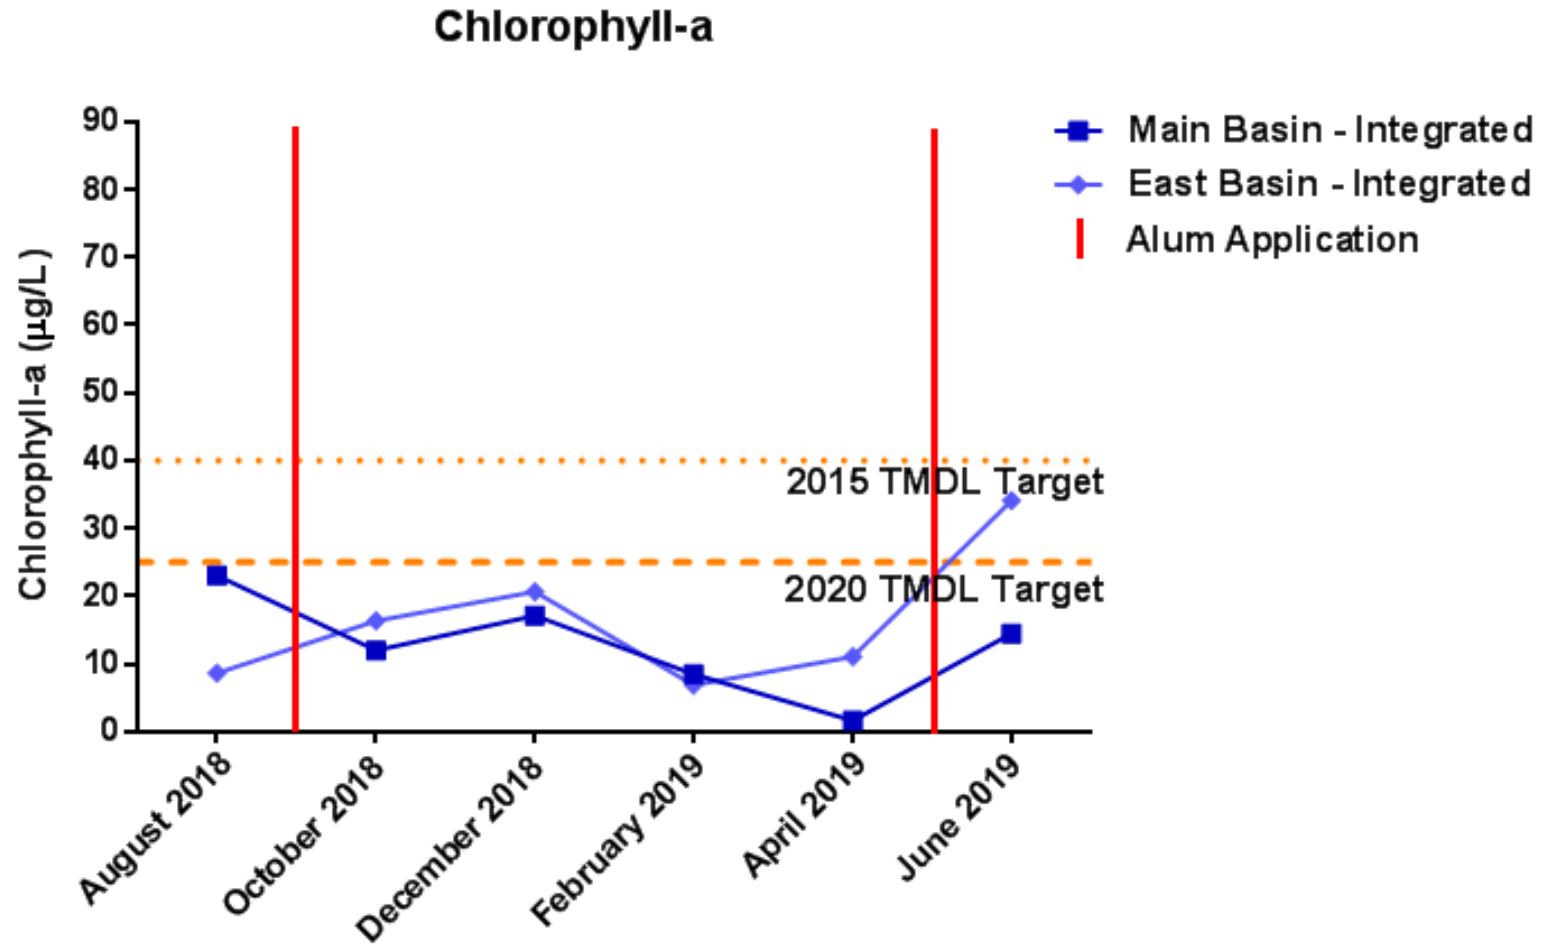
Canyon Lake Chlorophyll – 2018-2019

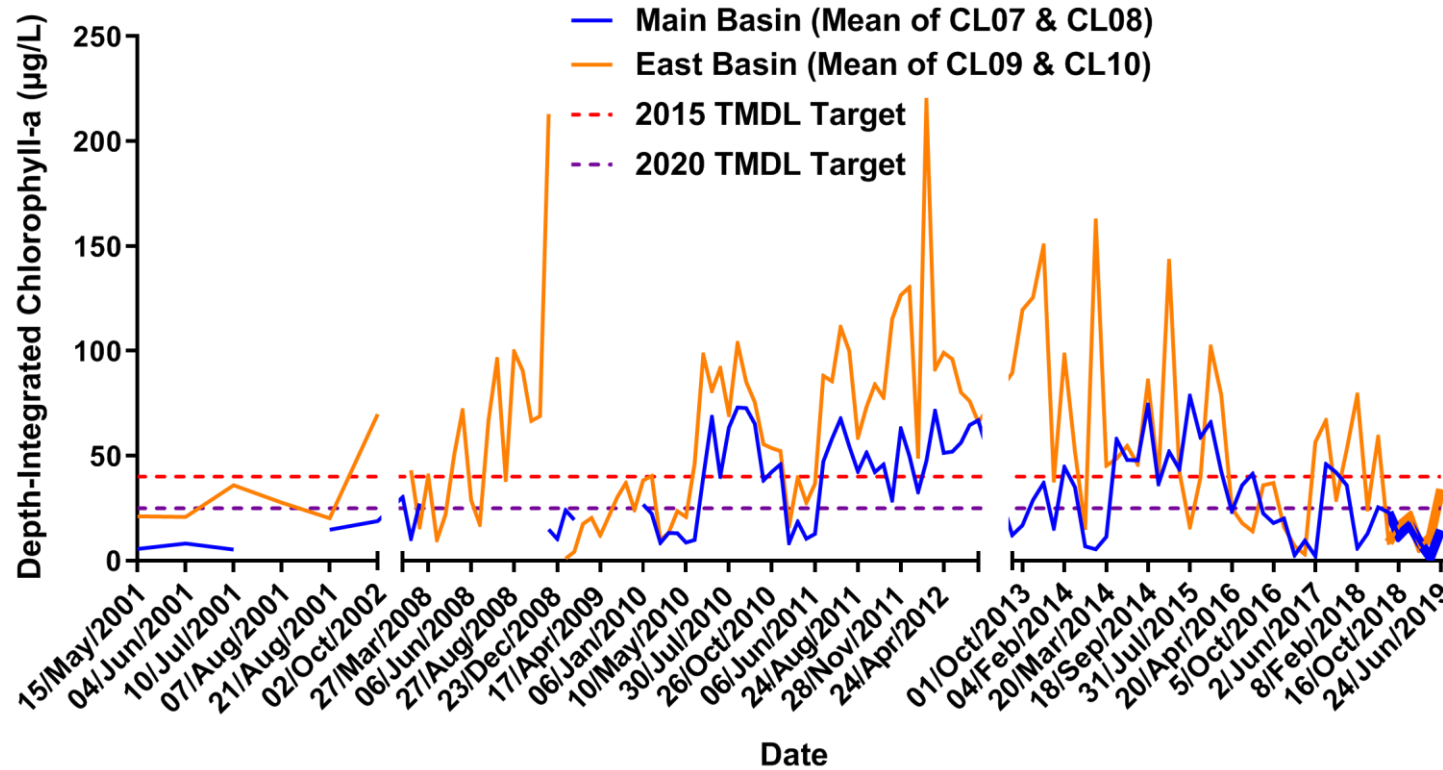
Canyon Lake Chlorophyll – Integrated Historic Data

No data available from June 2012-July 2015

2015 TMDL target of 40 µg/L is annual average to be attained by 2015

2020 TMDL target of 25 µg/L is annual average to be attained by 2020

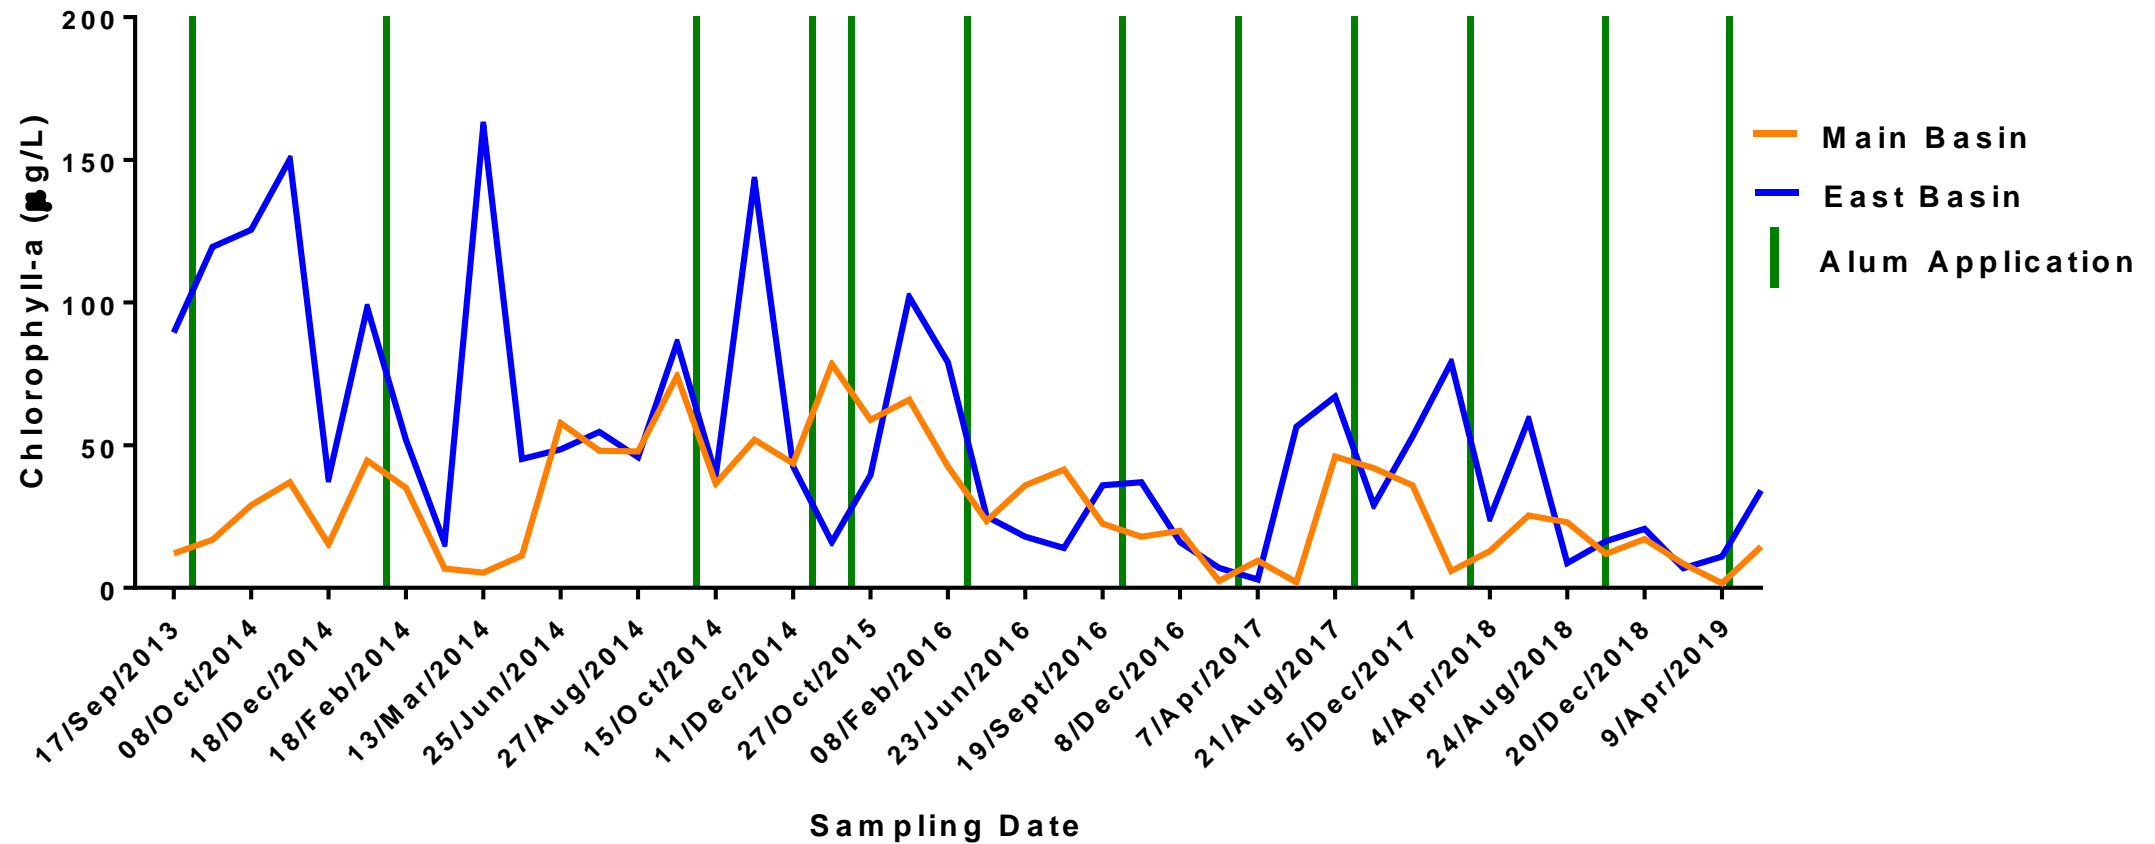
Alum Effectiveness – Canyon Lake Chlorophyll-a

* Note that x-axis does not include dates between sampling (not to scale)

* Alum applied in February 2015, but water not sampled again until October 2015

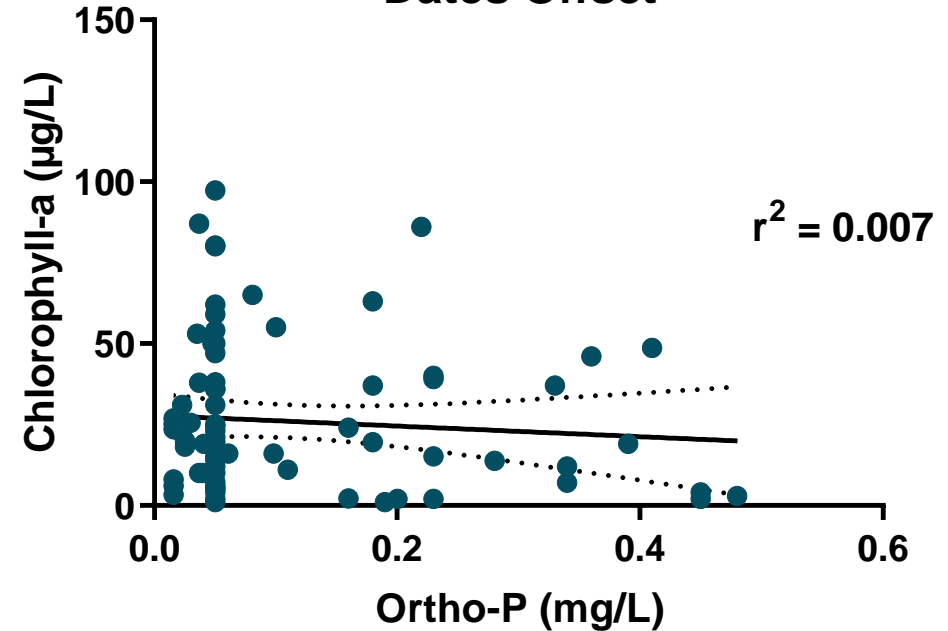
Ortho-P vs Chlorophyll-a Canyon Lake All Sites Dates Offset

Ortho-P vs. CHL measured in subsequent month

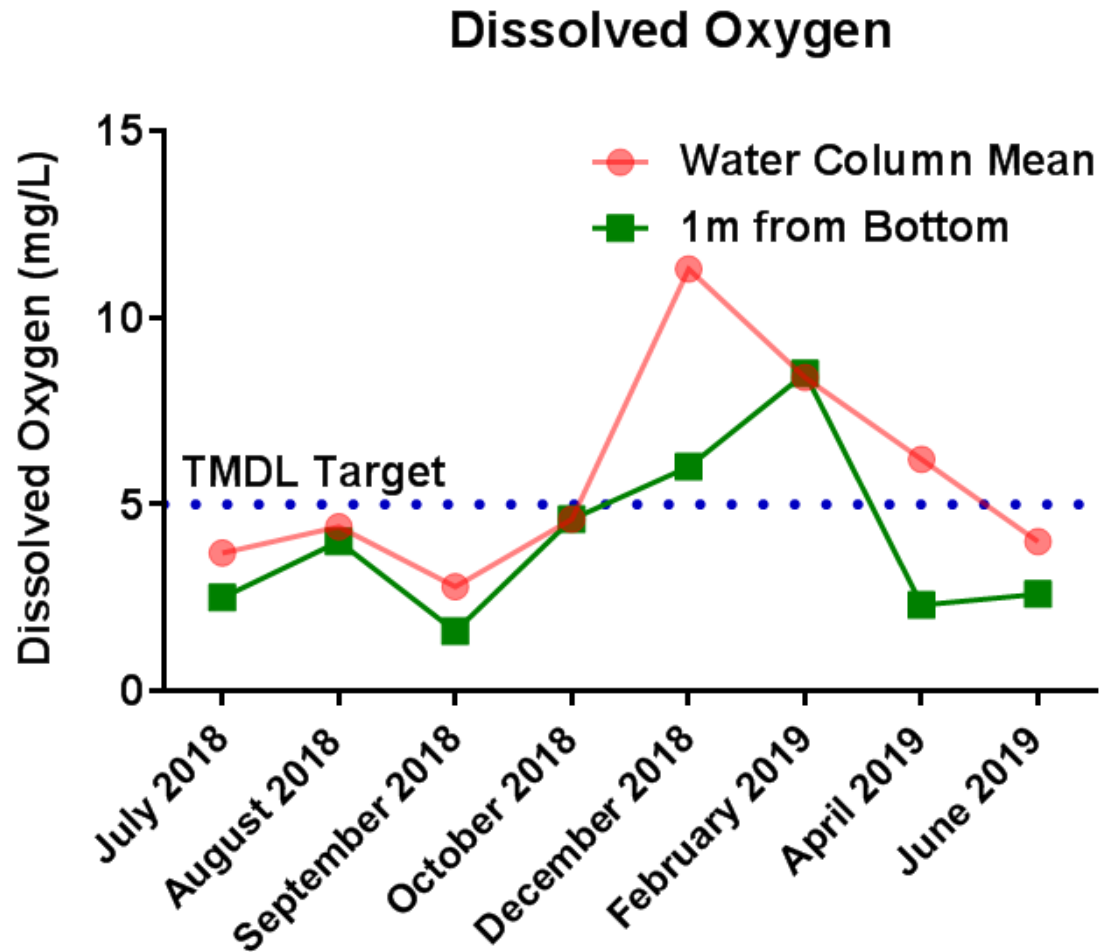
Lake Elsinore Dissolved Oxygen – LE02 Water Column Mean vs. 1m from Bottom 2018-2019

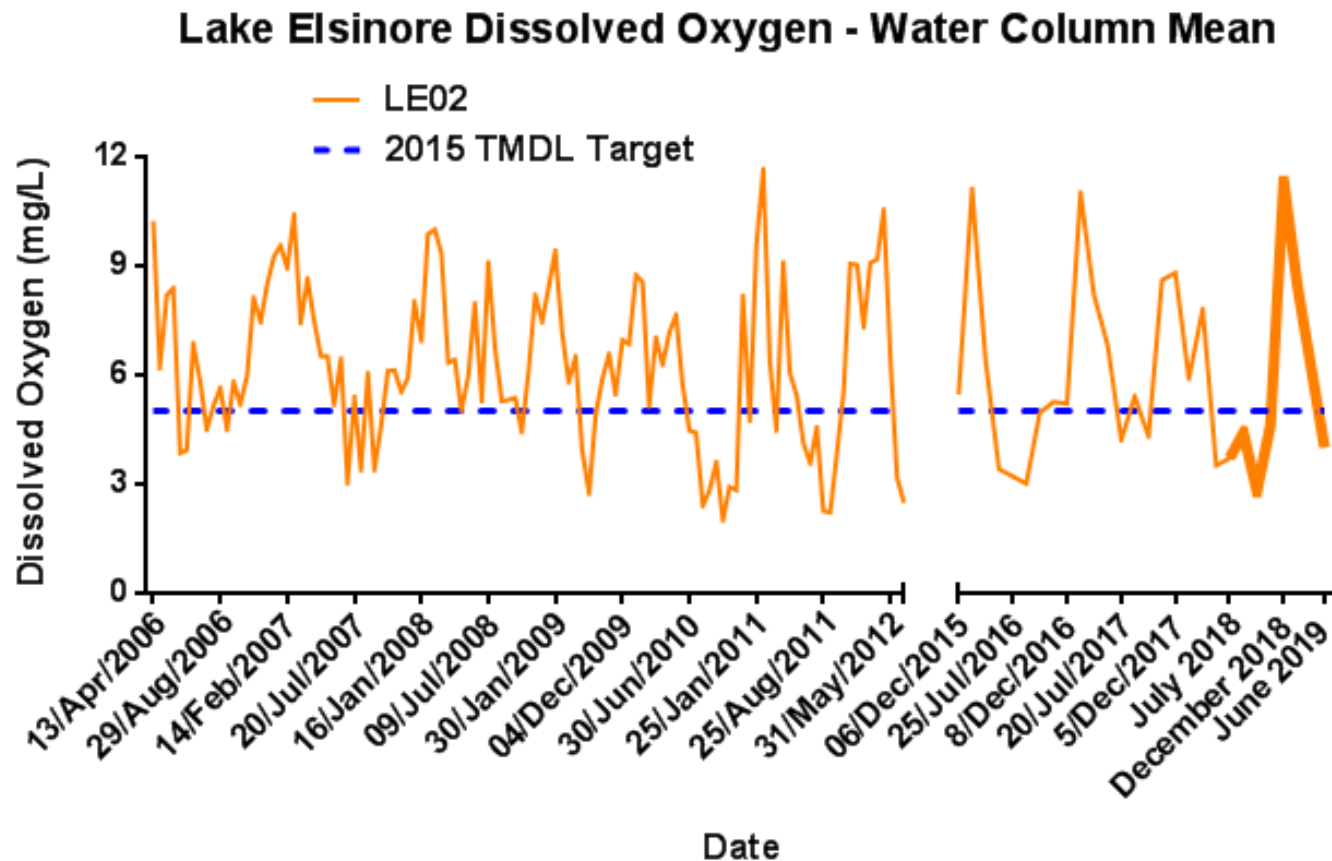
Lake Elsinore Dissolved Oxygen – LE02 Water Column Mean Historic Data

No data available from June 2012-July 2015

TMDL target of 5 mg/L is depth average to be attained by 2015

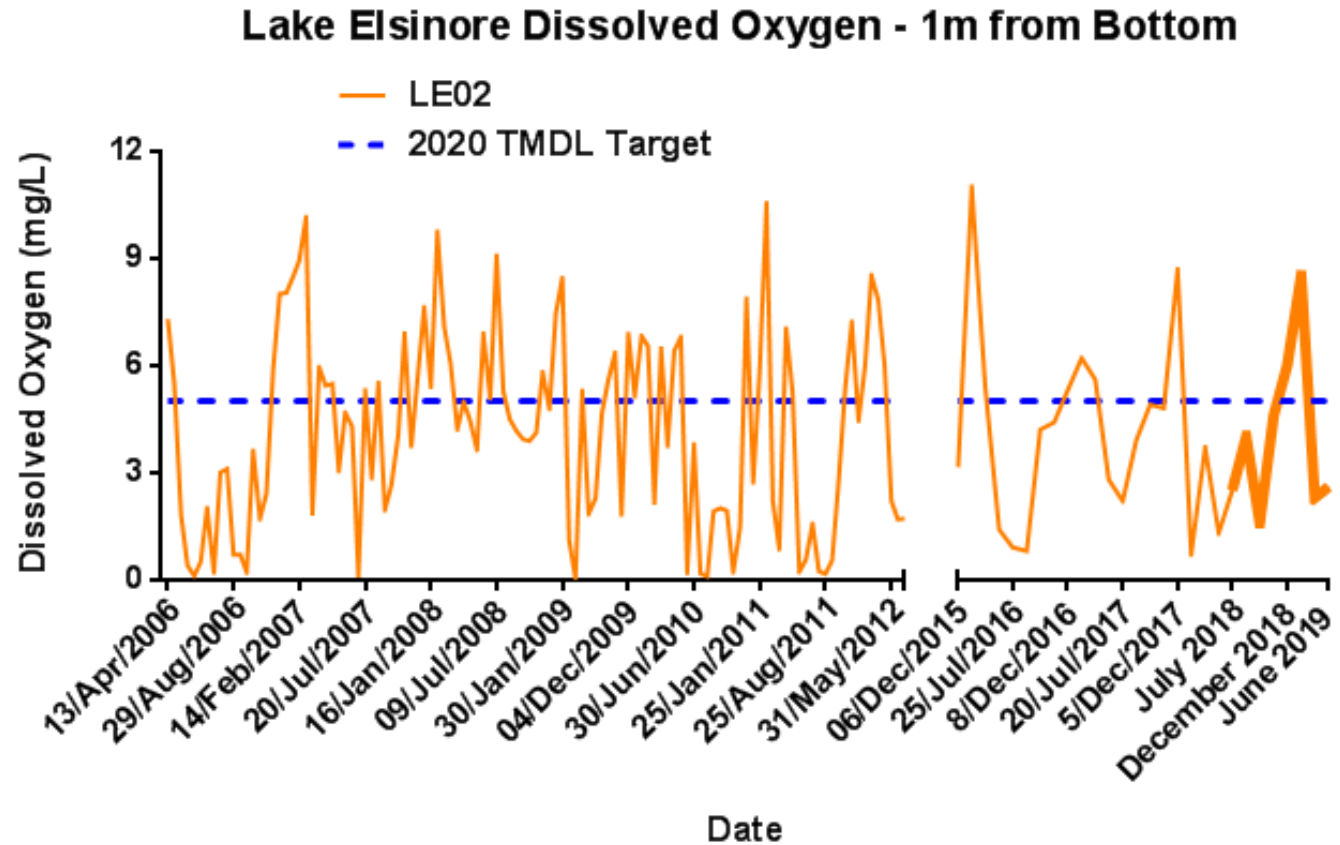
Lake Elsinore Dissolved Oxygen – LE02 1m from Bottom Historic Data

No data available from June 2012-July 2015
TMDL target of 5 mg/L is 1 m off lake bottom to be attained by 2020
Bold represents current monitoring year July 2018-June 2019
