Lake Elsinore and Canyon Lake TMDL Water Quality Monitoring Update – 2018-19 Summary

September 25, 2019

Watershed
Monitoring

In-Lake
Monitoring

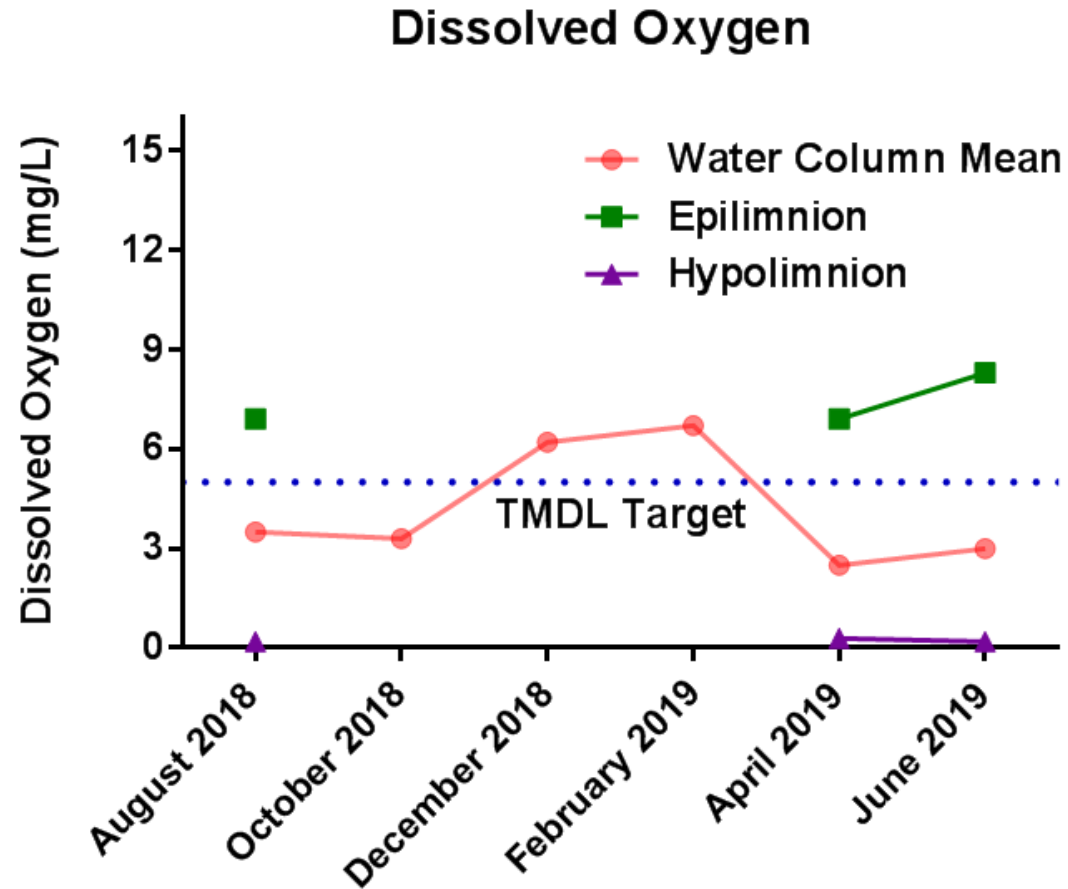
Canyon Lake Dissolved Oxygen – Main Basin Epilimnion vs. Hypolimnion 2018-2019

Mean of Sites
CL07 & CL08

No stratification in October, December or February
Lake not sampled in July 2018

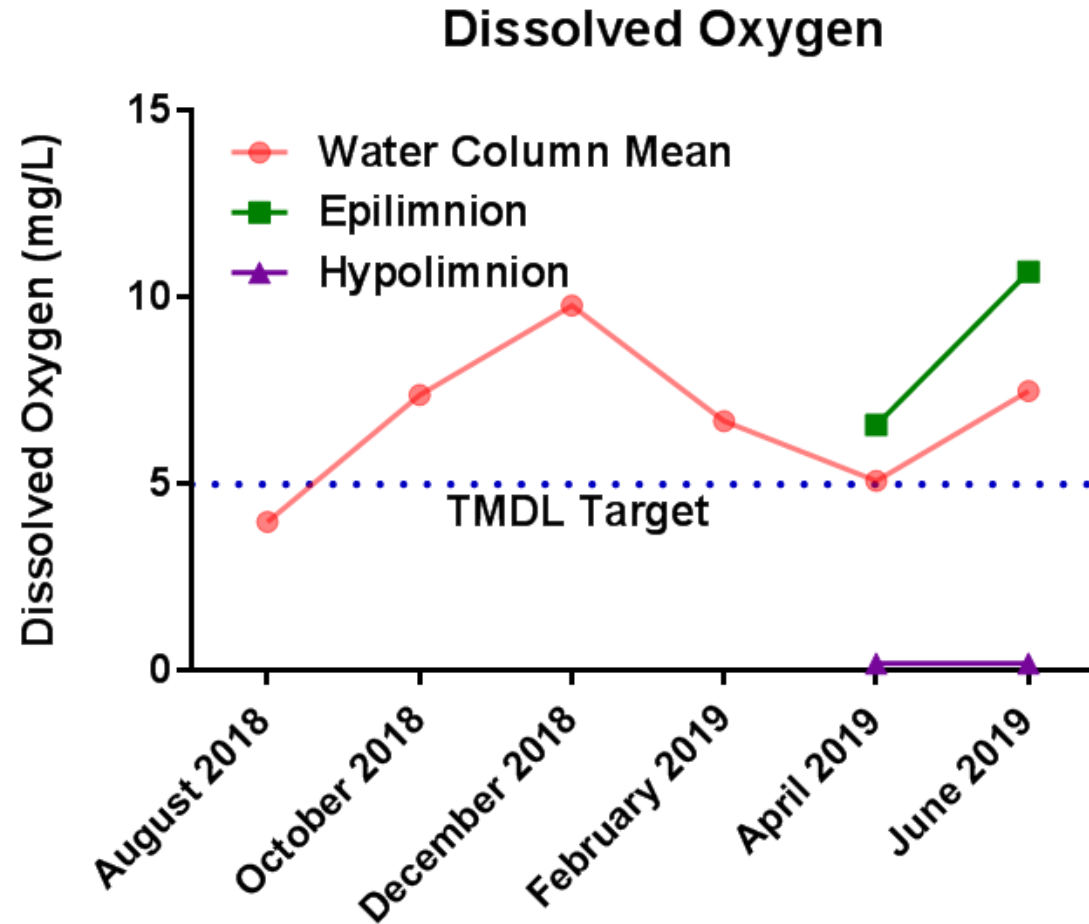
Canyon Lake Dissolved Oxygen – East Basin Epilimnion vs. Hypolimnion 2018-2019

Mean of Sites
CL09 & CL10

No stratification in August, October, December or February
Lake not sampled in July 2018
