# Inland Empire Brine Line

**Project Agreement 24 Committee | November 5, 2019**

# Inland Empire Brine Line Reach 4A/4B Lower Update

Carlos Quintero, Operations Manager  
Project Agreement 24 Committee | November 5, 2019  
Item No. 4.C

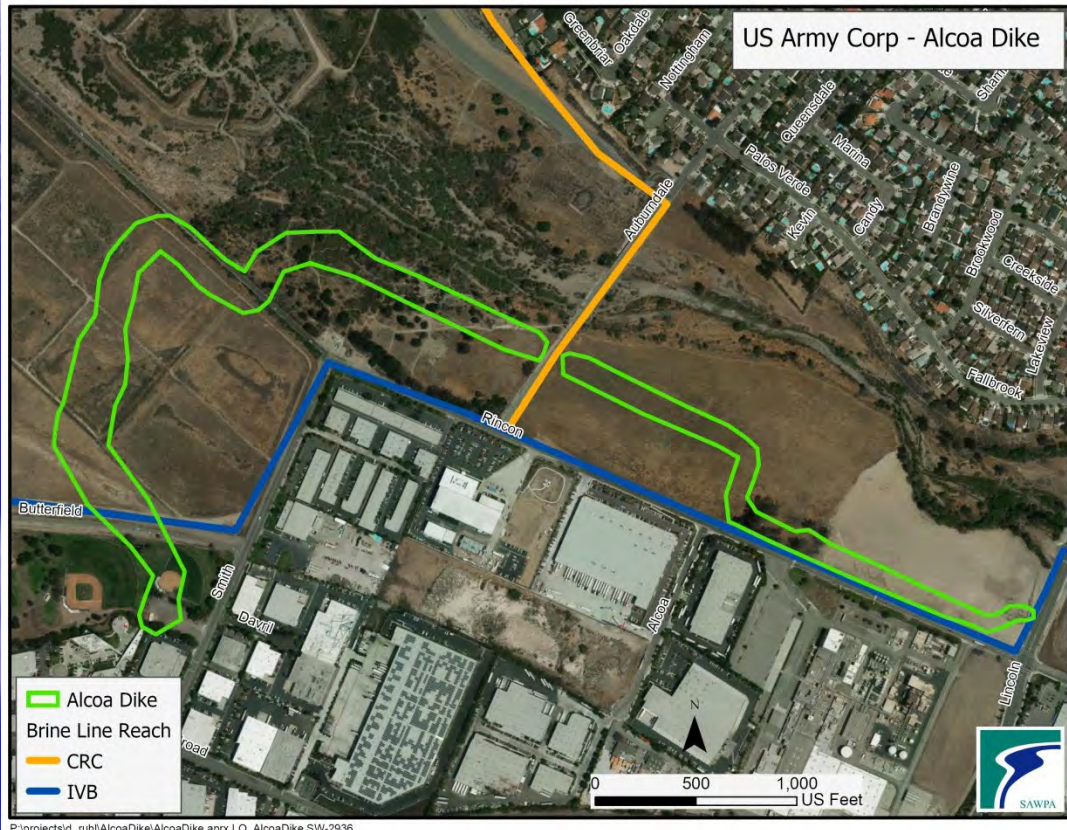
# Alcoa Dike - Reach IVB/CRC Lateral

2 areas of Brine Line Impacted

- Relocate 520 ft of Reach 4B
- Protect 115 ft of CRC Lateral
- Preliminary Estimate of Construction Cost
  - \$1,300,000 Reach 4B / \$400,000 CRC Lateral
- Hired Stantec to Prepare Plans and Specifications
- Peer review workshop
- Schedule – 8 months, complete prior to Dike Phase 2 Construction

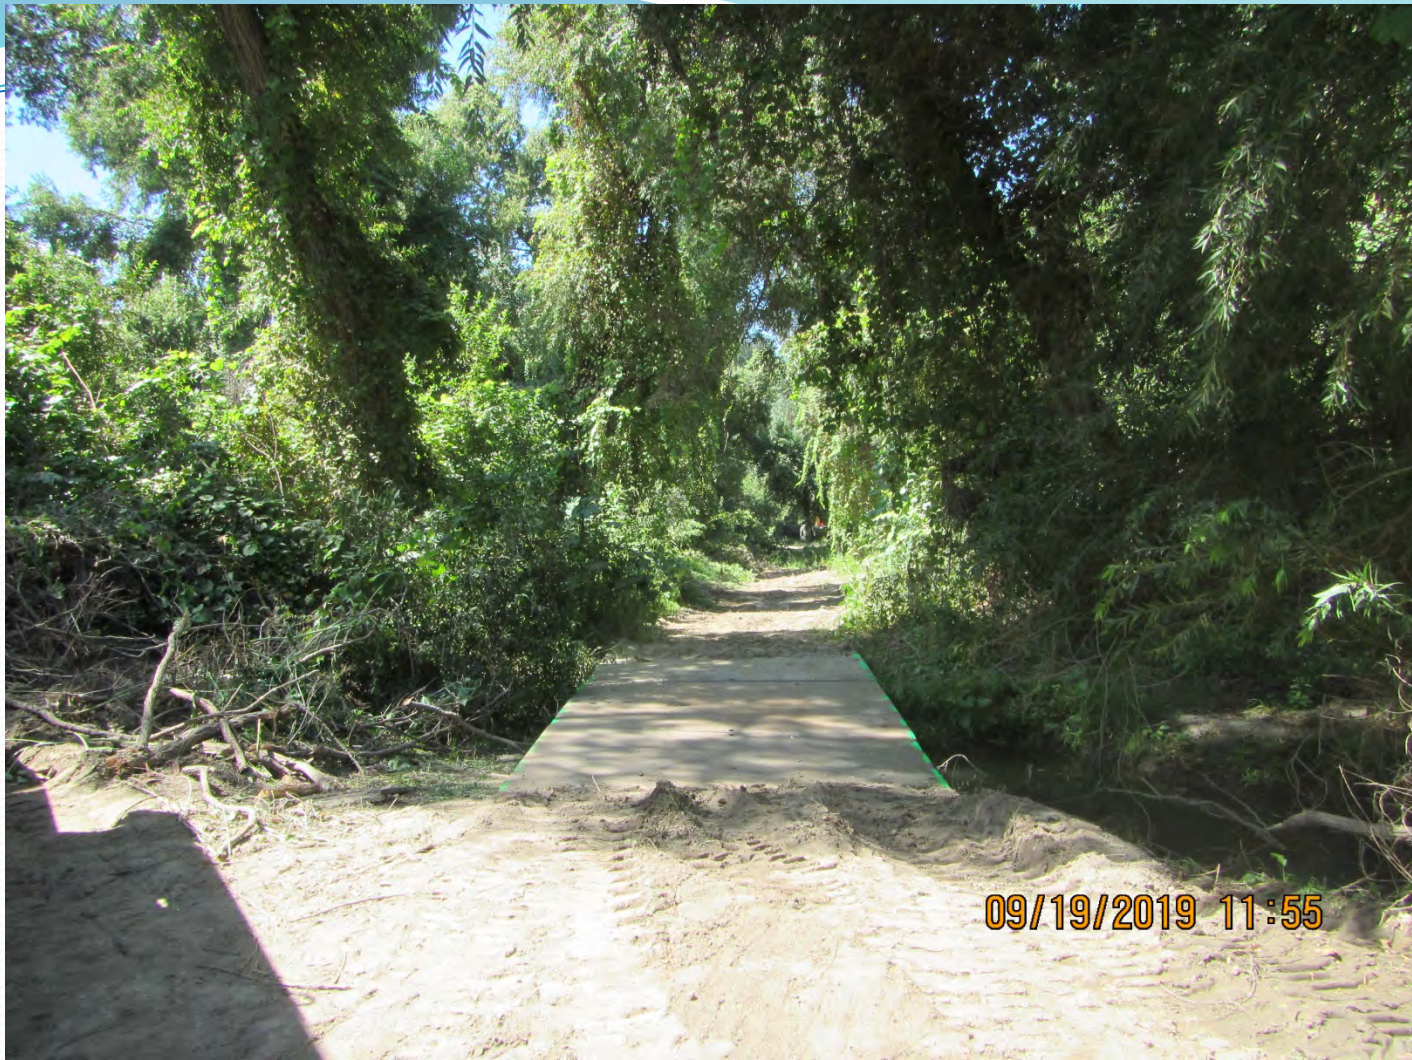
09/19/2019 11:55

Activity	Reach 4A Lower	Reach 4B Lower	Corona Lateral
ROW Maintenance	1.5 miles	3 miles	0.3 miles
Line Inspection	-	1,400 ft	1,250 ft
Line Cleaning		1,400 ft	1,250 ft
MAS Inspected	19	15	3

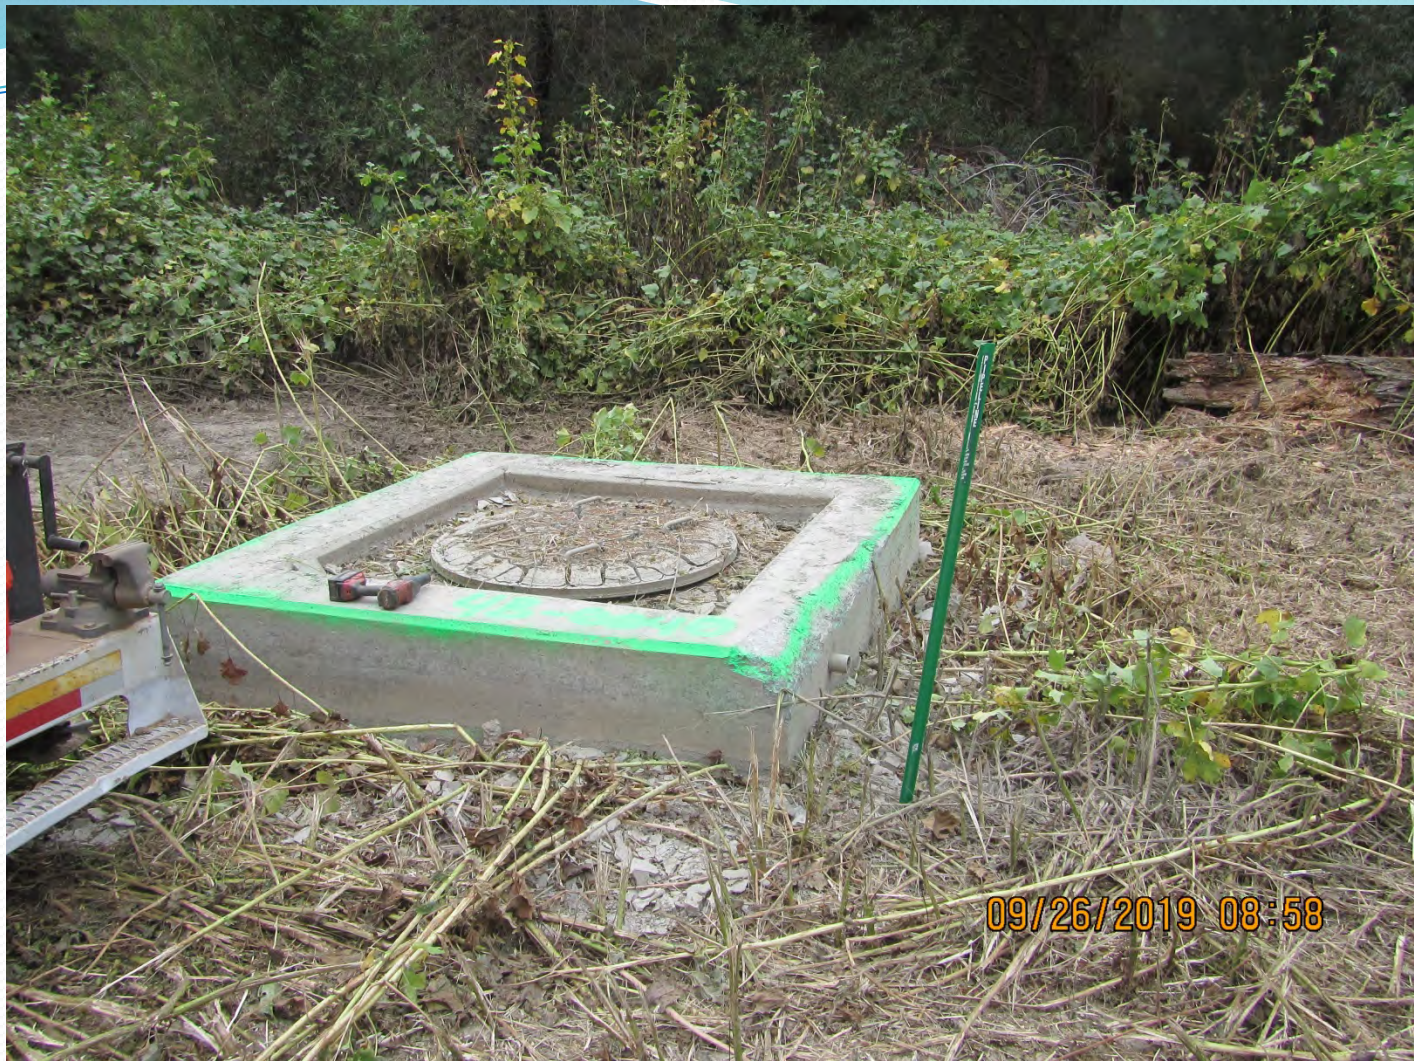
A photograph showing a cross-section of a pipe. The top edge of the pipe is heavily corroded and shows a layer of dark, flaking material. Below this, a layer of light-colored aggregate is exposed. The interior of the pipe is dark and shows some staining. Two red arrows point to specific features: one points to the exposed aggregate, and the other points to a location further downstream.

Exposed aggregate on top of pipe

Downstream from MAS 4A-0010

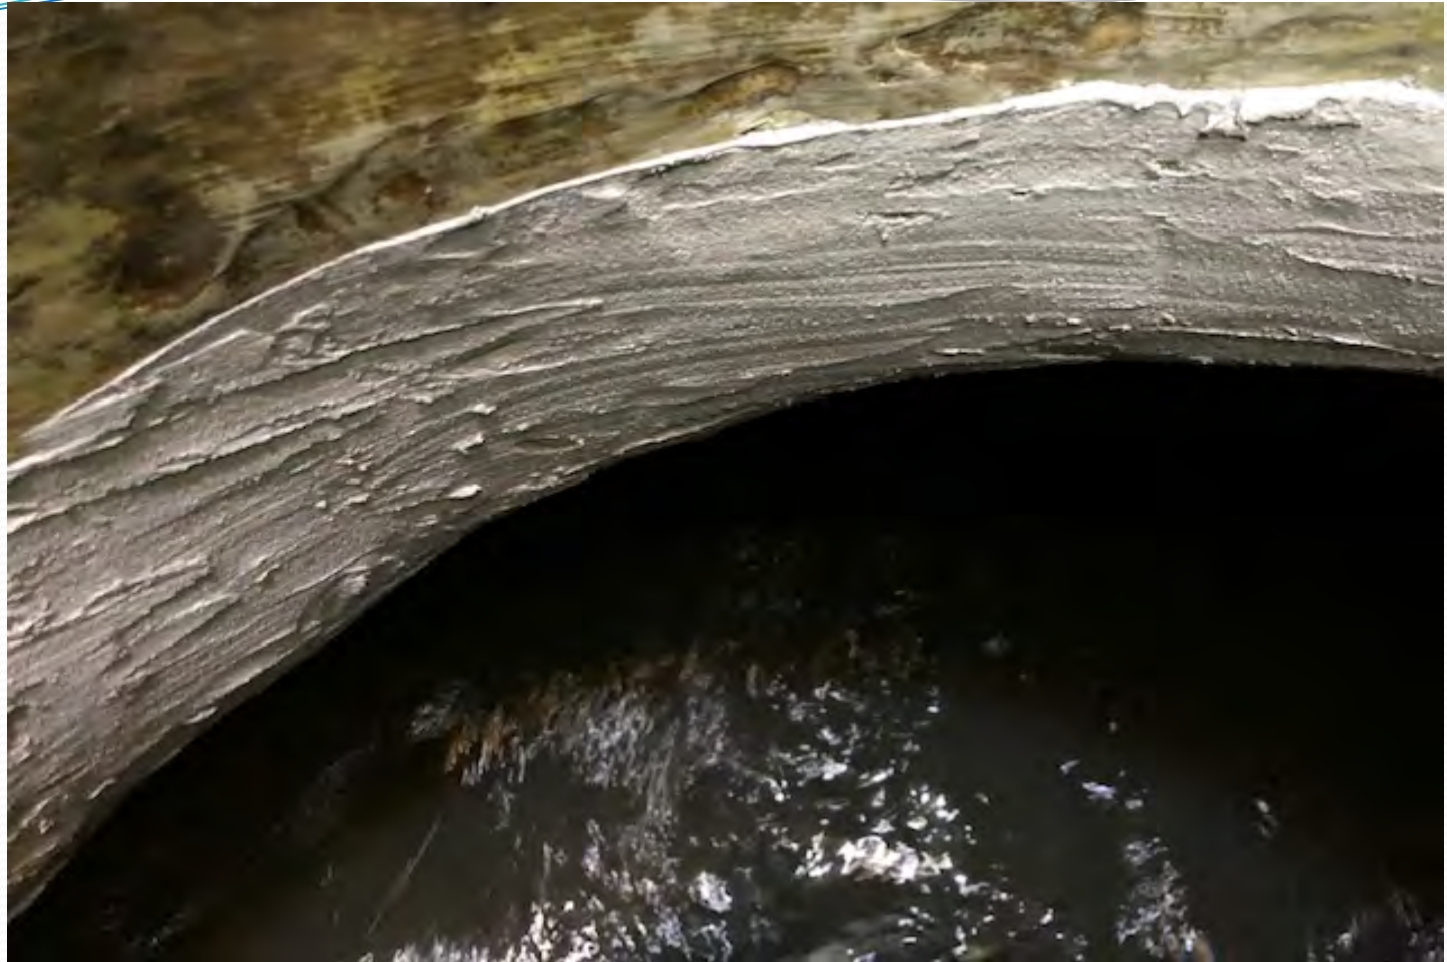
MH03\_MH02\_D\_514.1

Corona Lateral  
Crack in 15-in Ø vitrified clay pipe

MH03\_MH02  
16 ins VCP  
0335.8 ° 10/08/19 11:01

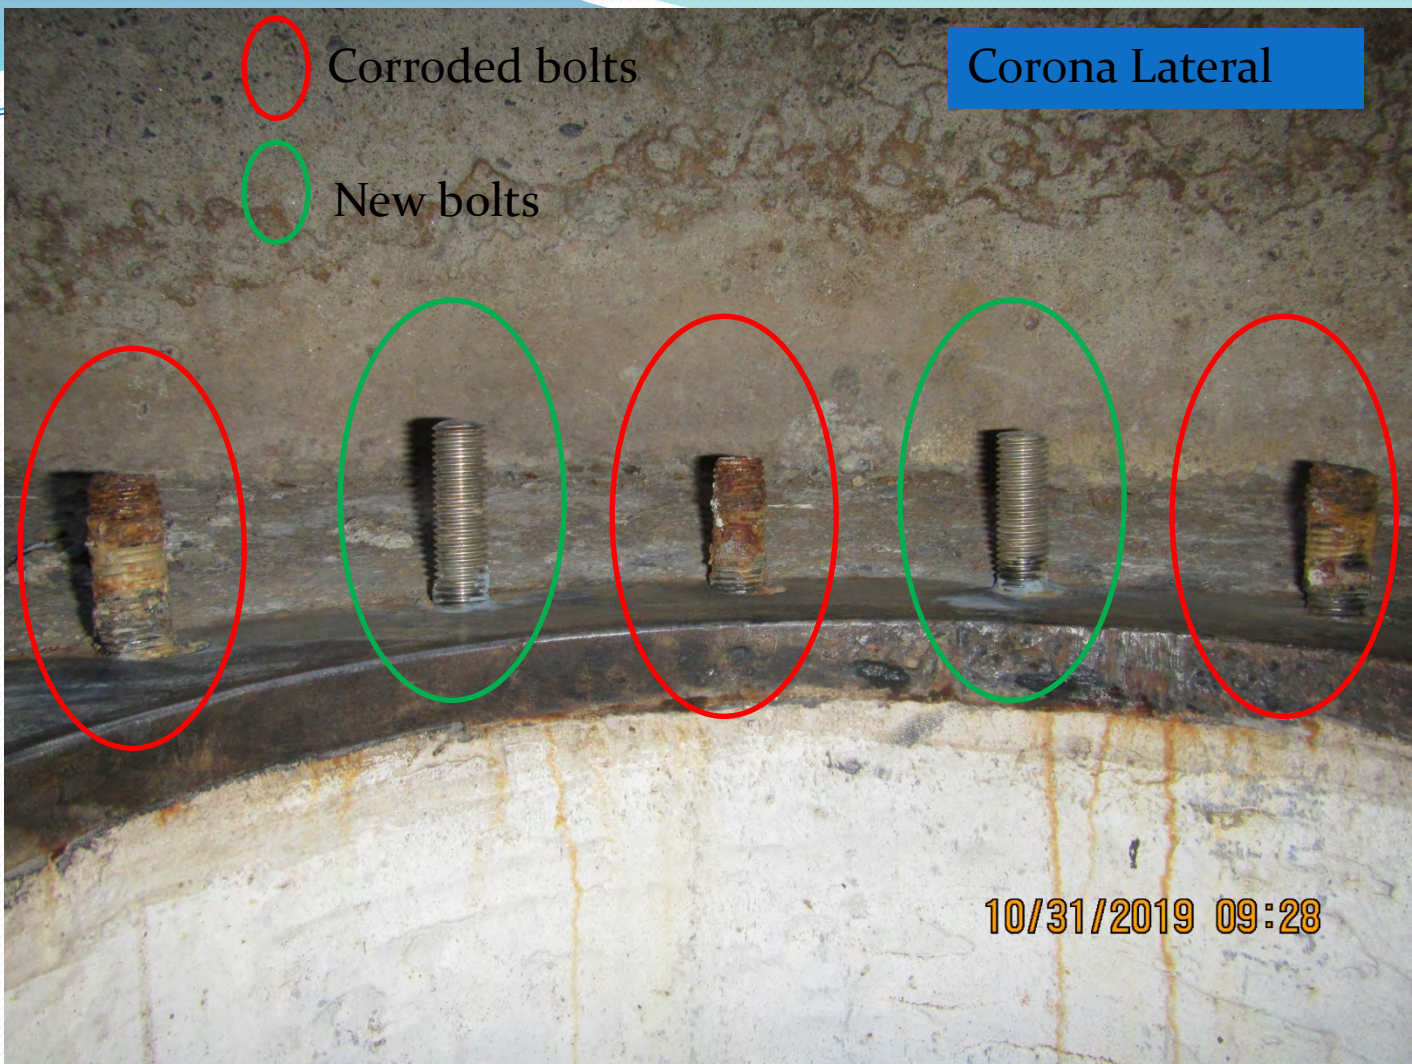
Corroded bolts

New bolts

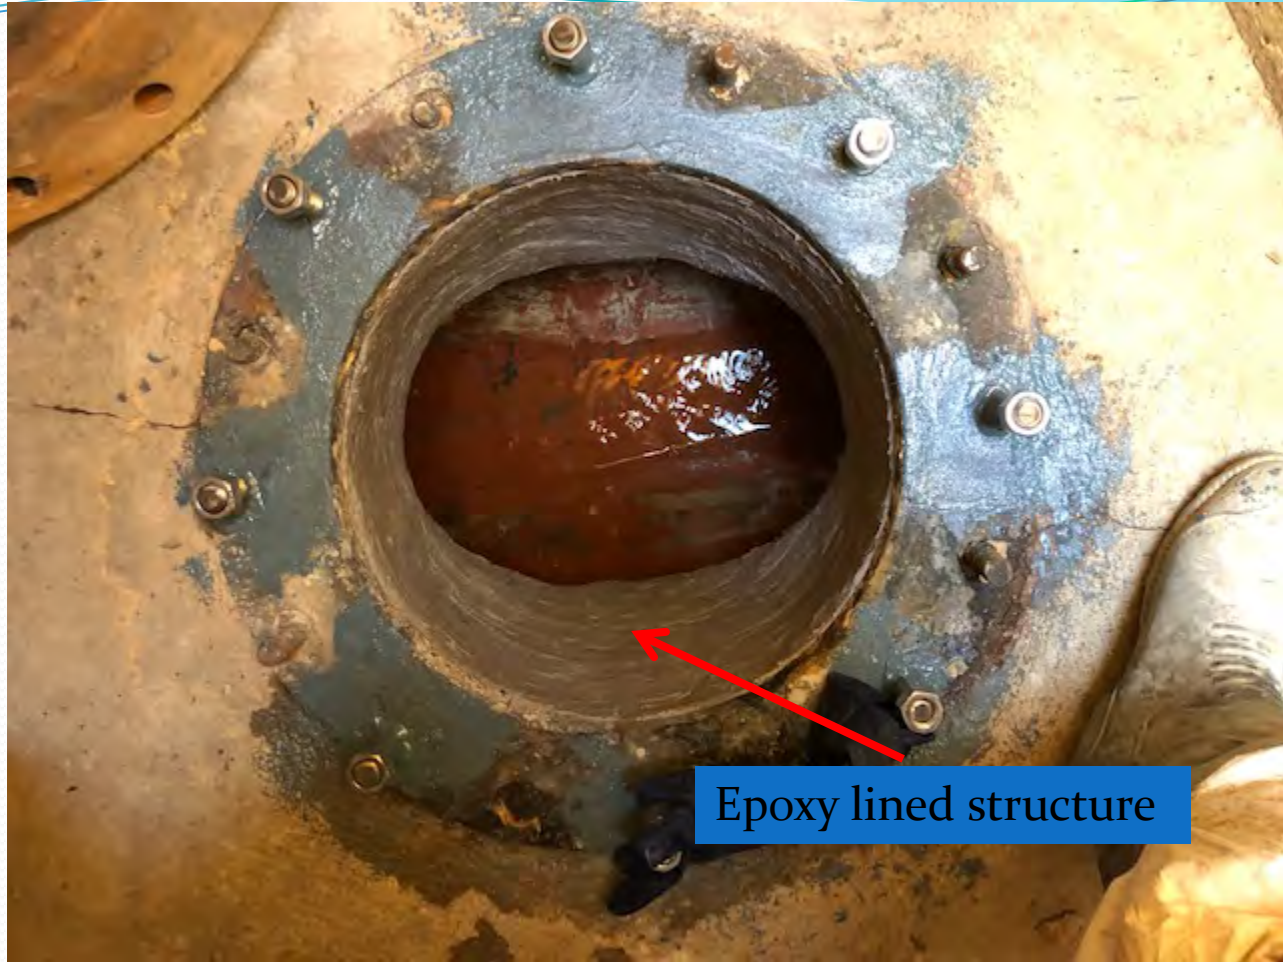
Epoxy lined structure
