# 2018 Holy Fire Post-Fire Stormwater Monitoring (2018-2019 Storm Season)

LE/CL TAC Meeting  
October 23, 2019

Presented by:  
Riverside County Flood Control and Water Conservation District  
and  
Alta Environmental an NV5 Company

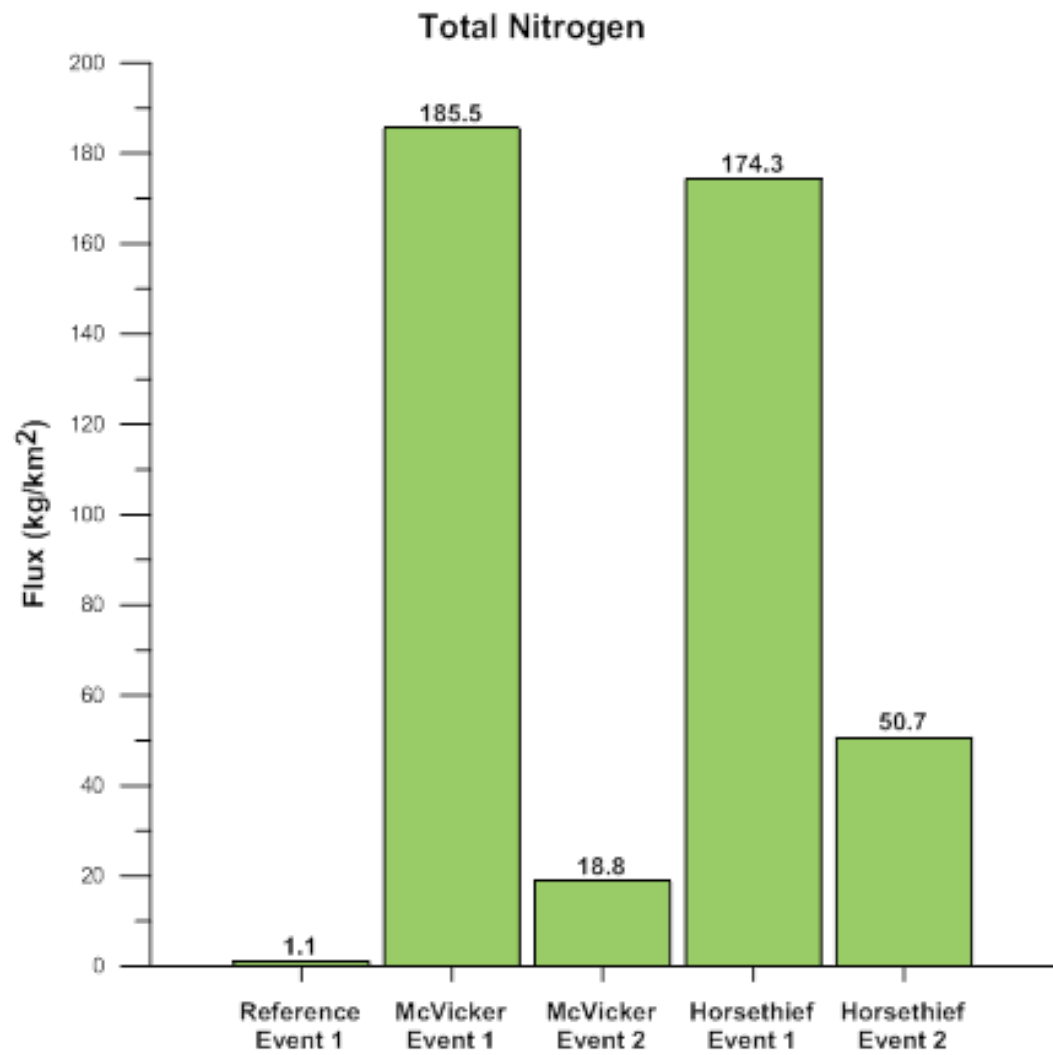
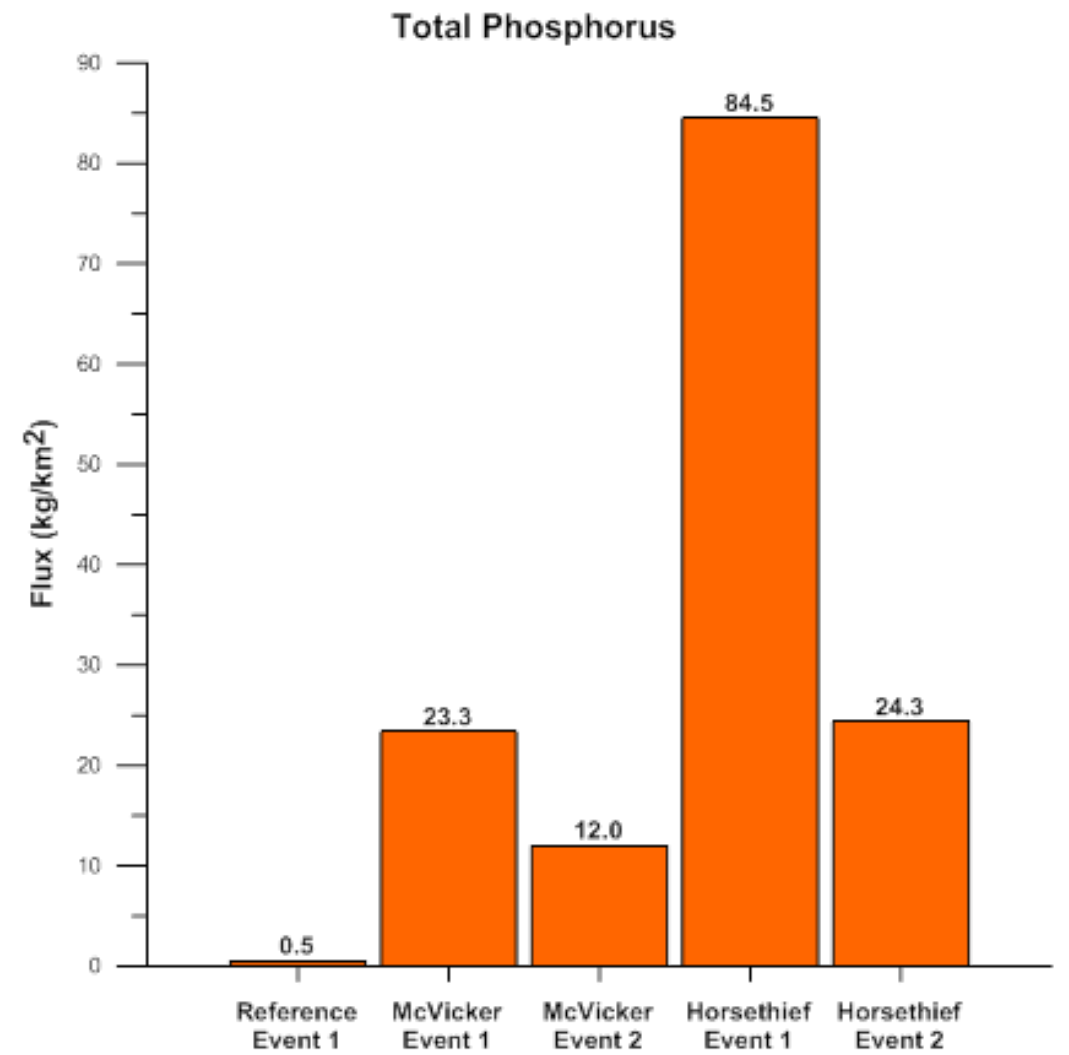
# CONTAMINANT FLUX

- Compare data from burned catchments and reference sites of different sizes.
- Ratio of the mass loading in kg and the contributing catchment area in km<sup>2</sup> for each storm monitoring event

- Above average rainfall and high intensity events in 2018-2019
- 'First Flush' observed significant post-fire sediment and debris flows
- Post-fire flows continued through wet season
- High concentrations and contaminant flux of sediment, nutrients, and metals
  - Significantly higher than reference data
  - Concentrations and flux lower in Event #2
  - Total metals significantly higher than dissolved
  - Metals primarily in particulate state
- Debris basins reduced downstream impacts
