EMWD and MARB PFAS Impacts

EMWD PFAS (PFOA and PFOS) Impacts

MARB Plume Delineation Report

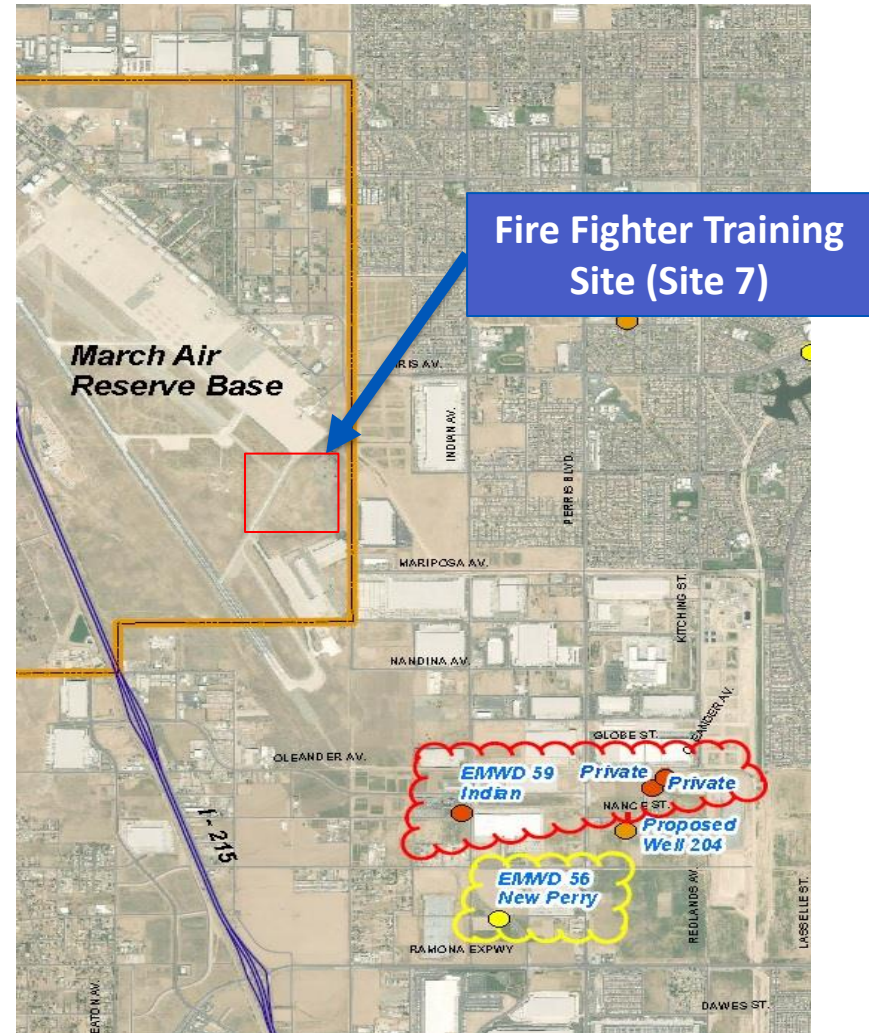
- PFAS was used at Site 7 for fire fighting training using aqueous film forming foam
- Well 59 and two private wells reported above EPA (federal) Lifetime Health Advisory levels:
 - Well 59 PFOA + PFOS = 168 ppt
 - Wells shutdown in May 2016
- Well 56 PFAS reported above the CA Notification:
 - ESI Reported PFOA + PFOS = 16.8 ppt
 - Removed well from service in February 2019
 - PFOA 19 ppt and PFOS 10 ppt*
