# Lake Elsinore and Canyon Lake Watersheds Nutrient TMDL Monitoring 2019-2020 Annual Report – FINAL

Lake Elsinore & San Jacinto Watersheds Project Authority  
11615 Sterling Avenue  
Riverside, California 92503

Wood Environment and Infrastructure Solutions Inc.  
9210 Sky Park Court  
Suite 200  
San Diego, CA 92123

October 2020

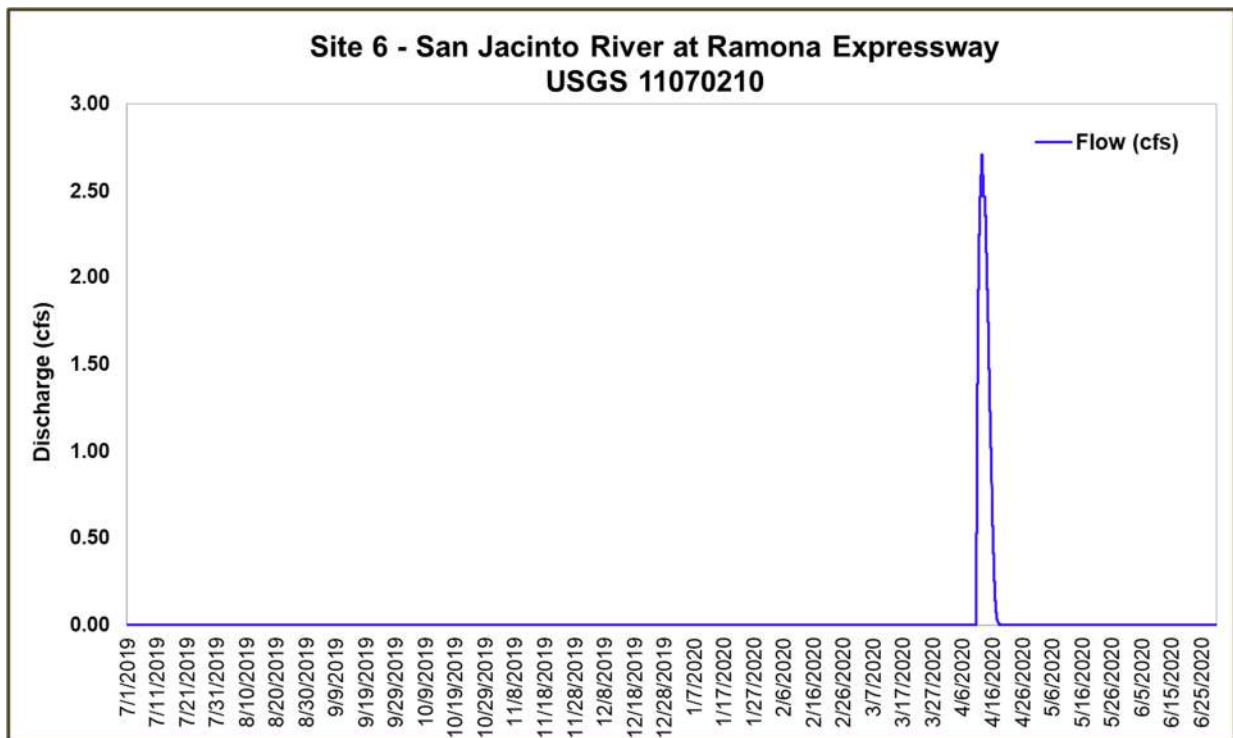
Figure 2-5. Site 6 – San Jacinto River at Ramona Expressway – Daily Stream Gauge Records

A summary of the stream gauge data recorded at each of the stations with measured flow for the monitoring period of July 1, 2019 through June 30, 2020 is presented in Table 2-5 and visually presented in Figure 2-2 through Figure 2-6. The mean monthly flows reported in Table 2-5 characterize the average instantaneous flow rate at the USGS stations. In general, the flows are only observed during wet weather storm events and dry weather flows are not observed from each of the USGS stations. The flow data are downloaded from the USGS website and are considered provisional for approximately six months; therefore, flow data presented after March 3, 2020 in this report are provisional. The provisional data provided by the USGS are subject to change and are not citable until reviewed and approved by the USGS. The complete set of stream gauge data is included as Appendix A.

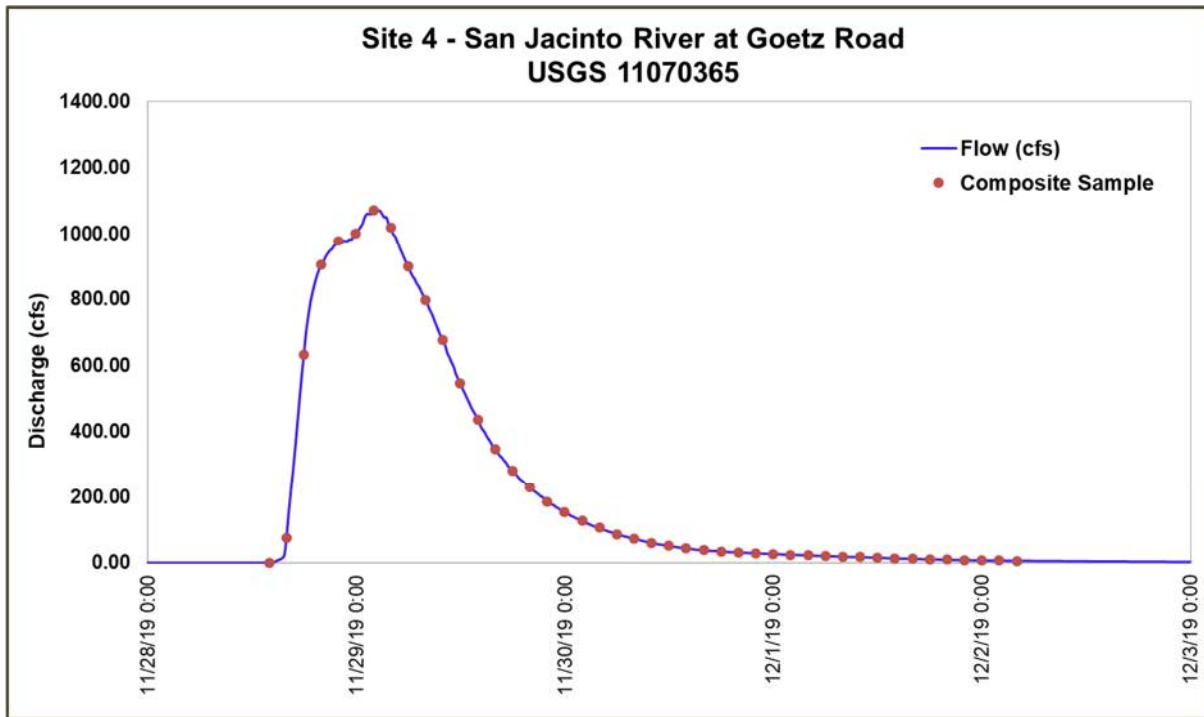
Figure 2-16. Hydrograph of First Storm Event at San Jacinto River at Goetz Road (November 28 – December 2, 2019)

Hydrographs with flow-weighted sample aliquot times is provided in Figure 2-16, Figure 2-17, and Figure 2-18. The figure was developed based on flow data provided by the nearby USGS stream gauge (Station ID 11070365).

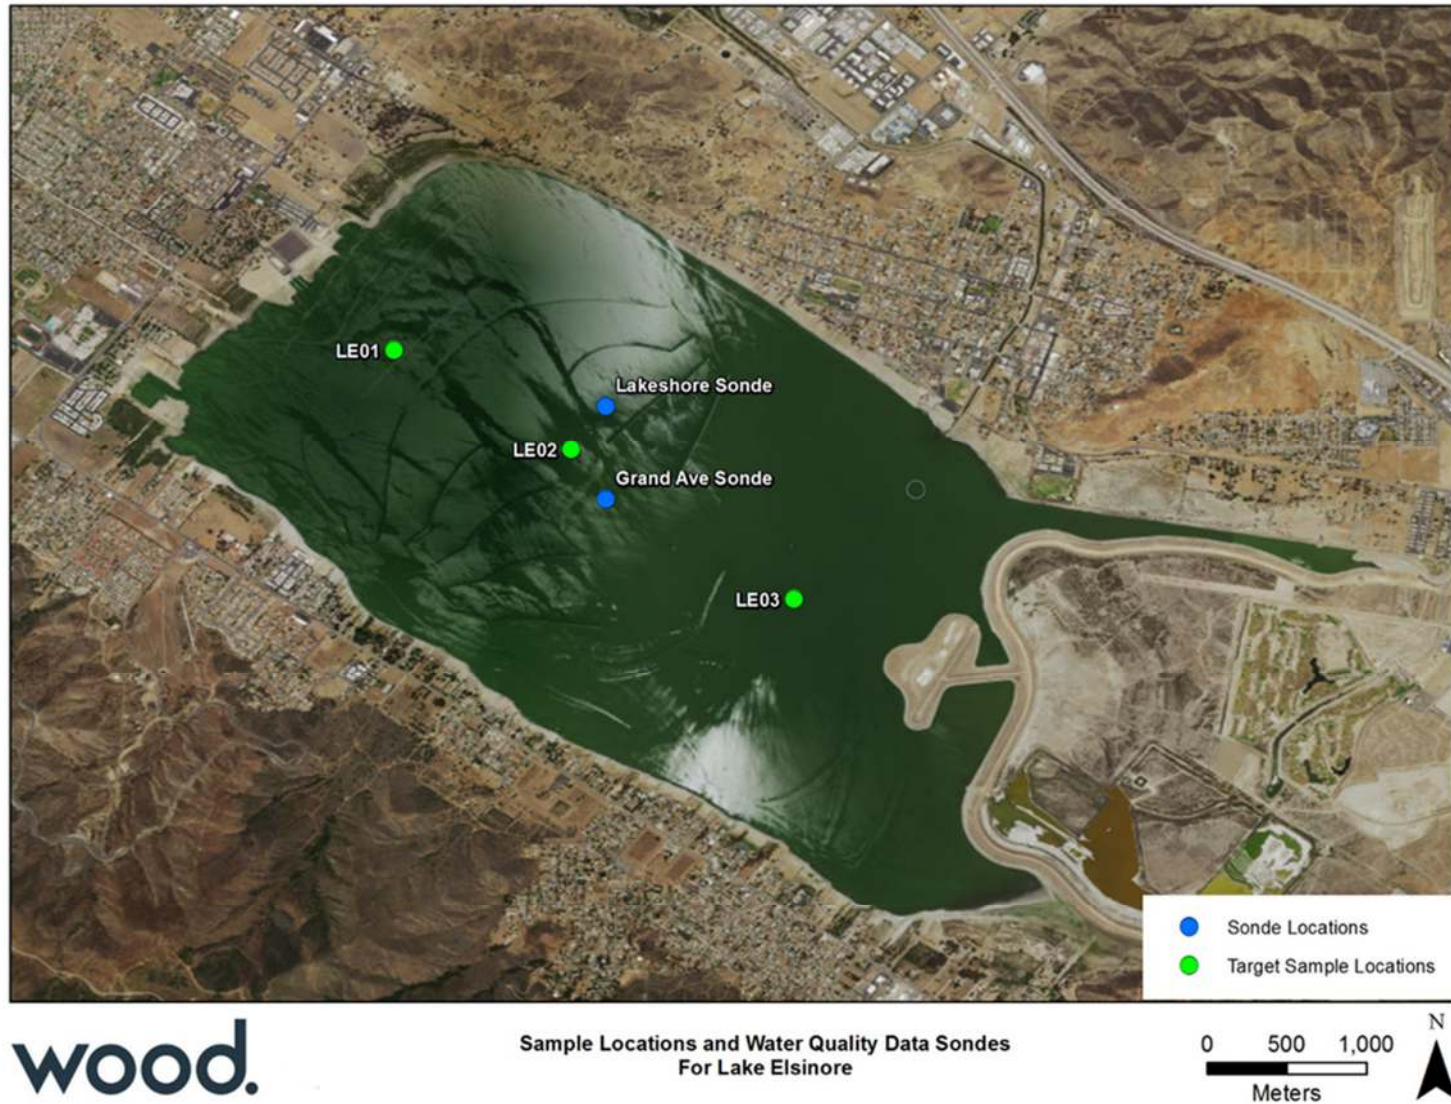
Figure 3-1. Lake Elsinore Sampling Locations

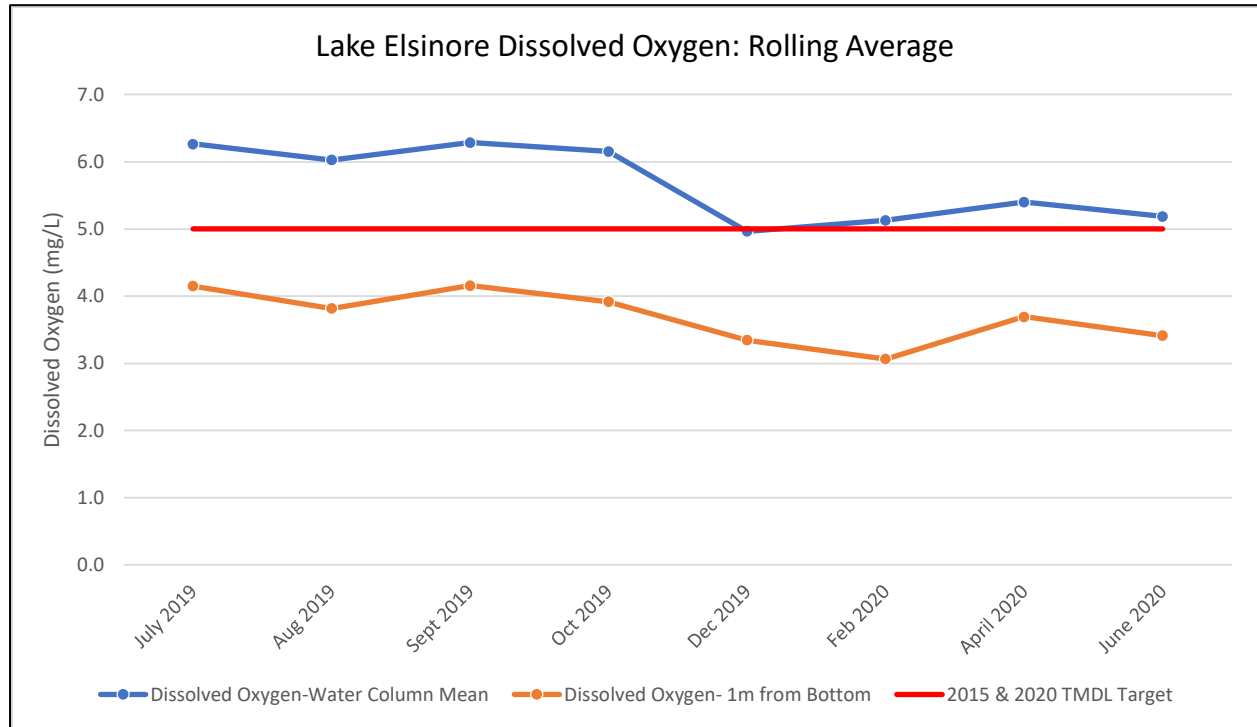
**Figure 3-2. Water Column Mean Dissolved Oxygen (DO) Rolling Average – Lake Elsinore for Site LE02**

*Each data point is calculated by averaging the measurement from each event with the previous seven events (i.e. one year of data) to obtain a rolling average. Therefore, the graph represents data collected from August 2018 to June 2020.*

Temperature exhibited a typical pattern with lowest values occurring during the winter events (December and February) and highest values in summer months (July and August). The greatest mean DO concentrations throughout the water column (both water column mean and 1-meter from bottom) were observed in February at all three sites. Concentrations of DO near the bottom, while lower, generally tracked with the overall water column mean for all three sites, with the exception of June 2020, for which the bottom of the lake averaged 0.1 mg/L across all sites during this monitoring event, compared to the lake-wide average of 4.0 mg/L for the water column mean. These measurements indicate that the lake may be starting to stratify, and is further supported by: 1.) associated temperatures recorded during the June event, 2.) the temperature and DO measurements recorded during the July and August 2020 monitoring events, and 3.) historical trends that demonstrate stratification in portions of the lake during this period. The 12-month rolling mean water column DO concentration for all events at Site LE02 was at or above the 2015 TMDL target of 5.0 mg/L (Figure 3-2). The rolling mean DO concentration 1-m above the lake bottom at Site LE02 hovered just below the 2020 TMDL target of 5.0 mg/L, ranging from 3.1 to 4.2 mg/L.

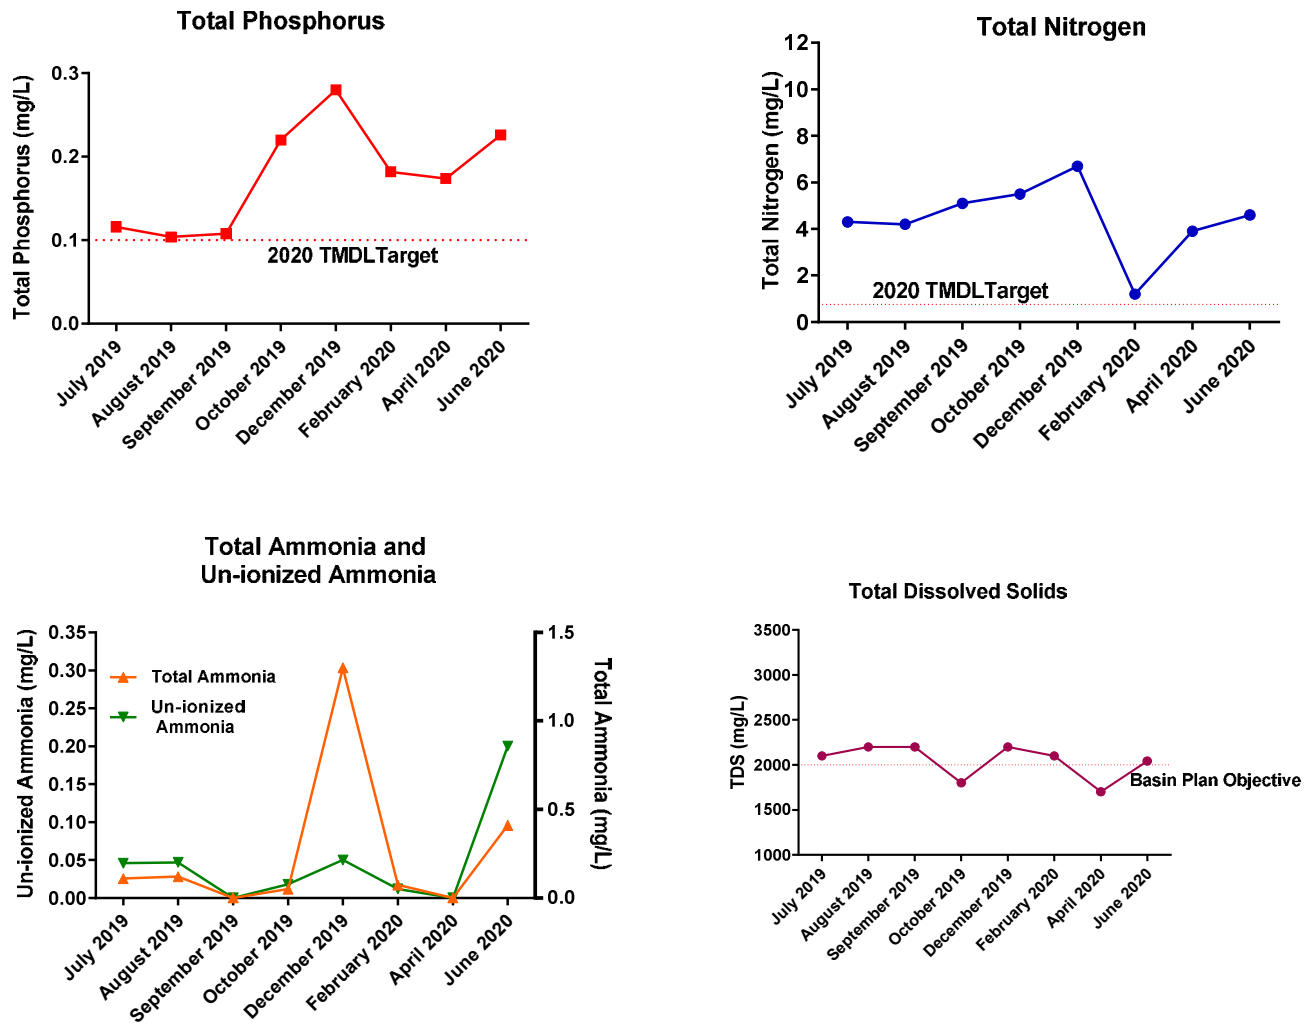
**Figure 3-8. Lake Elsinore Analytical Chemistry – Depth-Integrated Means at Site LE02 (July 2019-June 2020)**

Total phosphorus concentrations ranged from 0.10 to 0.28 mg/L across all monitoring events. Concentrations of total phosphorus remained steady July through September 2019, but then increased in both October and December before decreasing in February 2020 (Figure 3-8). Dissolved oxygen concentrations in August 2019 indicated that the lake had stratified, due to the differences observed between average DO concentrations throughout the water column and the bottom (Figure 3-6). In September, the lake began to de-stratify and was fully de-stratified during the October and December events. This destratification may have caused the total phosphorus that had fluxed from the sediment during the stratification period, likely caused from low dissolved

Total ammonia-N concentrations ranged from <0.044 to 1.3 mg/L, with an annual mean of 0.26 mg/L. The June 2020 un-ionized ammonia concentration of 0.2 mg/L exceeded the un-ionized ammonia Criterion Continuous Concentration (CCC) objective of 0.181 mg/L (Tables 3-6 and 3.7). No other samples exceeded the un-ionized ammonia Criterion Continuous Concentration (CCC) or the Criterion Maximum Concentration (CMC) objective. A spike in total ammonia-N was observed during the December 2019 event. There are several possible explanations for this including: 1) two large back-to-back storm events dropping 1.78 inches (Nov. 27 -30) and 1.08 inches (Dec. 4 – 9) of rain which had stirred up the water column as evidenced by the substantial increase in lake turbidity (see Secchi depths for December event); 2) the December 2019 event exhibited the lowest near-bottom (1-m from bottom) DO measurement, with the exception of June 2020, which also saw an increase in ammonia-N. This low DO near the sediment can facilitate the flux of ammonia into the water column; or 3) some particles of near-bottom suspended sediment could have been accidentally collected as part of the depth-integrated sample and been analyzed along with the water sample.

Total dissolved solids (TDS) concentrations remained relatively stable between July and December 2019 (1800-2200 mg/L), with a slight dip in October, before gradually declining through April 2020 as a result of the winter storms. The reported elevated TDS concentration observed in June 2020 appears anomalous and is likely a laboratory error. This is evident as the water column mean specific conductivity in June 2020 was 3050  $\mu\text{S}/\text{cm}$ . There is a known ratio of measured conductivity in water to its TDS concentration of approximately 0.67, with some slight variability in surface waters due to the composition of salts within the water. A specific conductivity of 3050 mg/L equates to a TDS of approximately 2043 mg/L. This calculated value would fall in line with other TDS values observed during the 2019-2020 monitoring year. Based on this assessment, the more accurate estimated value for TDS based on conductivity was used for summer and annual average calculations reported in Tables 3-6 and 3-7. The natural decrease of TDS in Lake Elsinore due to winter storm events is commonly observed, however, there has been a noticeable gradual decrease in TDS over the 2019-20 monitoring period compared to years prior (Appendix E).

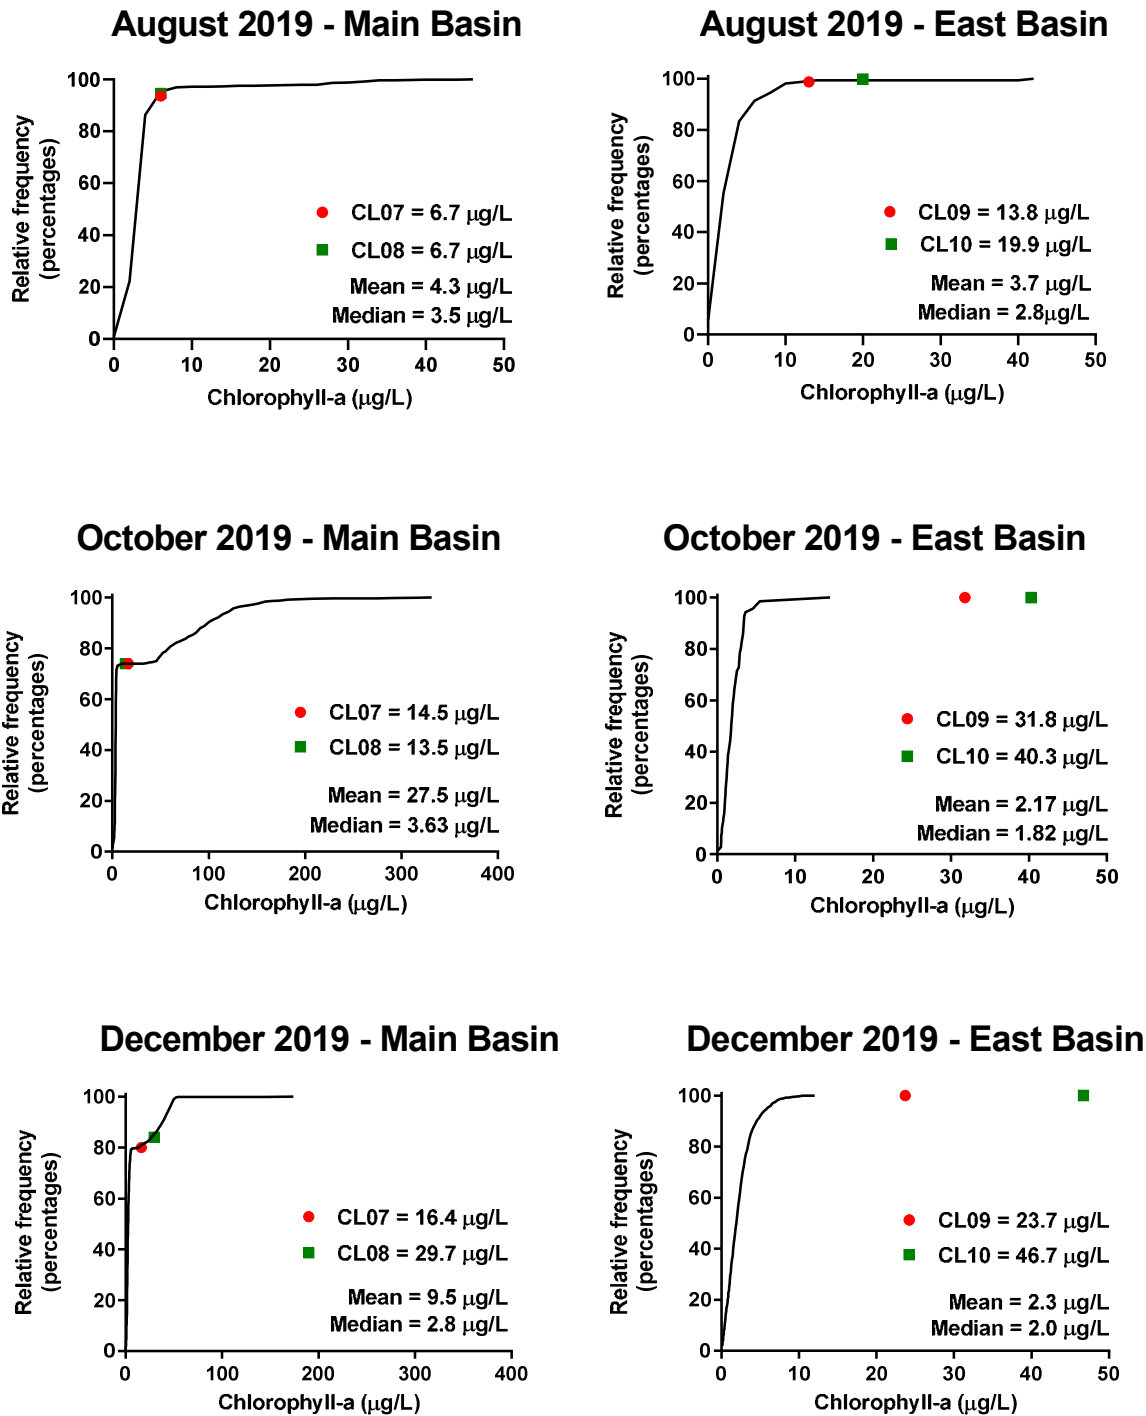
**Figure 3-25. Cumulative Distribution of Satellite Derived Chlorophyll-a Concentrations in Canyon Lake Relative to Measured Chlorophyll-a in Field Collected Samples**  
 Colored dots represent the in-lake surface (0-2m) analytical measured concentration for each event

**Figure 3-25. (cont). Cumulative Distribution of Satellite Derived Chlorophyll-a Concentrations in Canyon Lake Relative to Measured Chlorophyll-a in Field Collected Samples**

It was evident that some of the chlorophyll-a concentrations generated from the satellite images for both lakes did not consistently match with analytically measured values from in-lake water samples collected. In Lake Elsinore this was possibly due to the very high chlorophyll-a concentrations observed in this water body. During the initial satellite validation performed over the 2015-2016 sampling season, it was determined that satellite derived chlorophyll-a estimates tended to diverge from known in-lake concentrations when in-lake concentrations were above approximately 100 µg/L. Discussions and sharing of this data with EOMaps (the satellite data vendor) will continue to enhance model predictions and assess whether there may be other confounding factors (including turbidity) that are not accurately accounted for in this lake. It is also possible, that the discrepancy in satellite chlorophyll-a concentrations relative to in-lake concentrations is due to a difference in the depth being analyzed. In-lake “surface” analytical samples are collected as a composite of the top 2 meters of the water column, while the satellite imagery analyzes approximately one-half of that depth, or the top 1 meter of the water column. It is well known that some algae, particularly blue-green algae (cyanobacteria), can regulate their buoyancy and exhibit a diurnal pattern of rising to the surface during the day and sinking down in the water column at night. This would serve to concentrate the algae right at the surface during the day where the satellite imagery collects its data (i.e. top 3-feet), while the in-lake analytical sample is a composite of surface water (where the algae density is highest) and less concentrated deeper water, serving to somewhat dilute the in-lake analytical sample relative to what the satellite measures. Additionally, cyanobacterial algal blooms are known to have patchy distributions, which can result in high spatial variability in algal concentrations. Given that the resolution of a single satellite pixel varied between 10-m (Sentinel-2) and 30-m (Landsat), and that the estimated satellite chlorophyll-a concentration is a composite of the area within a pixel, this can lead to a potential discrepancy when compared to an in-lake grab sample collected at a single point. Chlorophyll-a concentration satellite estimates in Canyon Lake were more in-line with analytical measurements overall.
