Overview of OCWD's
Investigation into Source of
Newly Occurring High TDS
Surface Water
Behind Prado Dam

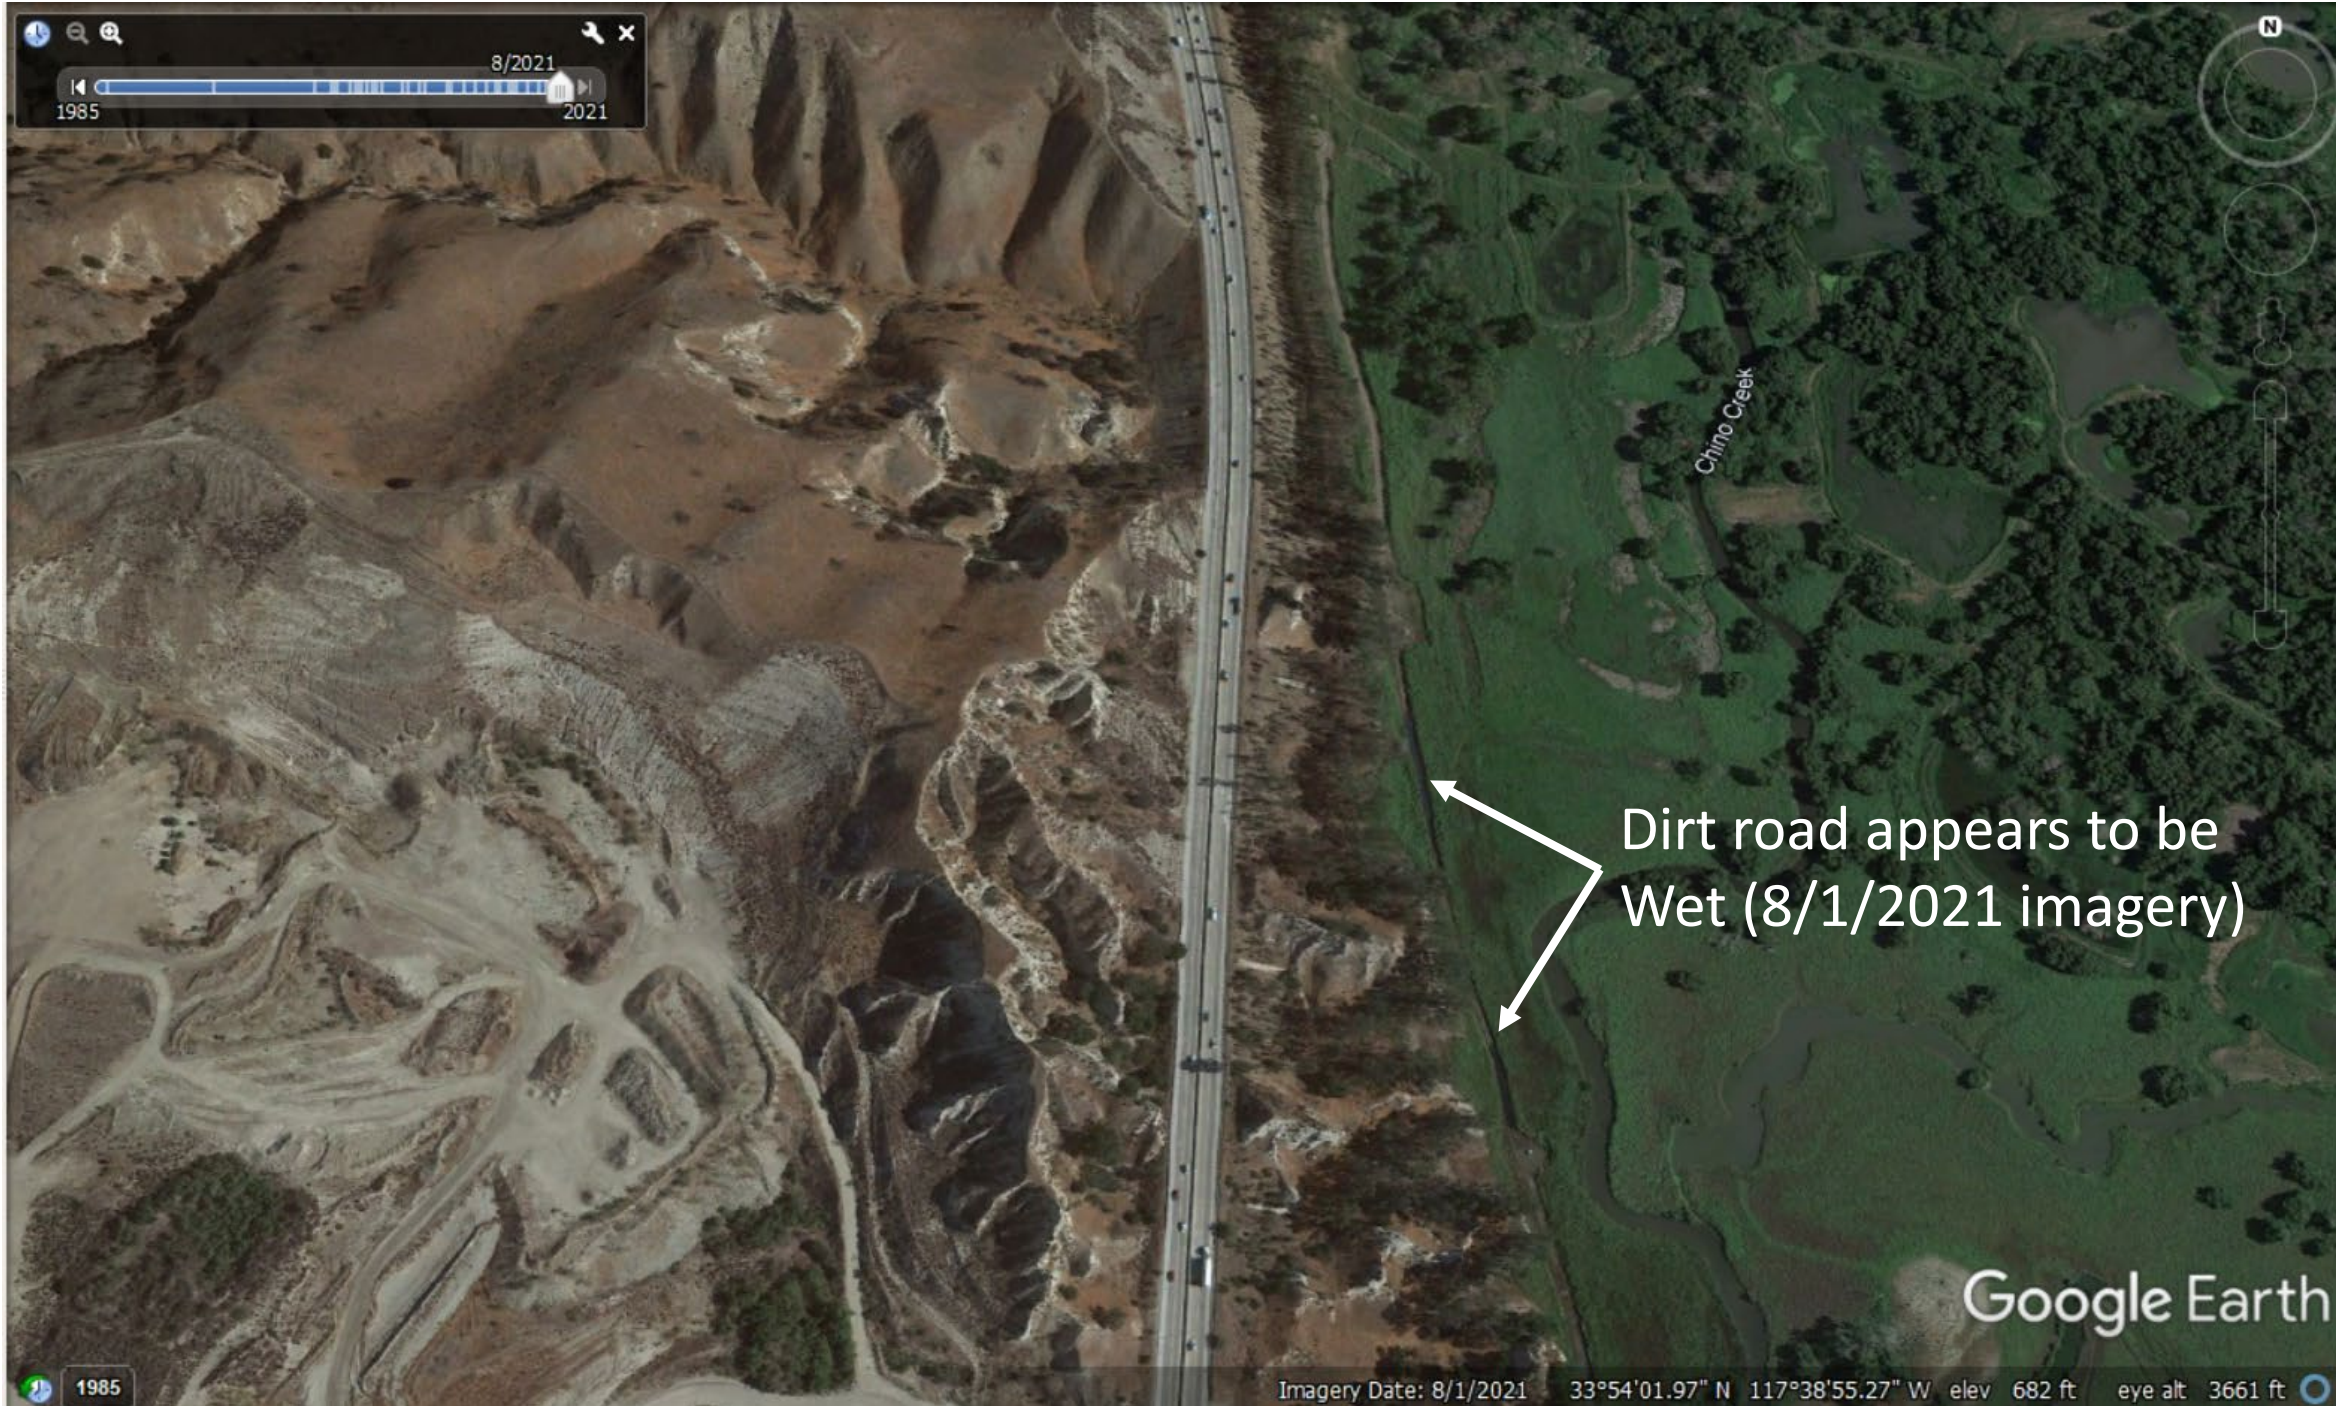
Dirt road appears to be
Wet (8/1/2021 imagery)

Imagery Date: 8/1/2021 33°54'01.97" N 117°38'55.27" W elev 682 ft eye alt 3661 ft

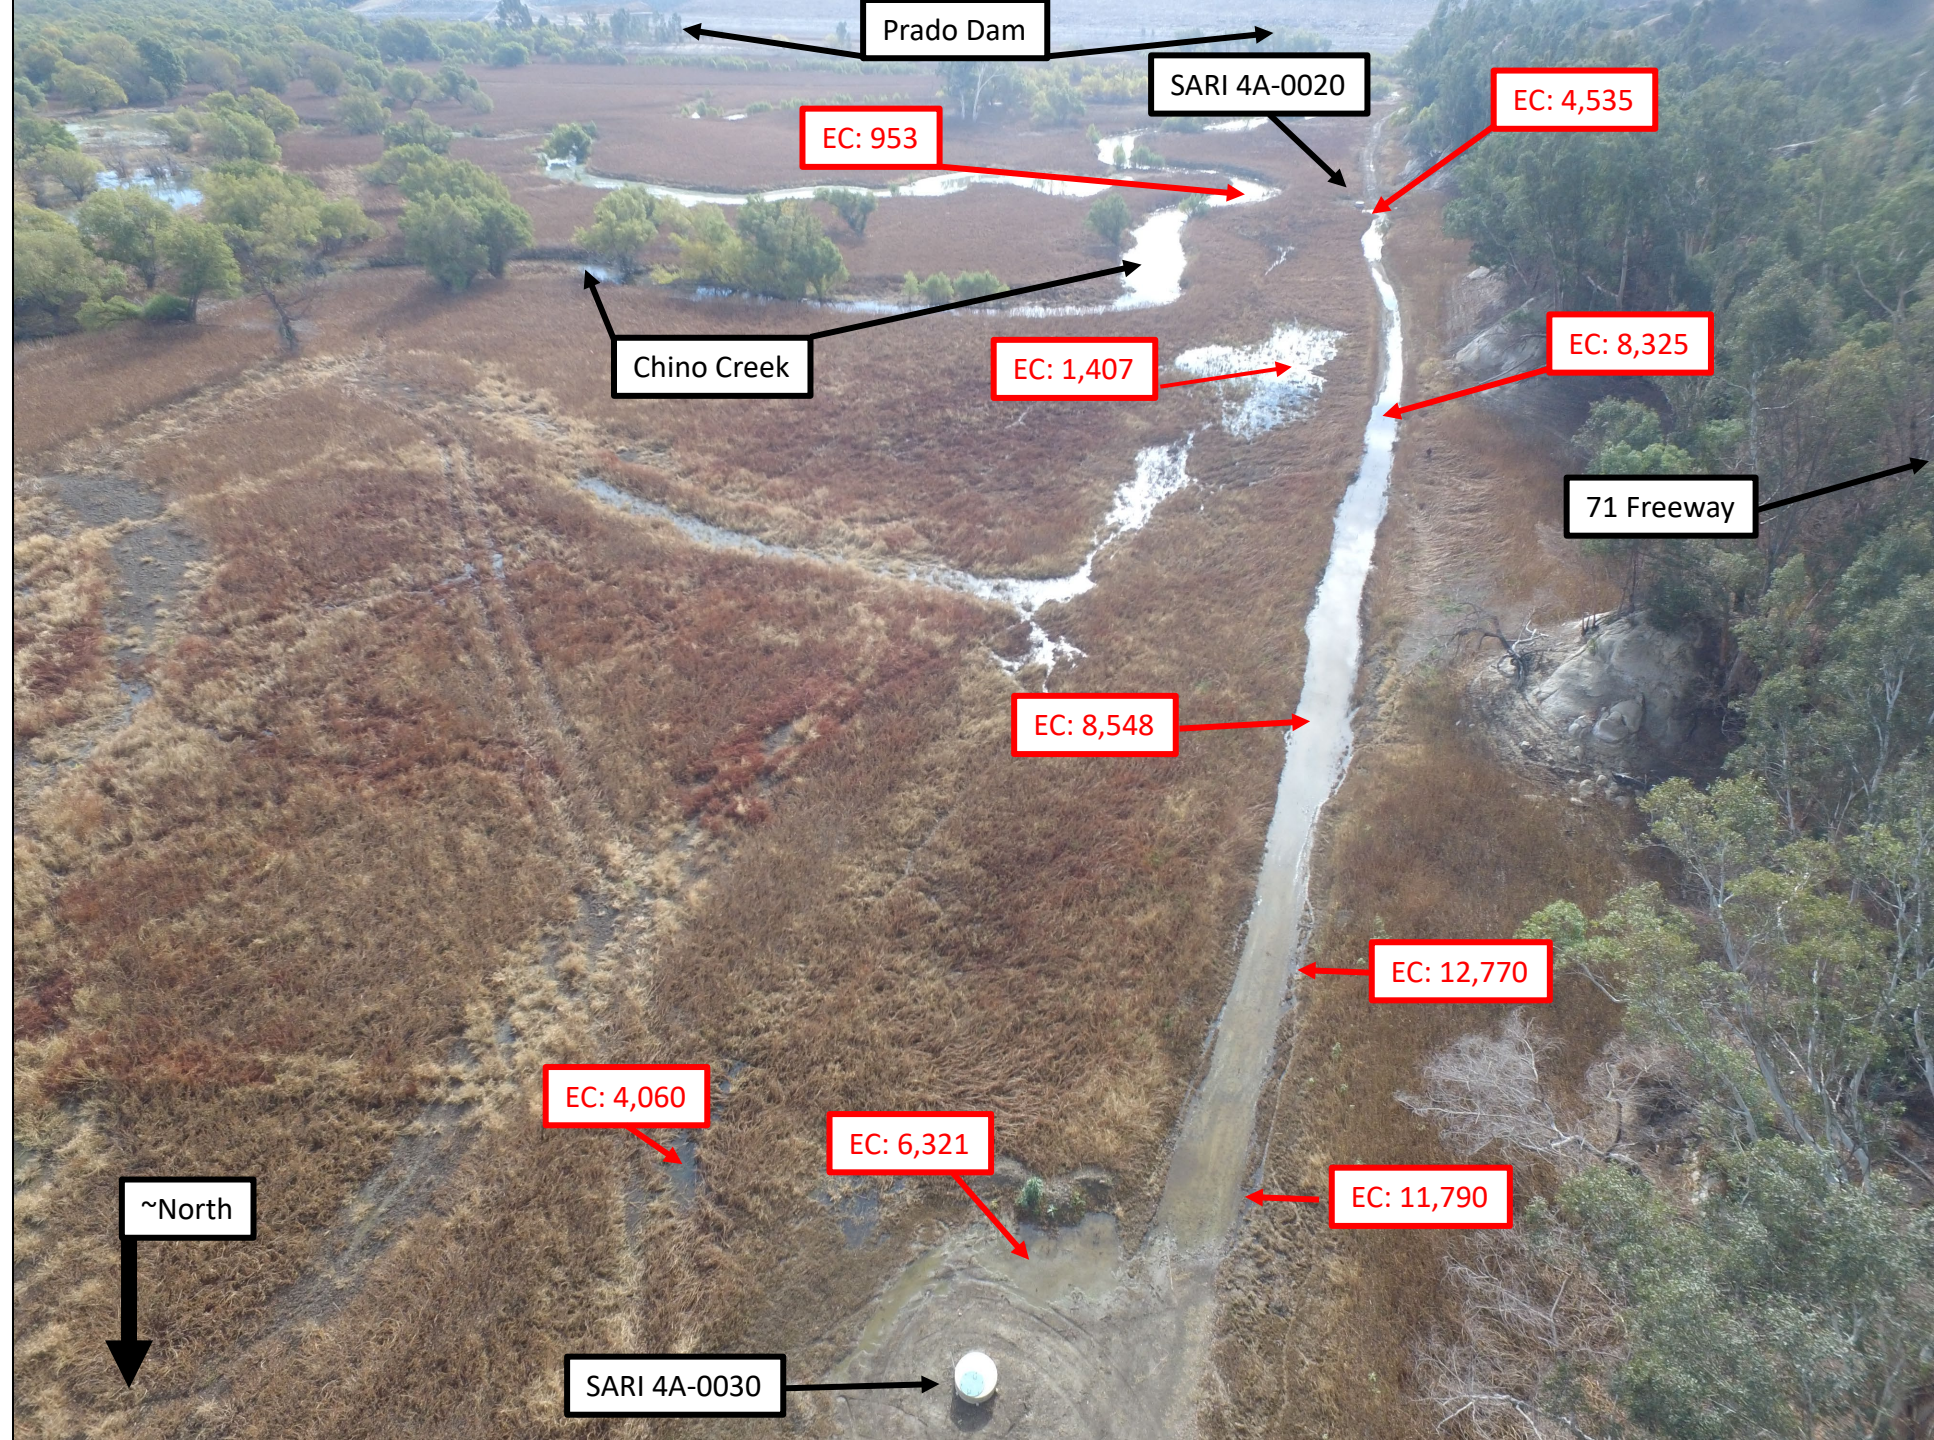
Dec 10, 2021

- Surface Water had high levels of electrical conductivity (EC) on the west side of road. Surface water was black and had distinct asphalt odor.
- EC from locations east of surface water in the road water generally had lower EC
- Visual salt build up in dry areas of the road south of SARI line. Some was reddish in color.

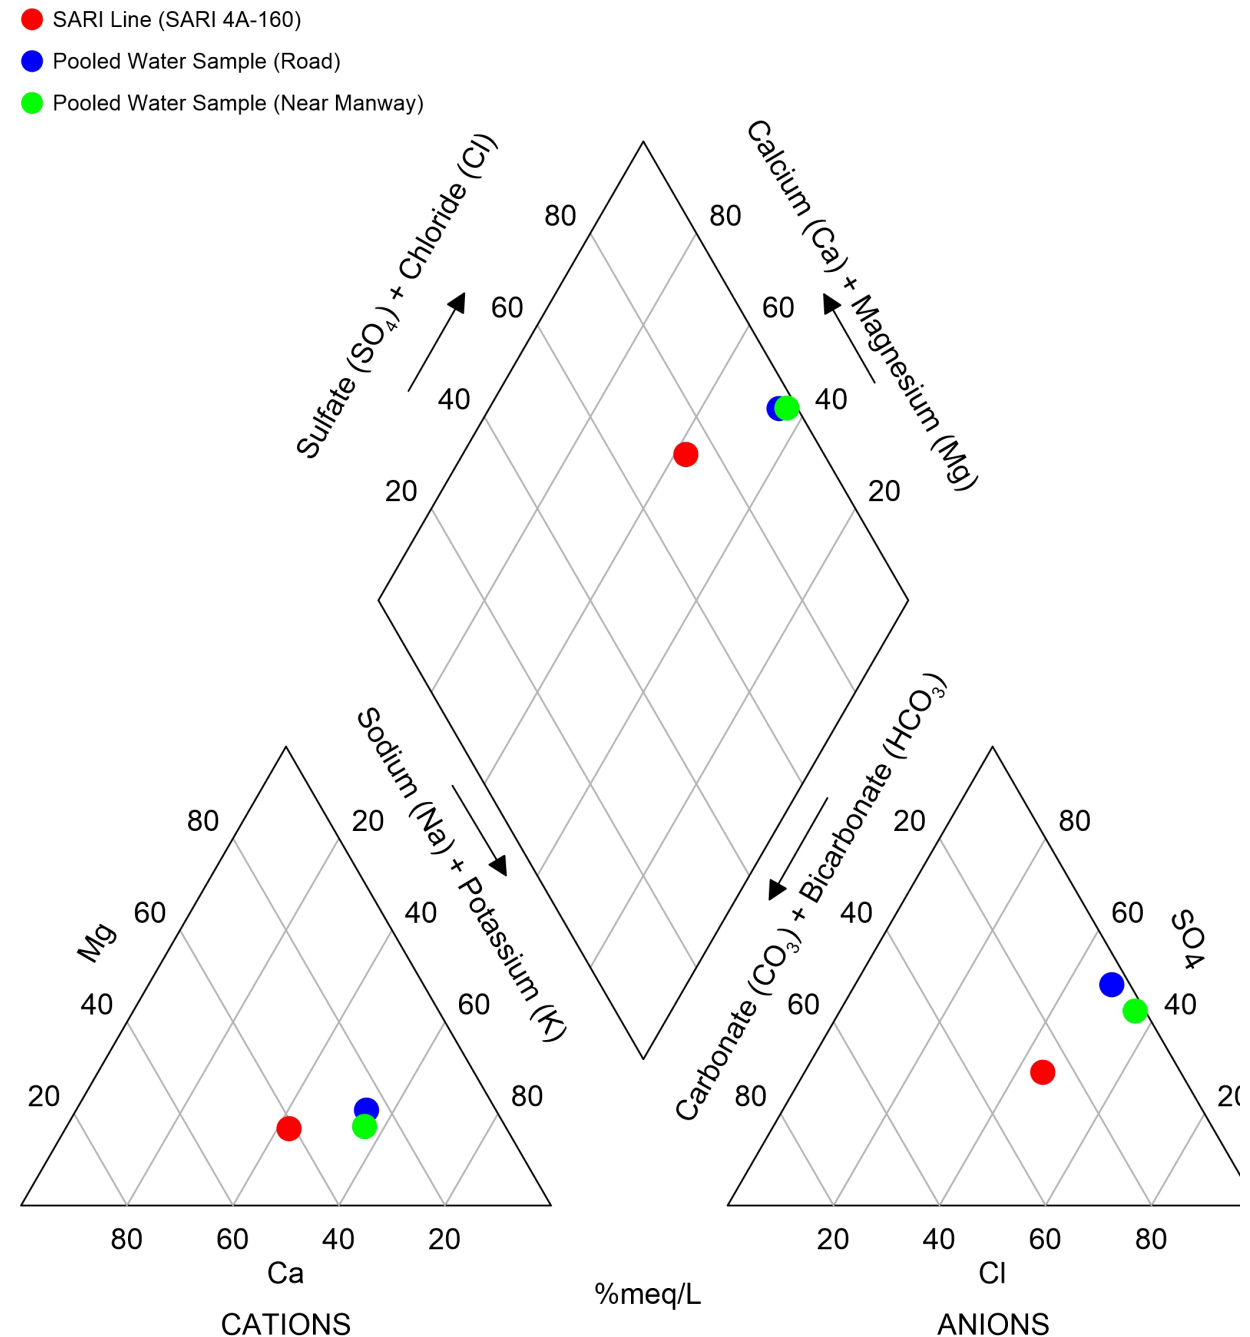
Piper Diagrams

- Compare inorganic ion concentration to create water fingerprint (SO₄, Cl, Ca, Mg, Na, K, CO₃, HCO₃)
- Surface water samples are nearly identical
- SARI Line sample similar but not identical. Do not conclusively indicate SARI Line is the source of high TDS surface water
- Content of SARI line can change through time depending on inputs
- Compared other possible indicators (ClO₄, TOC, TDS & NO₃-N)

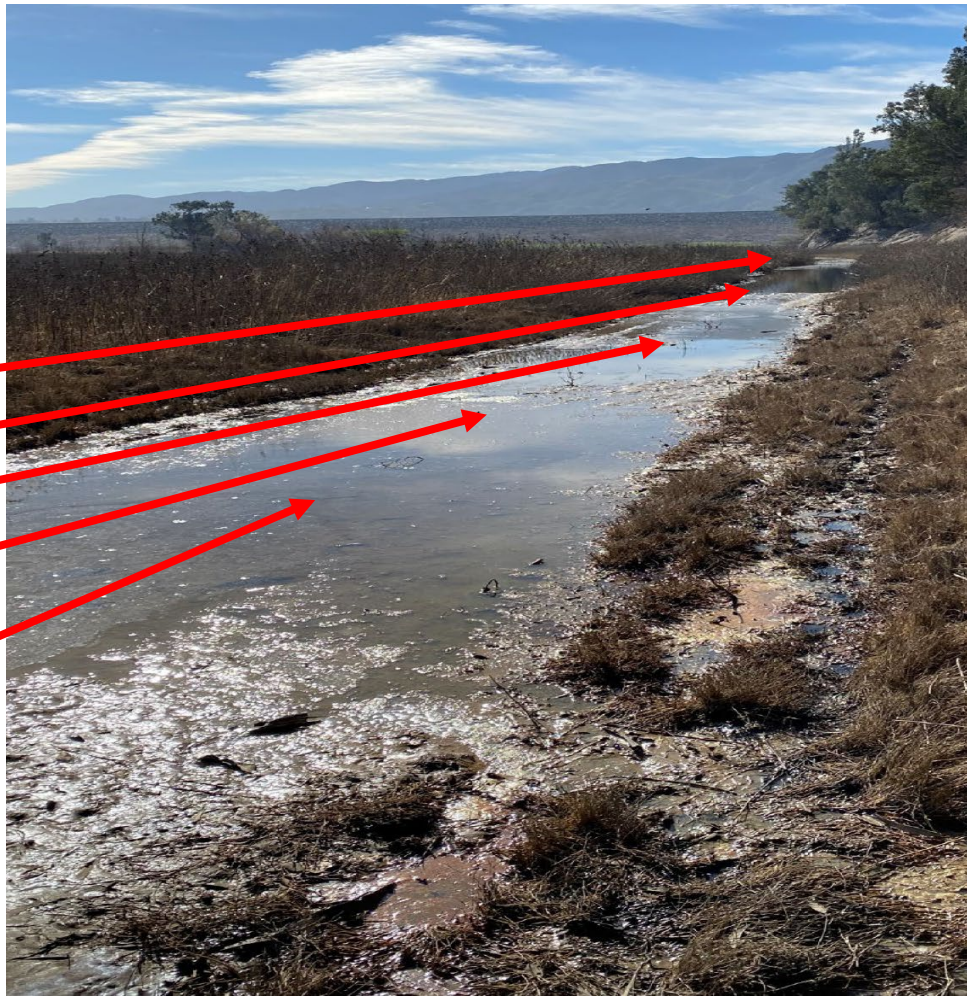
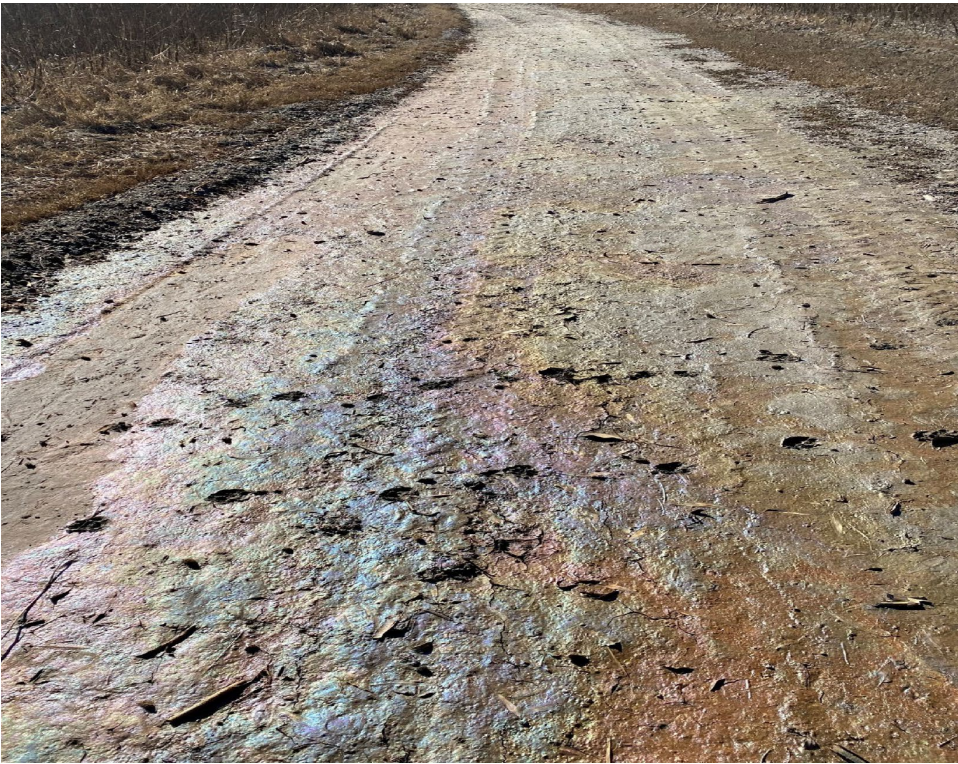
Site	EC (us/cm)
South 2	6010
South 1	6887
Middle 2	6929
Middle 1 (Sampled)	6852
North	8423

Standing Water Observations: Clear Water, Yellow Tint, Foul Odor, Sample Depth 4", Color sheen throughout dirt road approximately 1 mile

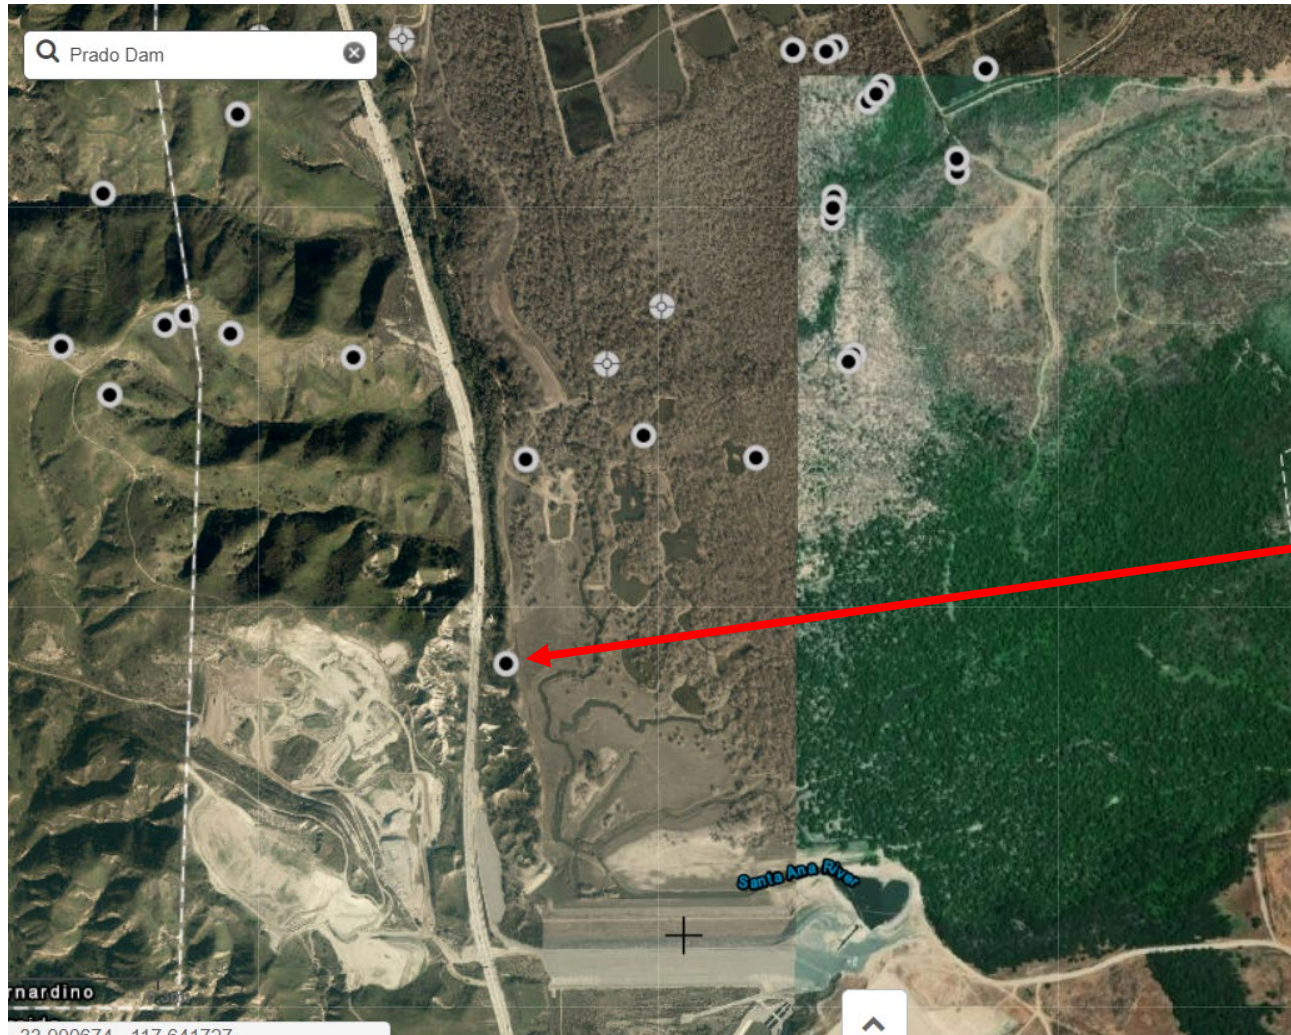
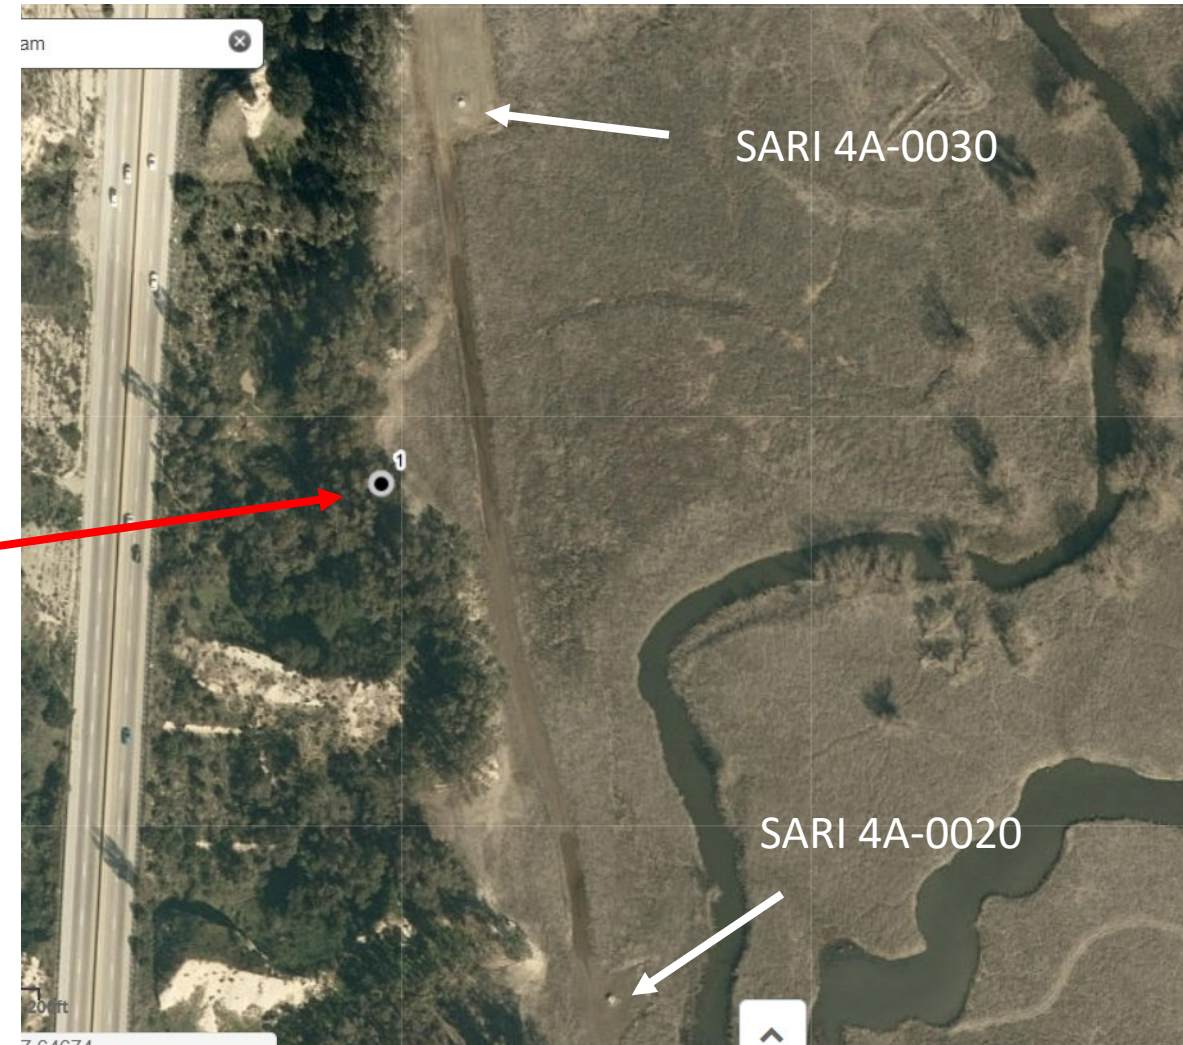
Doggr Wells

Maps from <https://maps.conservation.ca.gov/doggr/wellfinder/> - accessed 3.28.2022
