# US Army Corps of Engineers- Riverside Levees Rehabilitation Project

Joint Regional Water Quality  
Monitoring/MSAR TMDL Task Force  
Meeting

April 17, 2023

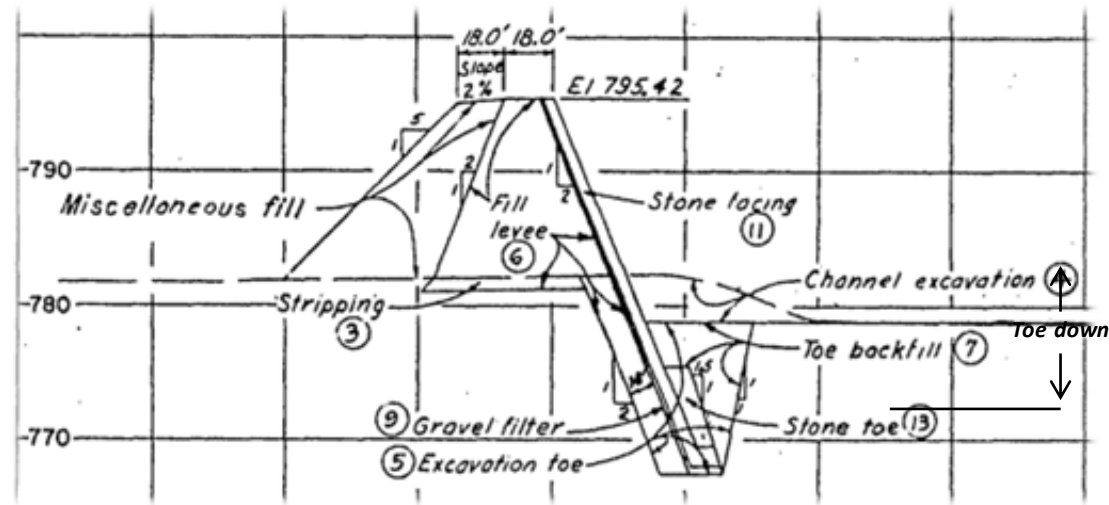
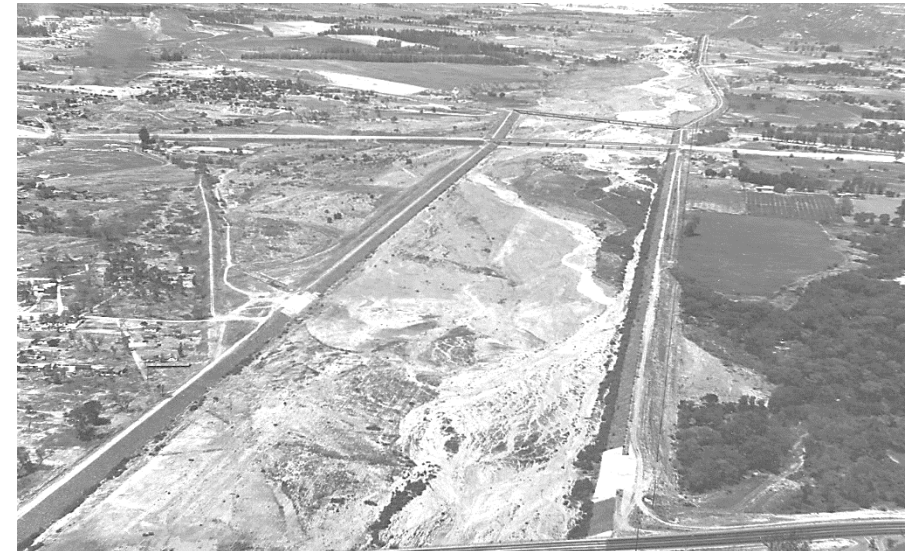
- Federally authorized under Flood Control Act of 1950
- Constructed by the Corps in 1957
  - Compacted Fill (landside)
  - 12-18" rip rap (riverside)
  - 1V: 2H slope
  - **3-feet toe down for scour protection**
- Turned-over to the District for Maintenance
  - Riverside Levee 1 – 1958
  - Riverside Levee 2 – 1959

1962 - Looking North towards the 60 fwy. Archive photo from RCFC&WCD

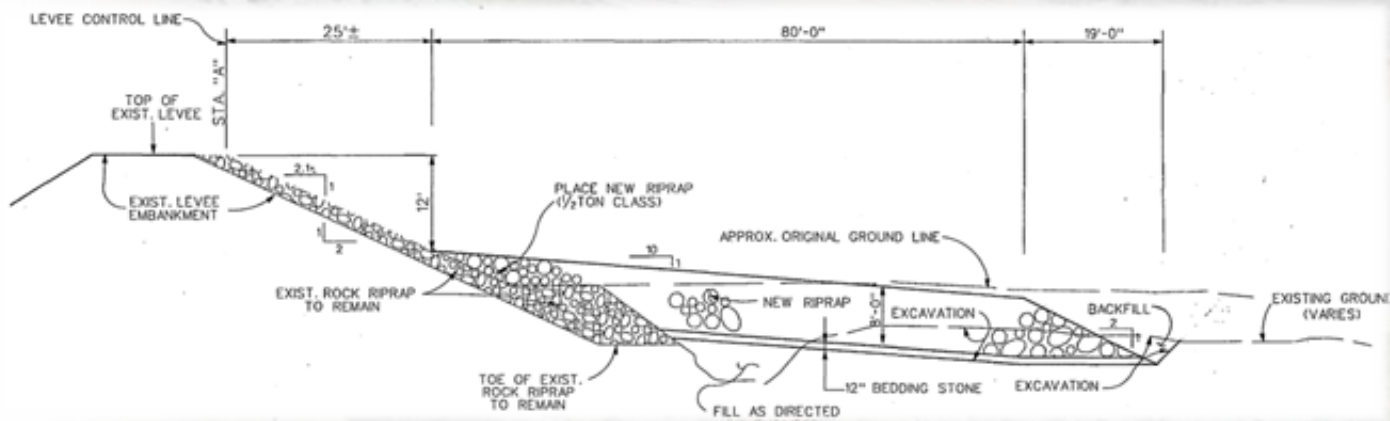
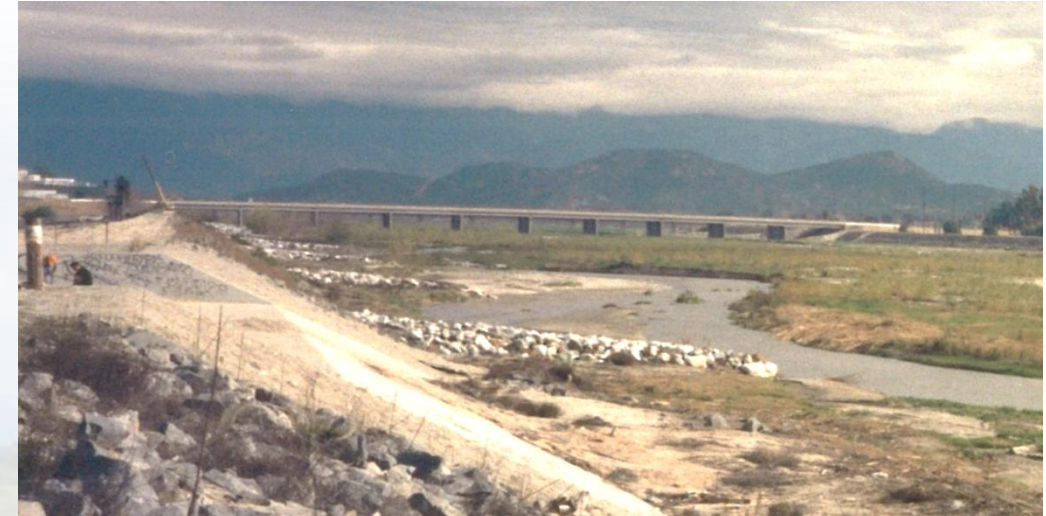
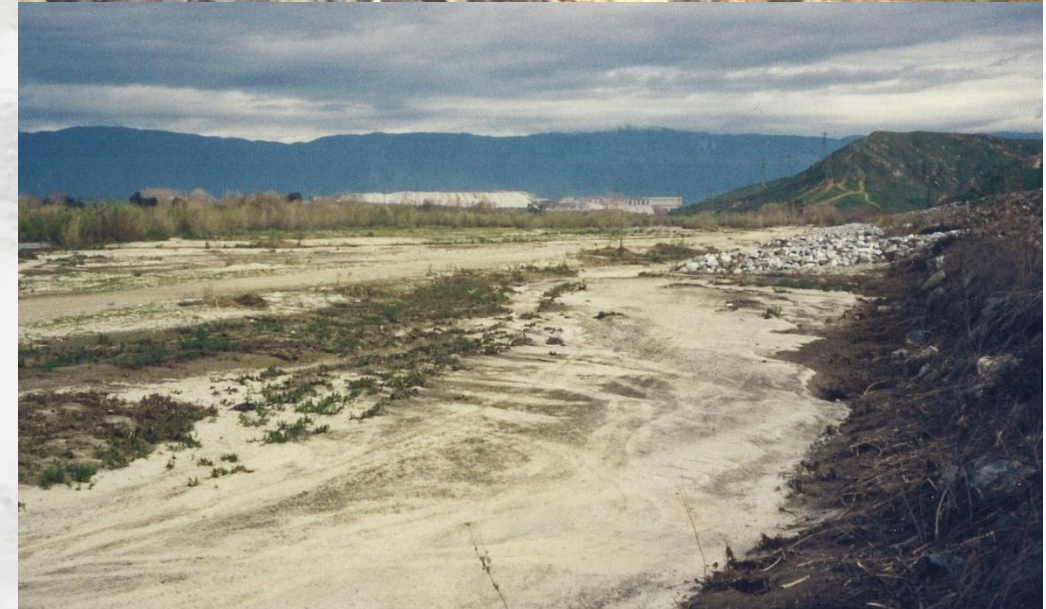
- District constructs levee groins in 1995
  - 100' long towards channel centerline
  - Located approx. 500' apart
  - 8-foot high and 48-feet wide
  - Used to keep water away from the levee toe
  - Located at:
    - Right levee between SR 60 and Mission Blvd.
    - Left levee between County Line and SR 60

1998 – Santa Ana River. Archive photo from RCFC&WCD

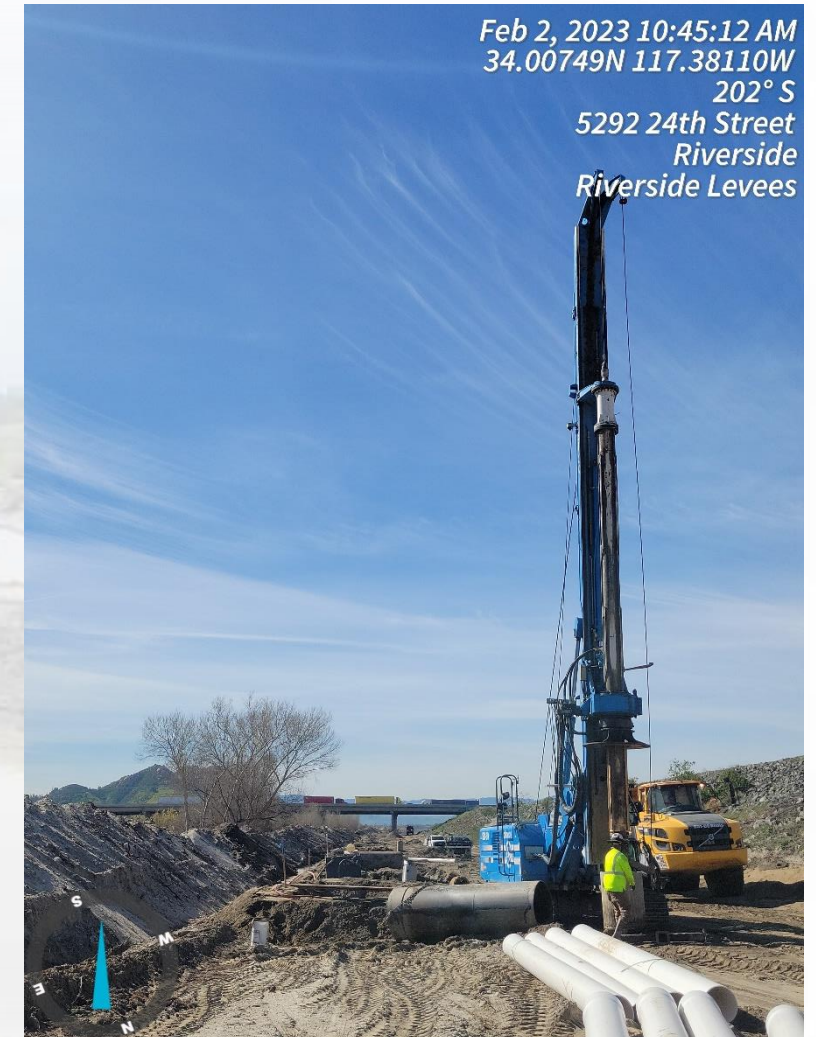
*Dewatering Well Installation*

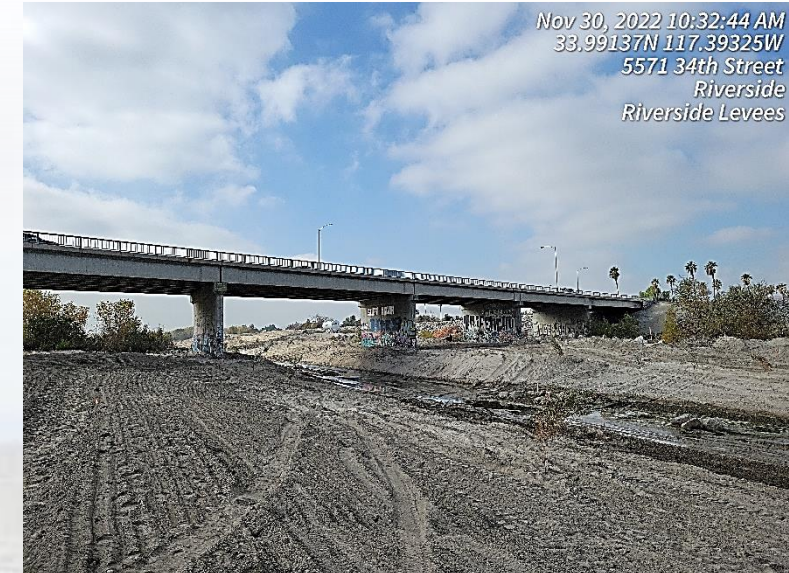
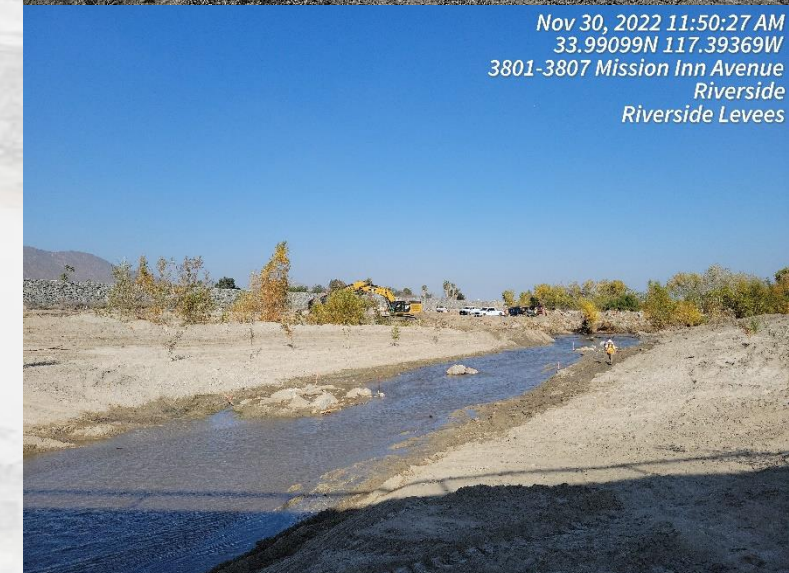
- 5-year period of monitoring and adaptive management for Santa Ana Sucker and **within the three Diversion Channels:**
  - Quarterly Monitoring for 1<sup>st</sup> year of construction
  - Biannual Monitoring for years 2-5
  - Survey Reports provided to USFWS within 30 days after completion of survey
- After 5 year monitoring period, Diversion Channel will remain in place to allow nature to take its course

*Southern Diversion Channel*
