Riverwalk Data Summary

December 9th, 2025

Sucker Conservation Team

Provide updates on the annual Santa Ana Sucker Habitat Survey and present preliminary findings from the 2025 survey, marking this to be the 20th year of monitoring the Santa Ana River.

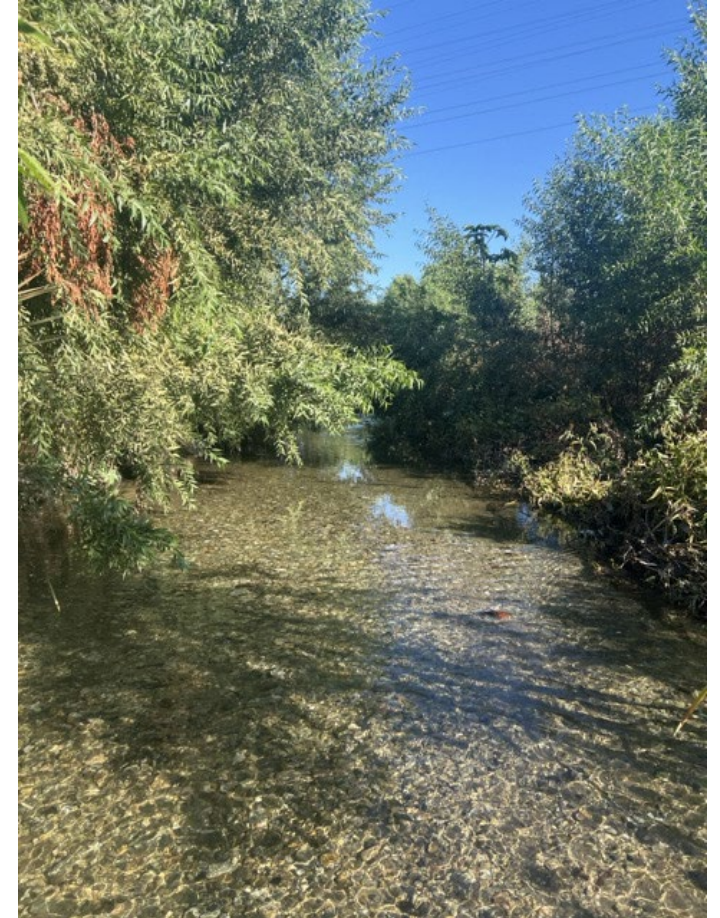
Survey Location

- Since 2006, Riverwalk data has been collected during the fall at approximately the same geo-located points each year, with each point labeled with a designating number: 9 through 116 (1-8 normally dry).
- These locations are chosen because the River is perennially flowing (i.e. downstream of Publicly Owned Treatment Works discharge points and rising groundwater).

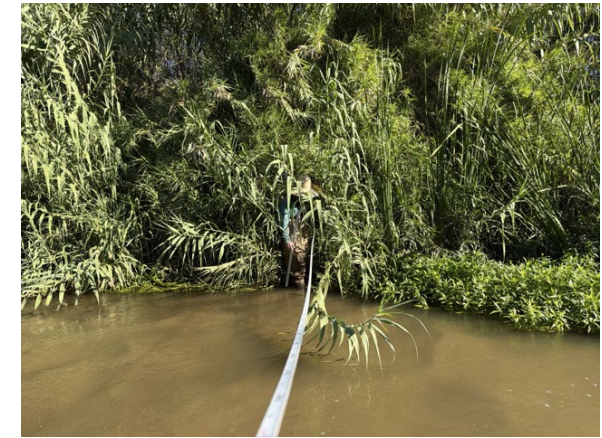
River Bottom Measurements

At each preset field point, a transect line is drawn from bank to bank.

To identify the area to monitor, a 4-meter-wide band is centered at the transect.

The area is surveyed by visually identifying river bottom material:

- Mud/Silt
- Sand
- Gravel
- Cobble
- Boulder

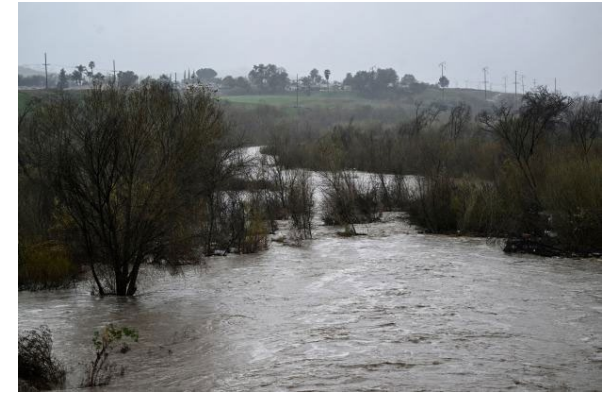
Credit: Press Enterprise

A minor storm on October 14 (less than 1 inch precipitation) prompted a short delay. The survey was rescheduled from October 16 to October 21 to allow river conditions to stabilize.

- Turbidity was an issue within that 7-day window (October 14 to October 21). Especially for the lower parts of the survey area near River Road.
- 61 sites were able to be surveyed (on average 99 transects are surveyed).
 - 25 sites were not surveyed due to active levee rehabilitation project.
 - 14 sites not surveyed due to high flows/turbidity.

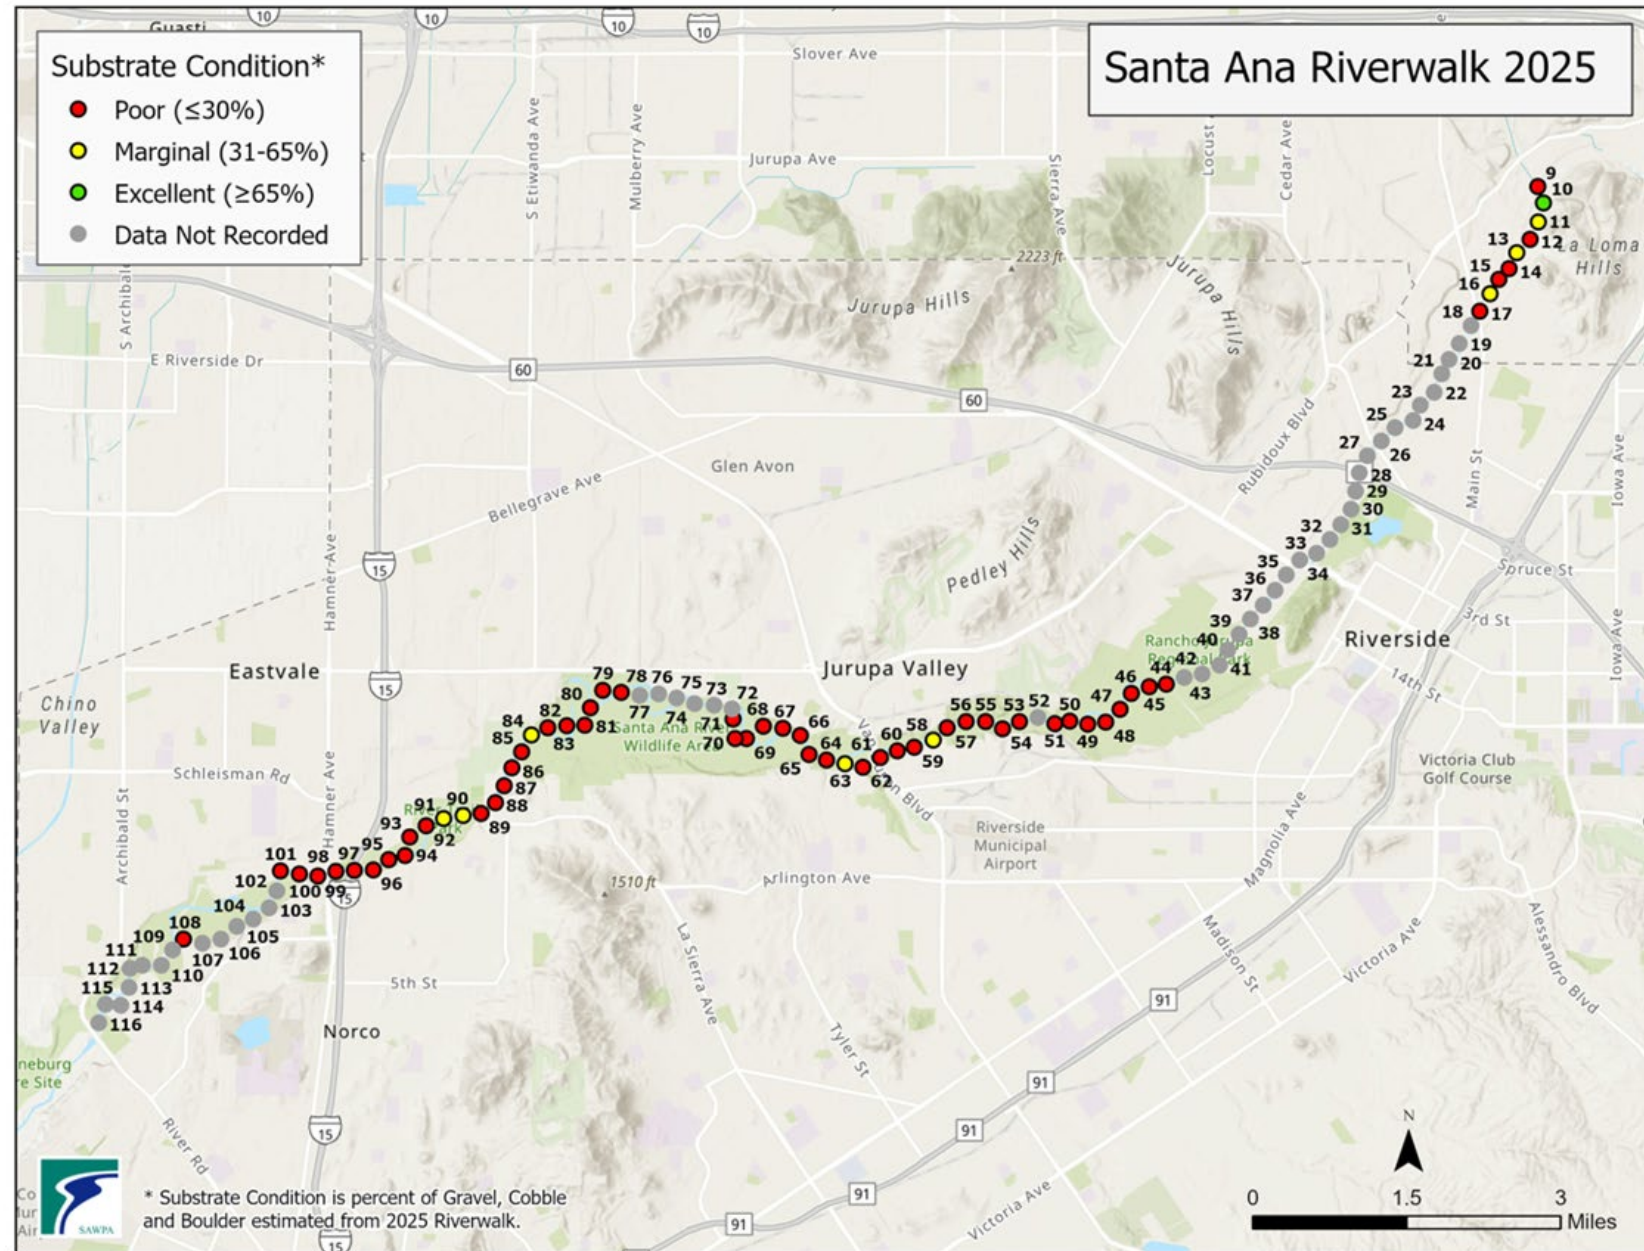
2025 Map

Restrictions:

- Transects **18-43**: Levee Project - Riverside County Flood Control District
- Transects **72-78**: Limited volunteers availability
- Transects **102-116**: High water flows
