SANTA ANA WATERSHED PROJECT AUTHORITY

REGULAR COMMISSION MEETING TUESDAY, OCTOBER 16, 2018 – 9:30 A.M.

A. INLAND EMPIRE BRINE LINE REACH 4D REHABILITATION WORK PLAN (CM#2018.106)..... 19

Reach 4D Manned Entry Condition Assessment

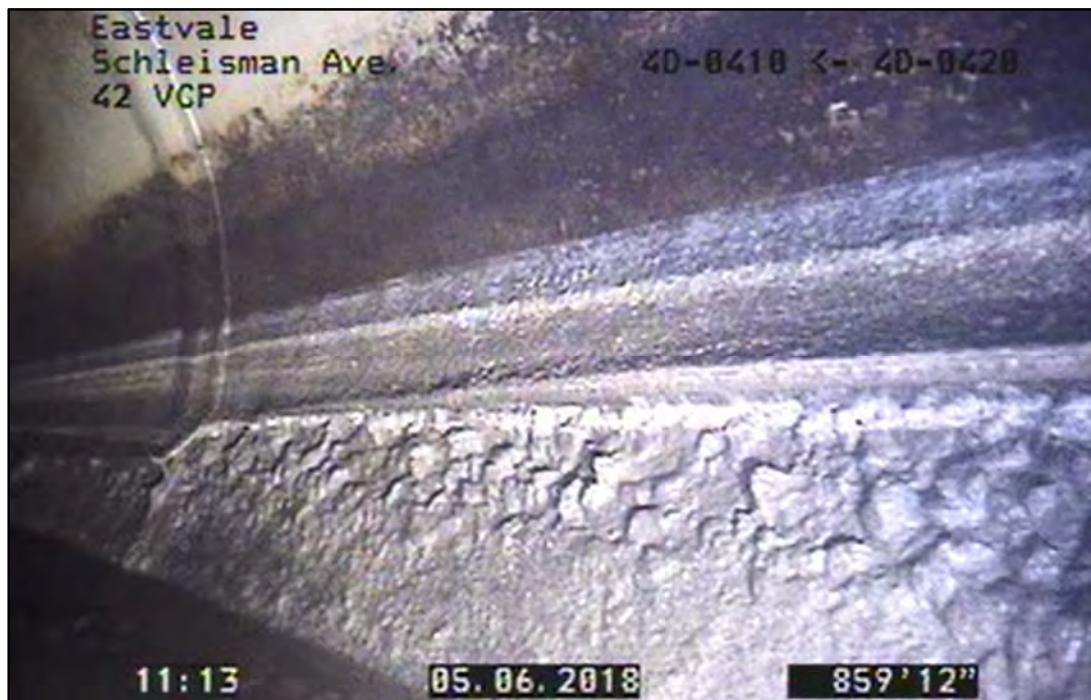
Figure 4: Minor Concrete Loss and Visible Aggregate Below Liner Termination and Rotated T-Lock Liner at Pipe Joint Between MAS 4D-0410 and 4D-0420

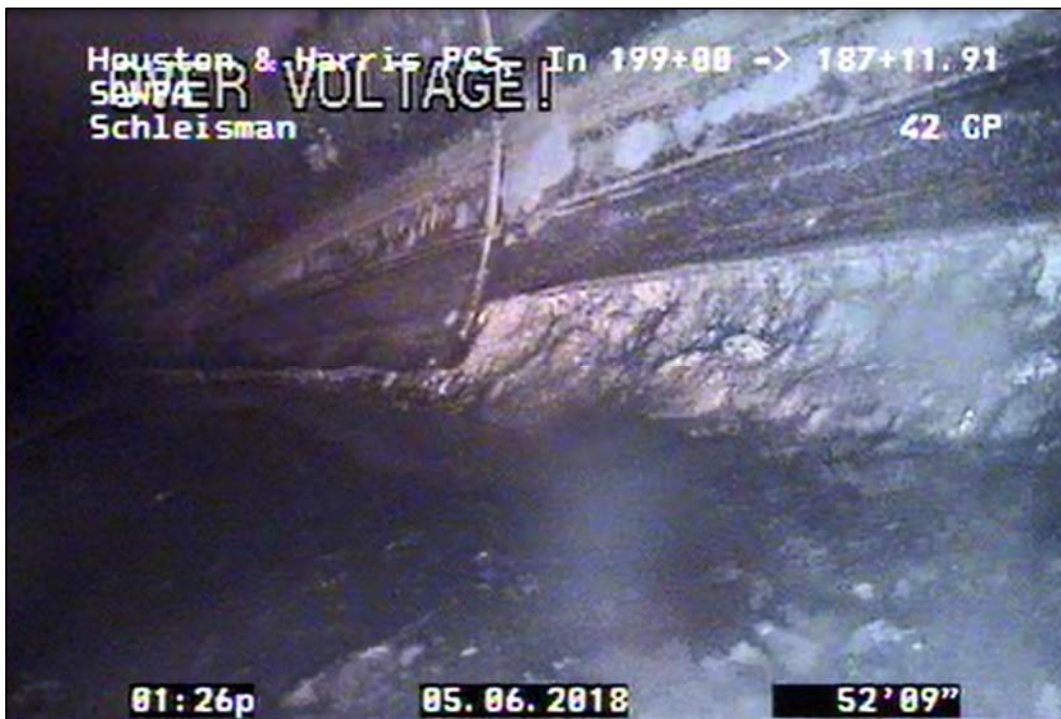
Figure 5: Minor Concrete Loss and Visible Aggregate Below Liner Termination and Rotated T-Lock Liner at Pipe Joint Between MAS 4D-0380 and 4D-0390

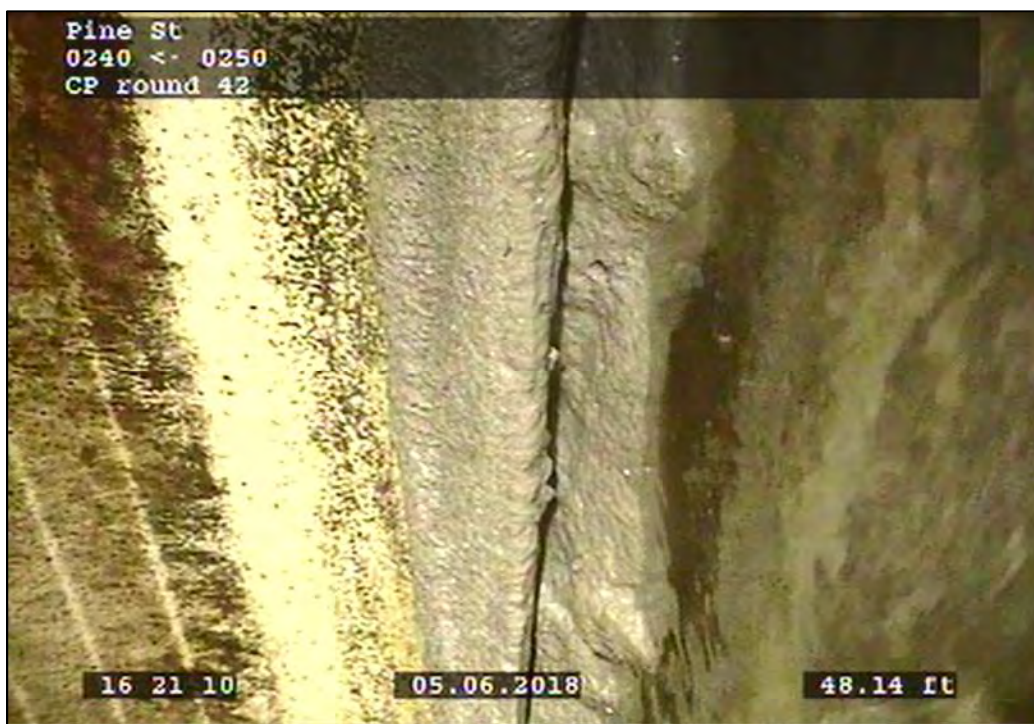
Figure 6: Liner Termination Uplift Along Pipe Segment Between MAS 4D-0240 and 4D-0250

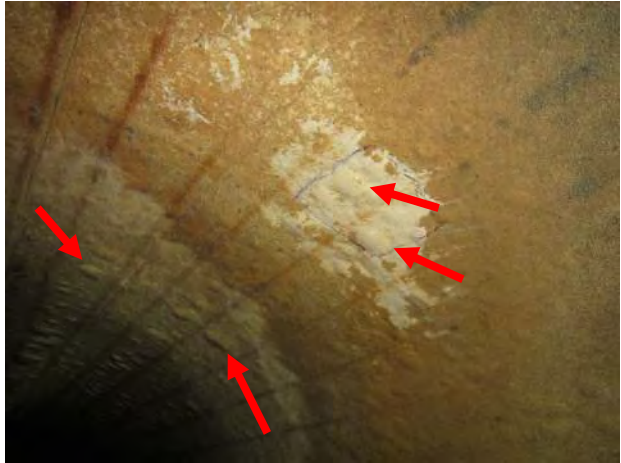
Photo 3-1. Typical lining blisters (indicated by red arrows).

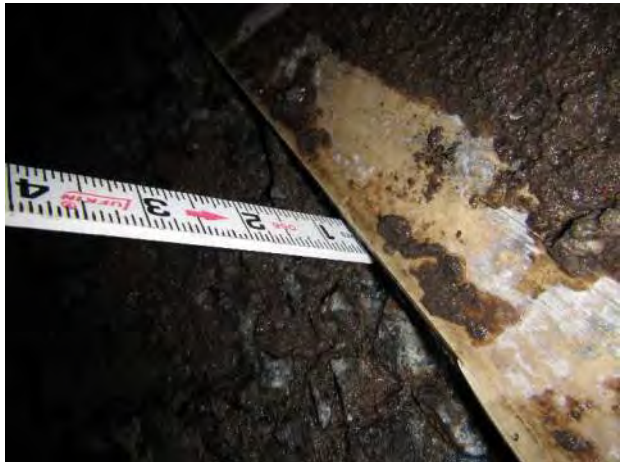
Photo 3-3. Typical undermined and unembedded liner termination. Typical exposed concrete aggregate.

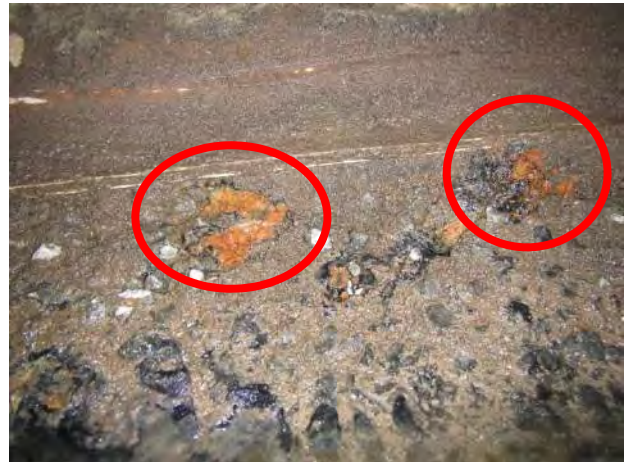
Photo 3-4. Exposed reinforcing steel only seen at Manhole 4D-0470 (circled in red).

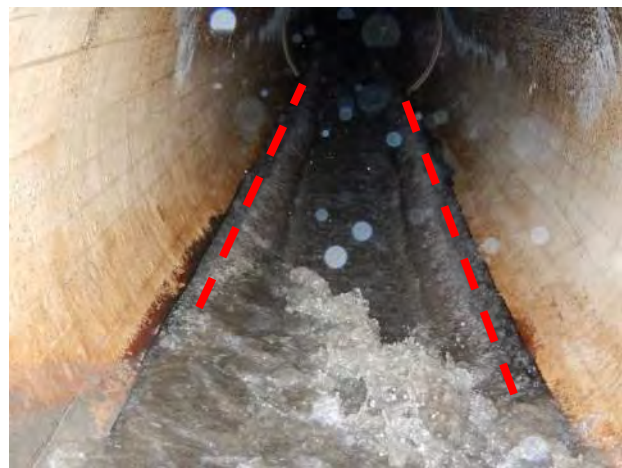
Photo 3-6. Steep slope for Manhole 4D-0150 influent pipe. Apparent typical water level indicated by red

dashed line.

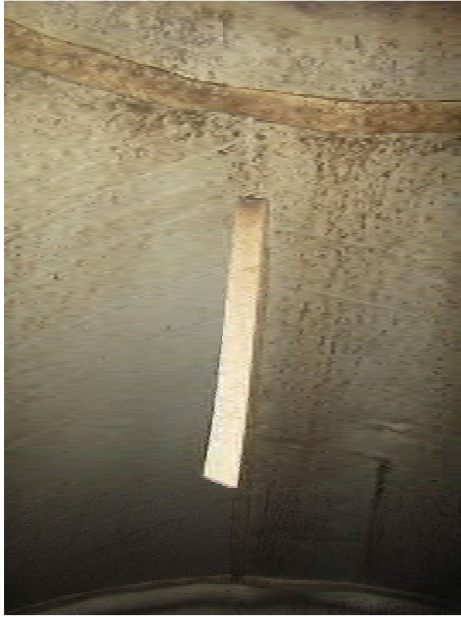
Photo 4-1. Typical failed liner weld strip.

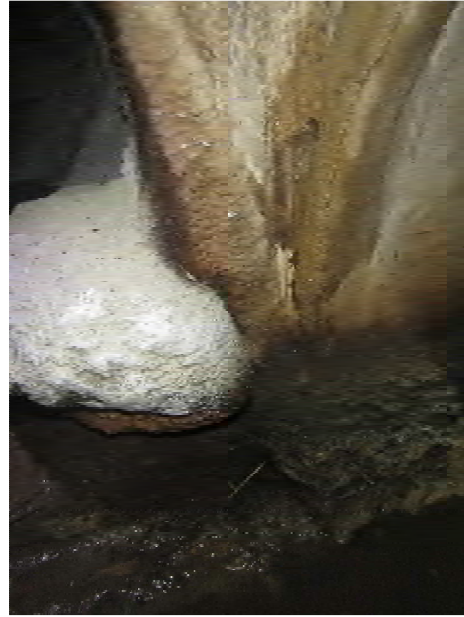
Photo 4-2. Typical slime layer and encrustation.

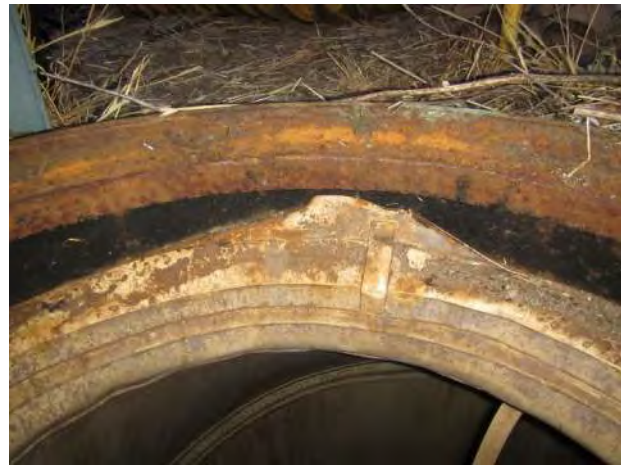
Photo 4-4. Typical loose liner termination.

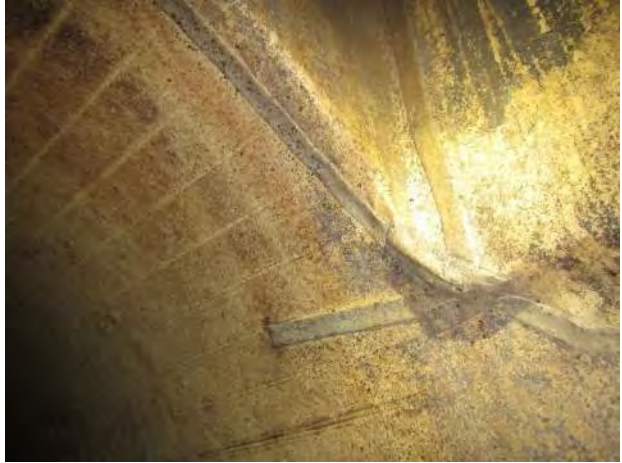
Photo 4-5. Typical main pipe connection in good condition.

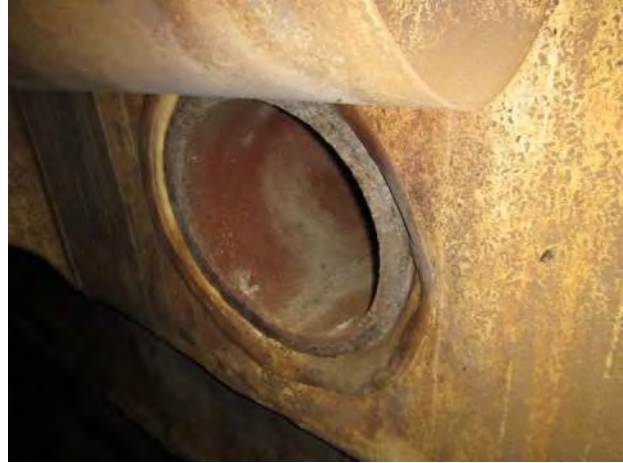
Photo 4-6. Typical lateral penetration in good condition.

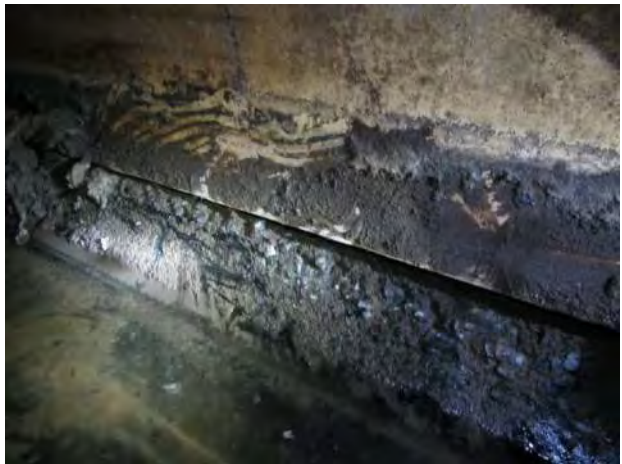
The manhole channels appeared to have been constructed as indicated in the available record drawings. A pipe segment was cut and tied into the manhole structure, and the concrete surfaces were lined with a PVC lining system (Figure 4-1). The liner terminations at installed laterals and at the opening of the cut RCP were in good condition at the assessed manholes (Photo 4-5 and Photo 4-6). However, for the majority of the assessed manholes the liner termination within the channel has failed or is undermined (Photo 4-7 and Photo 4-8).

Photo 4-7. Typical undermined liner termination and exposed aggregate.

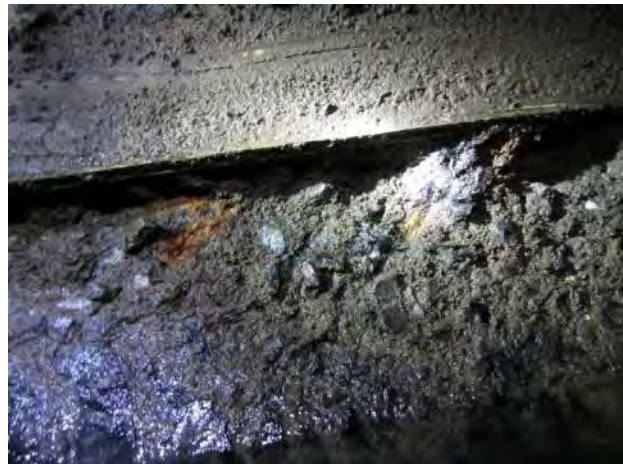
Photo 4-8. Exposed reinforcing steel only seen at MH 4D-0470.

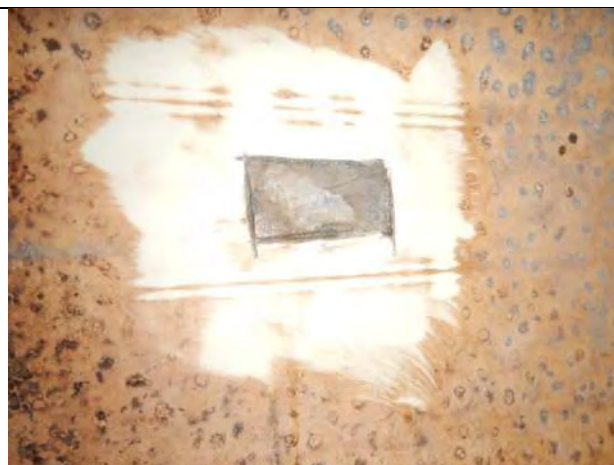
Effluent pipe liner cut at spring line (9:00)

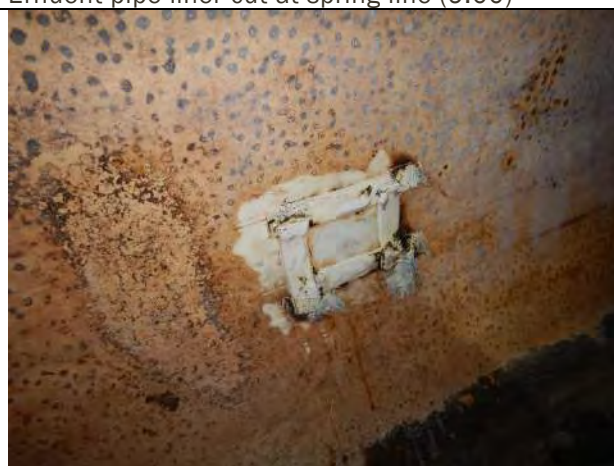
Liner repair at spring line (9:00)

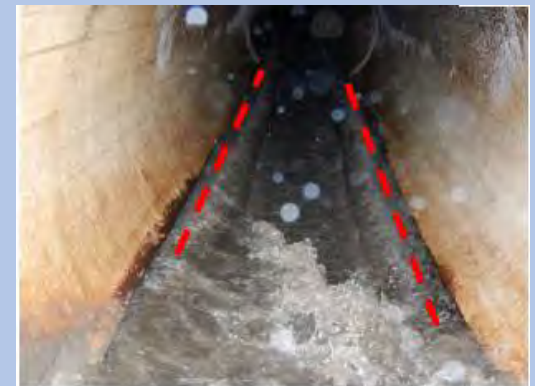
Photo 3-6. Steep slope for Manhole 4D-0150 influent pipe. Apparent typical water level indicated by red
