SANTA ANA WATERSHED
PROJECT AUTHORITY

Reach IV Condition Assessment Status Update

PA 24 Committee
Item No. 6.A
Daniel Vasquez
Manager of Operations
July 2, 2024

Inland Empire Brine Line Reach IV-D Condition Assessment

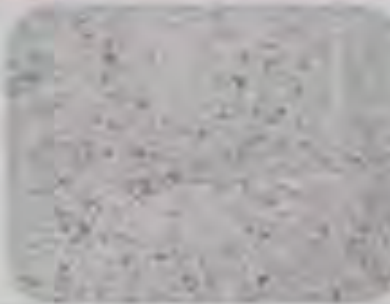
| Condition Rating | Description | Representative Photograph |
|---|---|---|
| Level 1 | <p>Little or no damage to concrete</p> <ul style="list-style-type: none"> ▪ Hardness..... hard surface ▪ Surface profile smooth, apparently intact ▪ Cracks hairline width, minimal frequency ▪ Spalling none ▪ Reinforcement not exposed or damaged | |

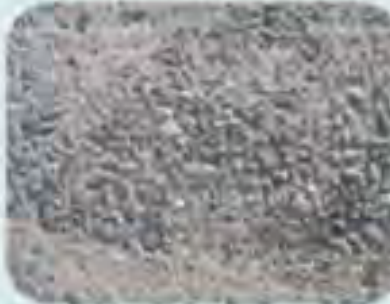
| Condition Rating | Description | Representative Photograph |
|---|---|---|
| Level 2 | <p>Minor surface damage</p> <ul style="list-style-type: none"> ▪ Hardness..... soft surface layer to 1/8-inch depth ▪ Surface profile fine aggregate exposed ▪ Cracks hairline width, moderate frequency ▪ Spalling shallow spalling, minimal frequency ▪ Reinforcement not exposed or damaged | |

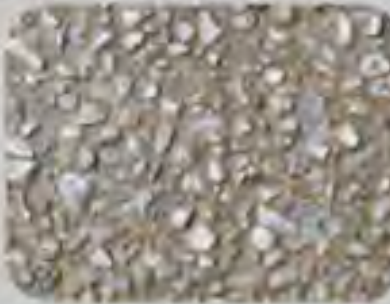
| Condition Rating | Description | Representative Photograph |
|---|---|---|
| Level 3 | <p>Moderate surface damage</p> <ul style="list-style-type: none"> ▪ Hardness..... soft surface layer to 1/4-inch depth ▪ Surface profile large aggregate exposed or protruding ▪ Cracks up to 1/32-inch width, moderate frequency ▪ Spalling shallow spalling, minimal frequency ▪ Reinforcement exposed; minor damage, minimal frequency | |

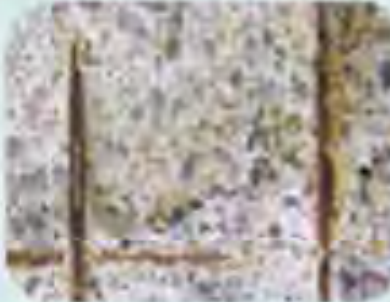
| Condition Rating | Description | Representative Photograph |
|---|---|---|
| Level 4 | <p>Loss of concrete mortar and damage to reinforcement</p> <ul style="list-style-type: none"> ▪ Hardness..... soft paste beyond 1/4-inch depth ▪ Surface profile large aggregate exposed, loose, or missing ▪ Cracks 1/8- to 1/4-inch width, moderate frequency ▪ Spalling deep spalling, moderate frequency ▪ Reinforcement exposed with damage, moderate frequency | |

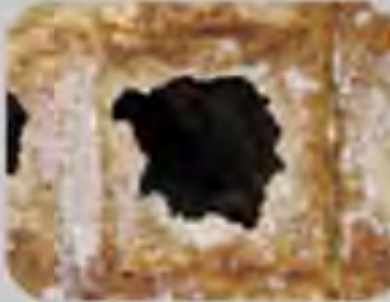
| Condition Rating | Description | Representative Photograph |
|---|---|---|
| Level 5 | <p>Bulk loss of concrete and reinforcement</p> <ul style="list-style-type: none"> ▪ Hardness..... soft paste beyond 1-inch depth ▪ Surface profile large aggregate exposed, loose, or missing ▪ Cracks over 1/2-inch width, or narrower and frequent ▪ Spalling deep spalling, high frequency ▪ Reinforcement consumed; loss of structural integrity | |
