SANTA ANA WATERSHED PROJECT AUTHORITY
11615 Sterling Avenue, Riverside, California 92503 • (951) 354-4220

REGULAR MEETING OF THE PROJECT AGREEMENT 24 COMMITTEE TUESDAY, APRIL 1, 2025 – 10:00 A.M. (or immediately following the 9:30 a.m. SAWPA Commission meeting)

- B. **INLAND EMPIRE BRINE LINE REACH IV-D CONDITION ASSESSMENT FINAL REPORT (PA24#2025.10)**53

Inland Empire Brine Line Reach IV-D Condition Assessment Report

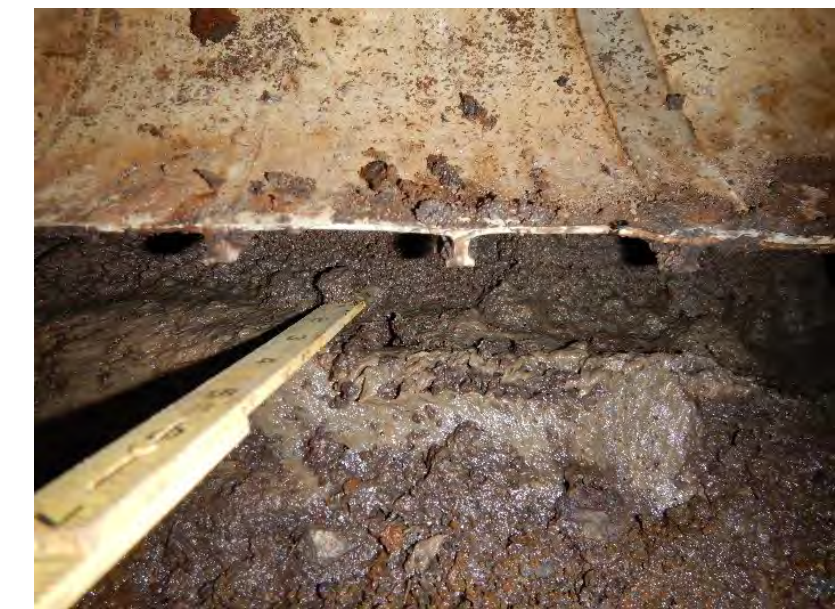
- Pipe segments and MAS appear to be in a similar condition as in 2018 and 2019.
- Unlined concrete surfaces below the liner termination point have moderately deteriorated, meaning the concrete has exposed aggregate.
- Testing results indicate the lined concrete appear to be well protected from the corrosive environment and in good condition.
- Draft Report provided to Member Agency staff for review in August 2024.
- Final Report completed in November 2024

Figure 2: Unlined concrete testing

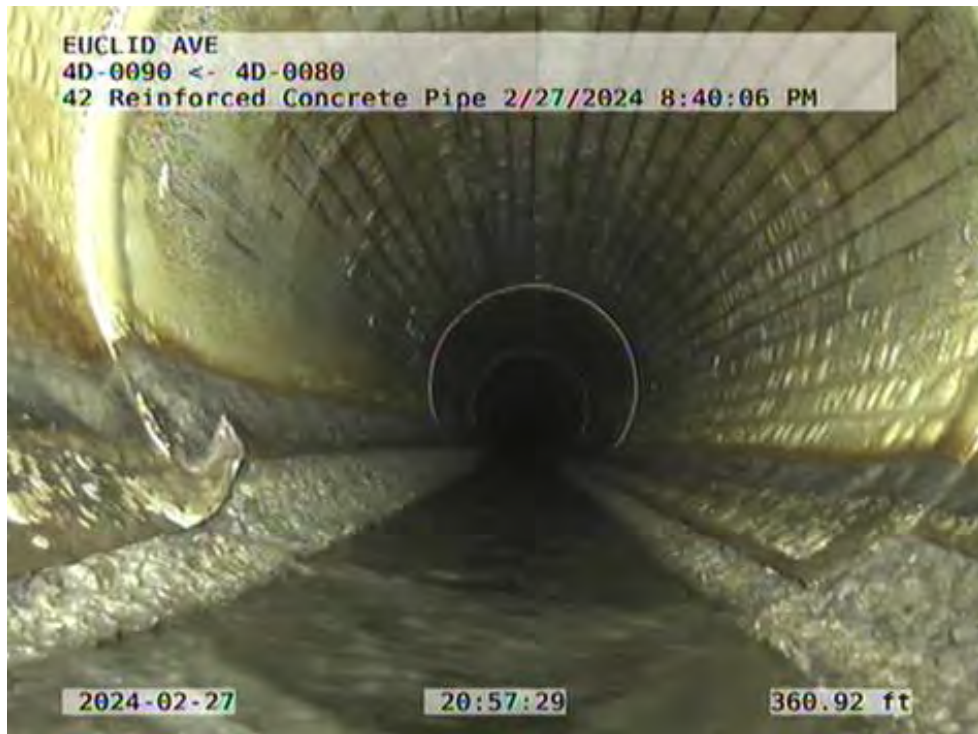
The T-Lock liner appeared to be rotated between individual pipe sticks throughout all of the inspected segments. The rotation varies from approximately one-inch to six-inches, measured from the liner termination at the pipe joints along each side of the pipe (**Figure 3**). The primary issue associated with these rotated segments is liner rotation increases the liner termination height above the pipe invert on one side of the pipe, thereby increasing the likelihood of the water surface dropping below the liner. As a result, the observed concrete corrosion below the liner was not consistent on both sides of the pipe along the segments with rotated sticks.

Figure 2: Liner Termination Uplift and Longitudinal Groove from Aggregate Loss Under Liner Between MAS 4D-0260 and 4D-0270

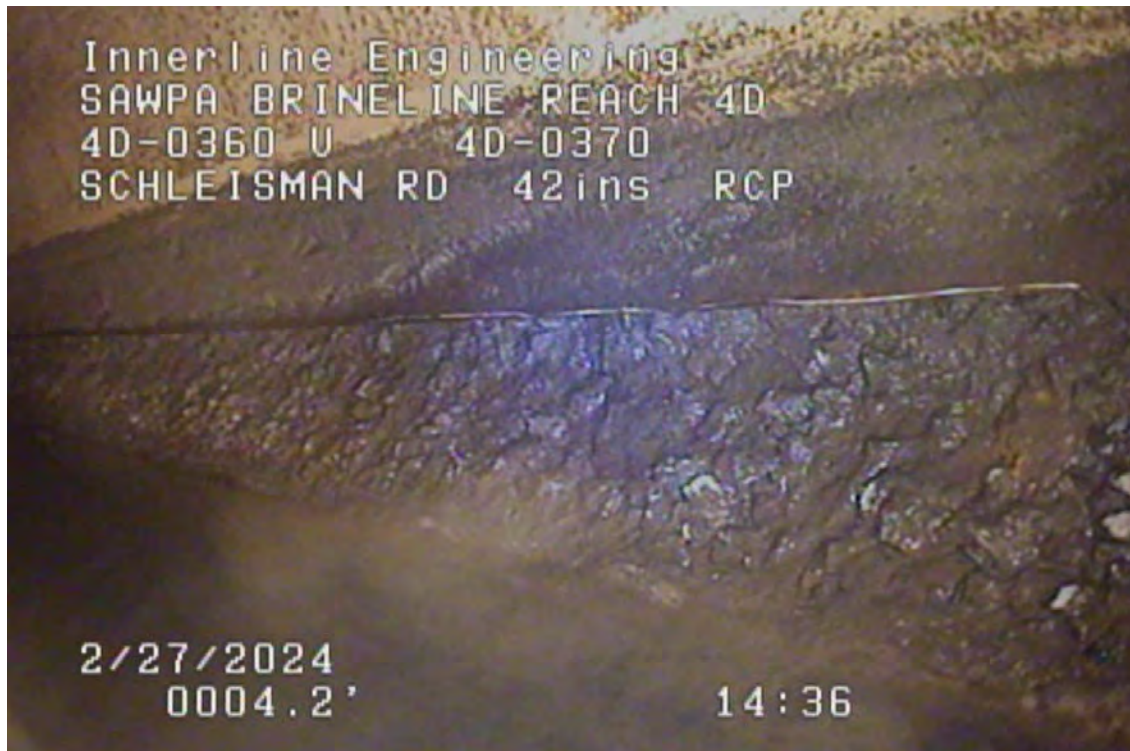
The February 2024 inspections resulted in significantly more quality CCTV inspection footage compared to 2018 because of the extensive pre-inspection pipe cleaning that was performed. Overall, the pipe segments appeared to be in similar condition as in 2018 and 2019. The unlined concrete surfaces below the liner termination point have moderately deteriorated resulting in exposed aggregate. Longitudinal grooves have formed under the liner termination due to aggregate loss for approximately 50% of the total inspected length. These grooves under the liner will eventually result in uplifting of the liner termination (see **Figure 2**). No exposed rebar was positively identified in the CCTV inspections.

Figure 4: Minor Concrete Loss and Visible Aggregate Below Liner Termination Between MAS 4D-0450 and 4D-0460

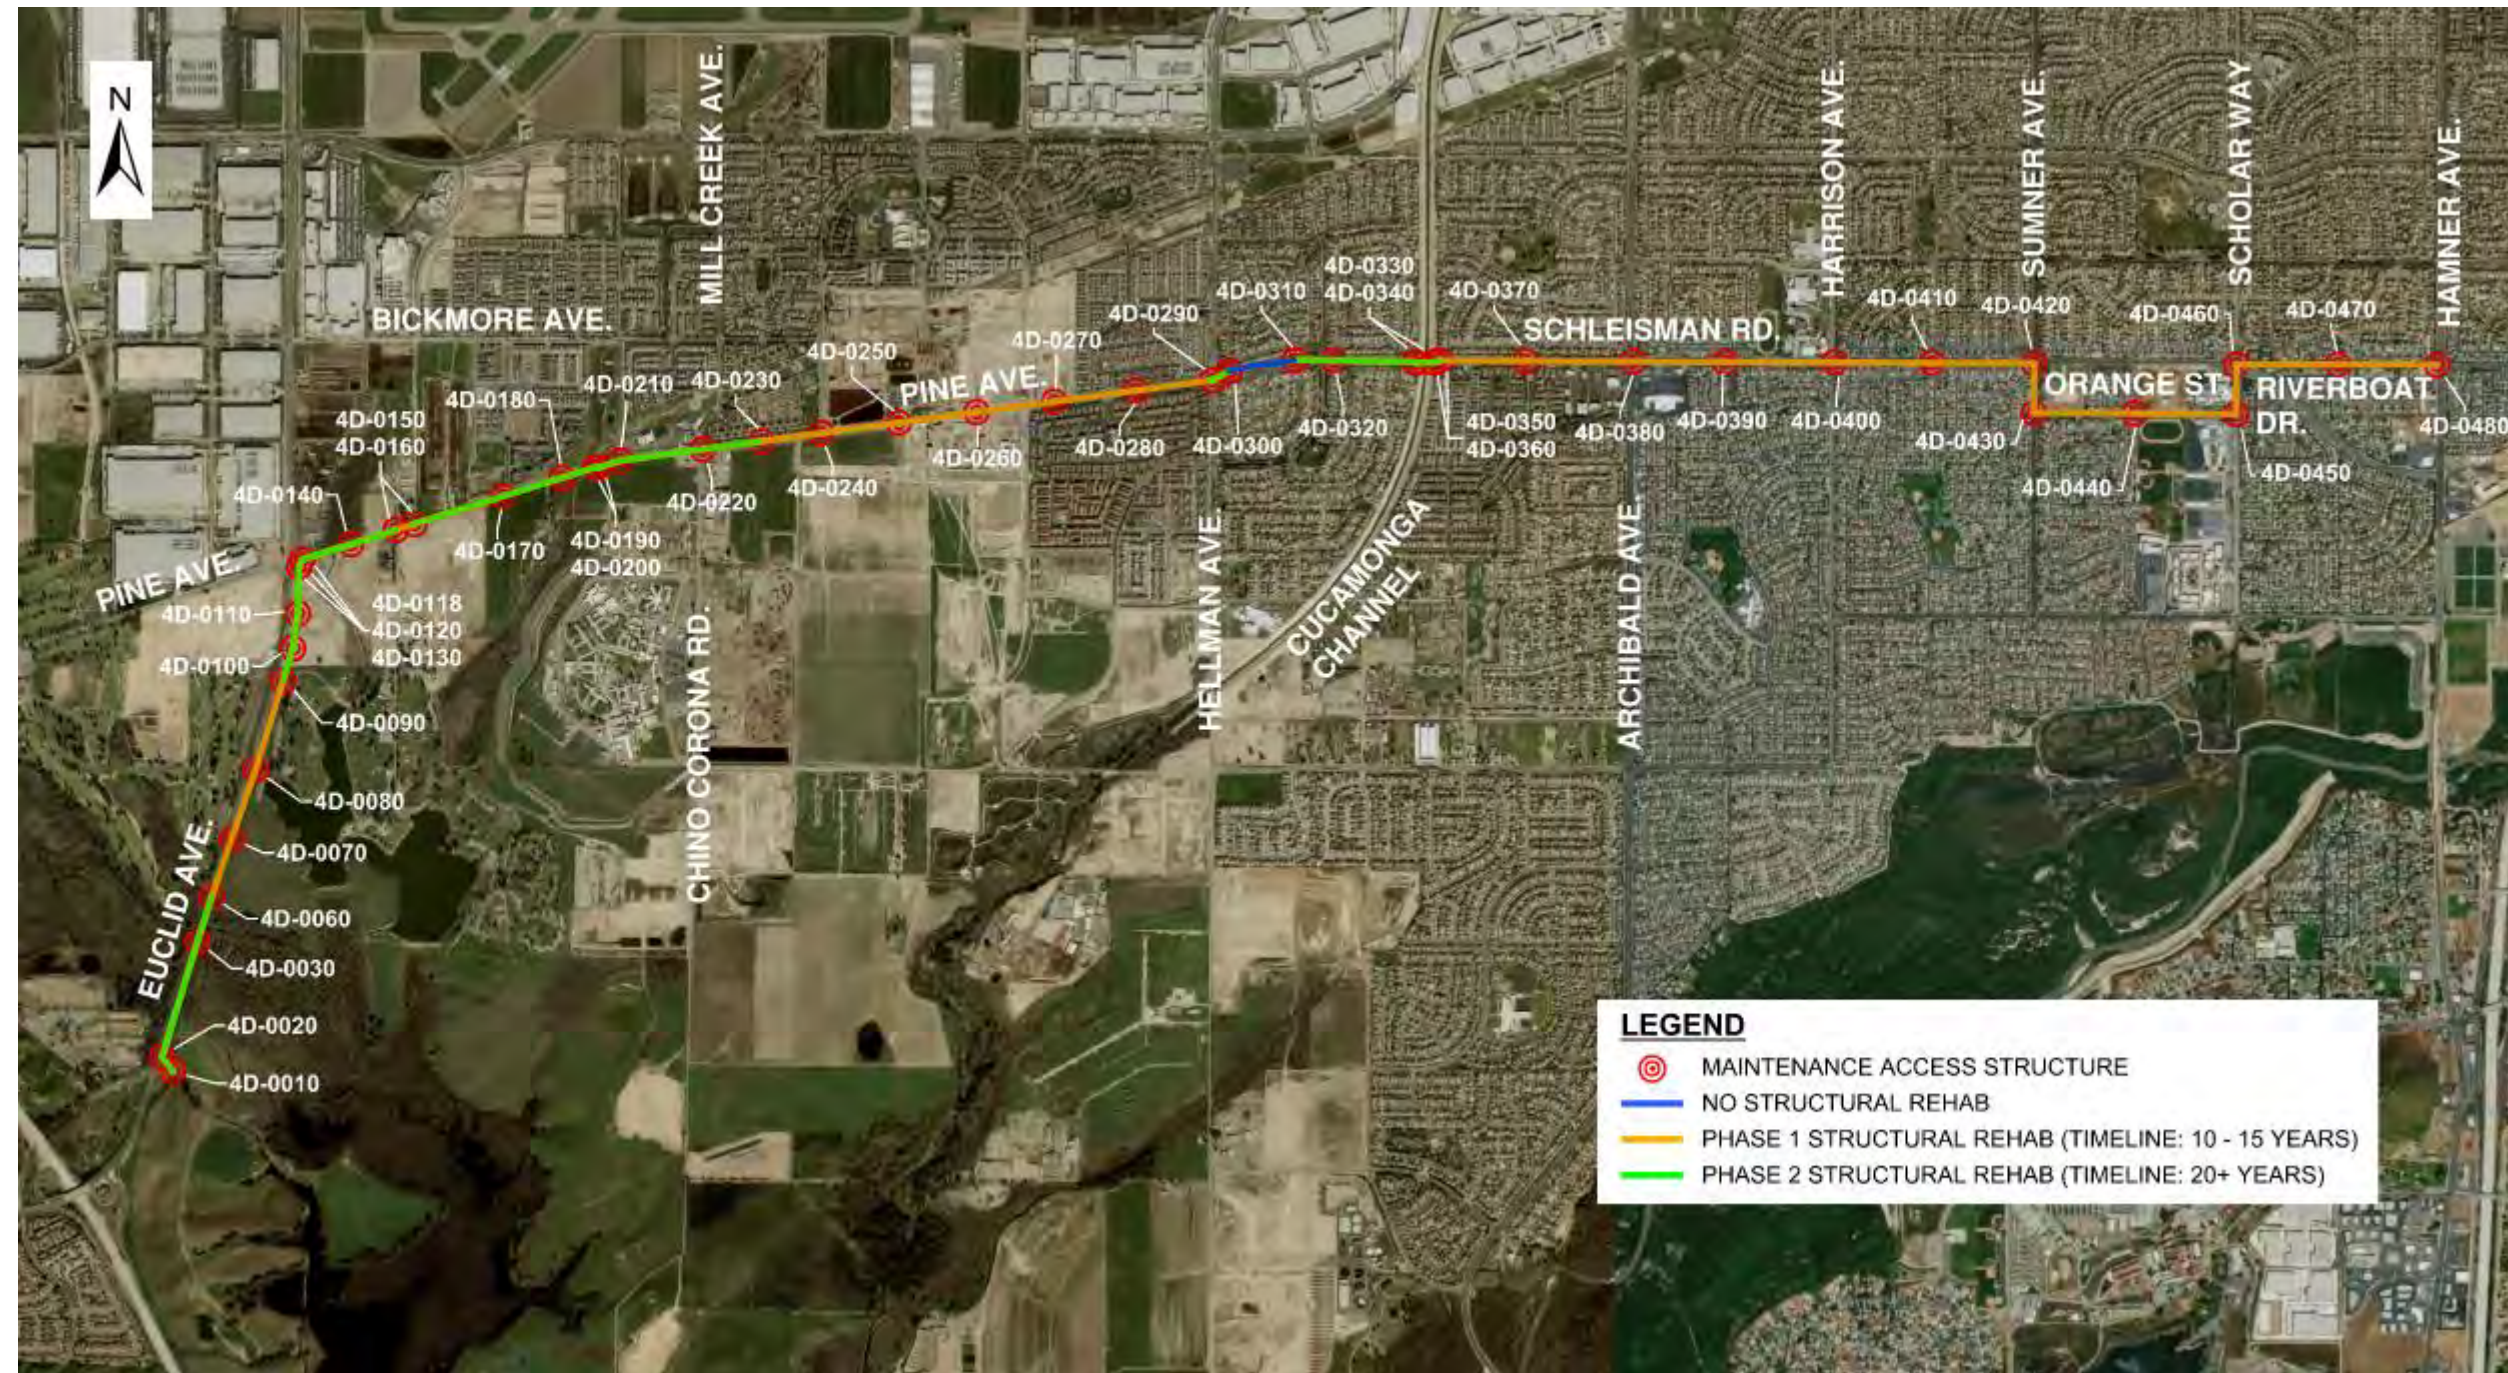
A summary of the segments designated for structural rehabilitation in Phase 1 and Phase 2 are provided below in **Table 13** and **Table 14**, respectively. Refer to **Figure 6** for a map of the segments designated for structural rehabilitation in Phase 1 and Phase 2.

Figure 6: Reach 4D Contract 1 and 2 Alignment Segments Designated for Structural Rehabilitation in Phase 1 and Phase 2

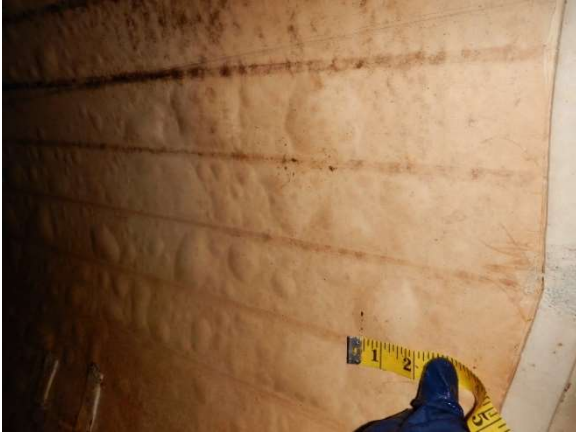
Photo 3-1. Typical lining blisters.

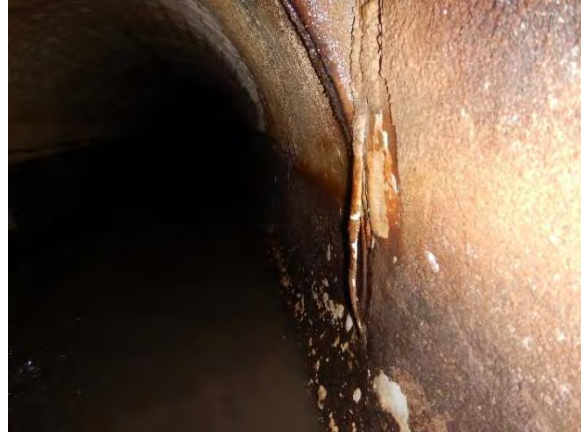
Photo 3-2. Failed weld strip (seen at 4D-0060 and 4D-0118).

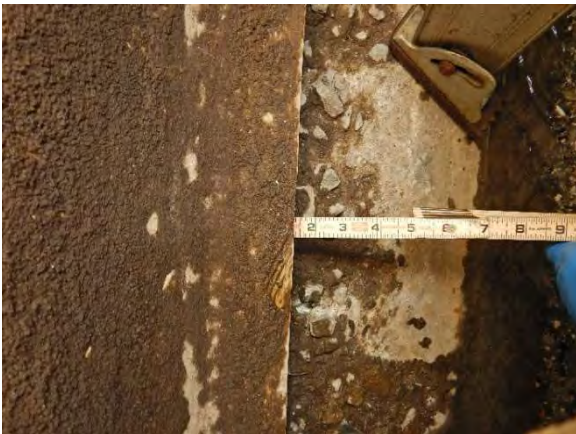
Photo 3-3. Typical lining termination undermined and unembedded.

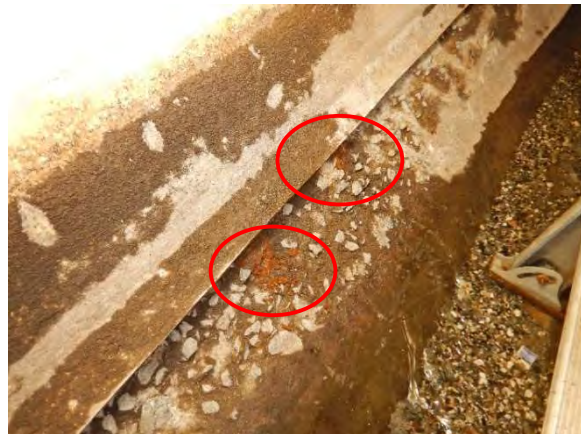
Photo 3-4. Reinforcement corrosion staining (only seen at 4D-0470)

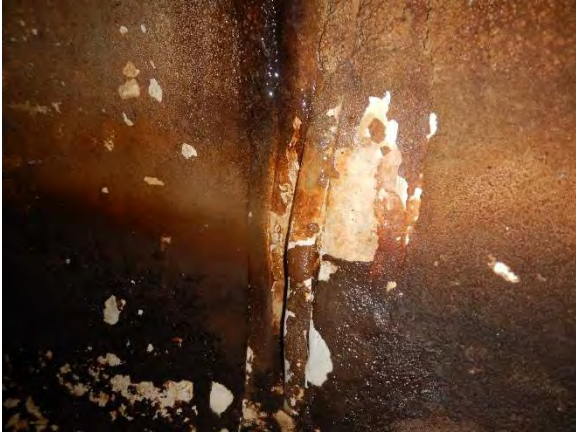
Photo 3-7. Typical failed weld strip.

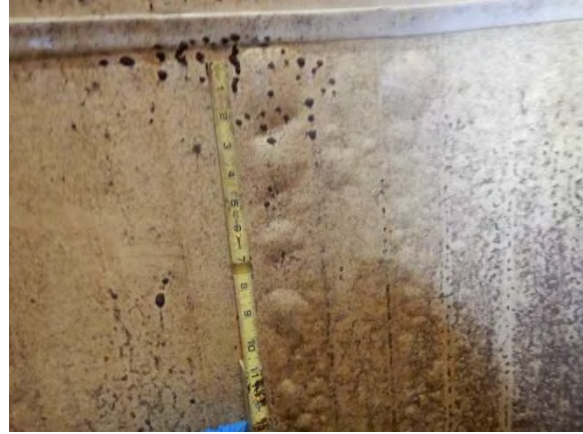
Photo 3-8. Typical blisters in lining on MAS walls.

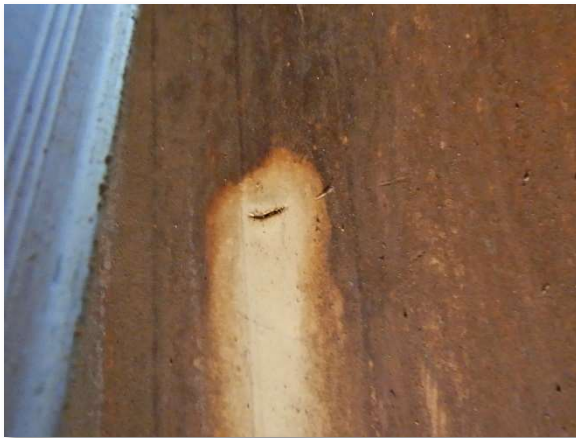
Photo 3-9. Cut in liner (only seen at 4D-4360 and 4D-0470).

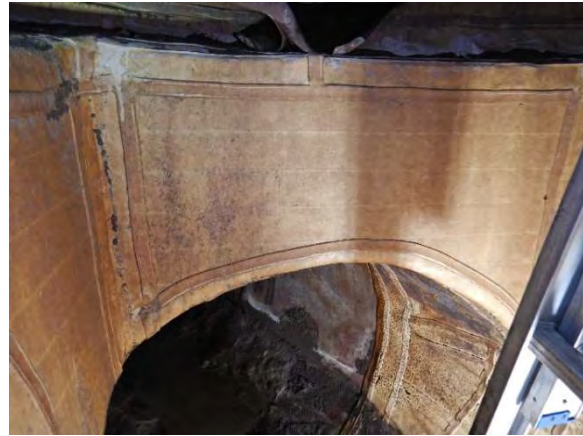
Photo 3-10. Typical termination at pipe and MAS interface.

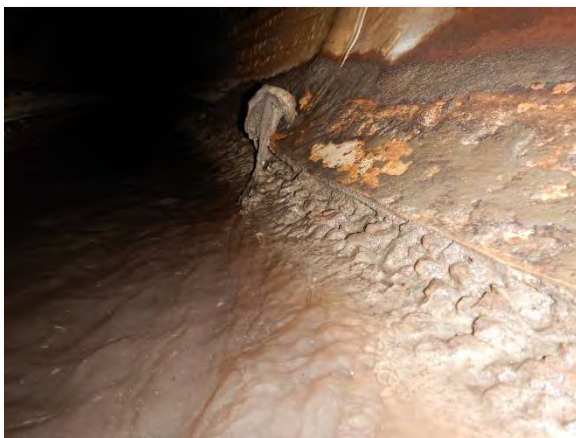
Photo 3-11. Typical exposed aggregate in channel.

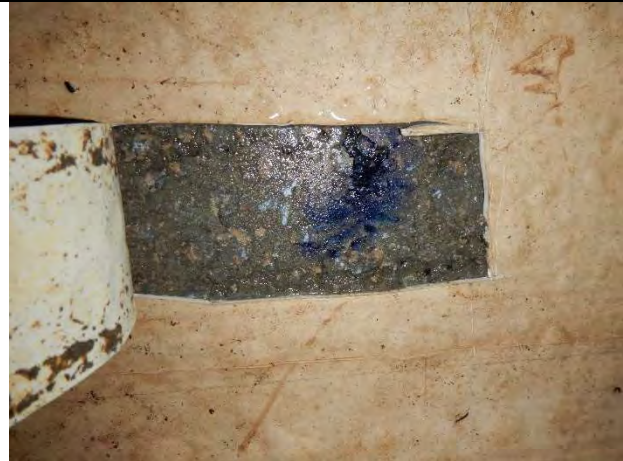
Effluent pipe liner cut at the crown (12:00)

Location	Surface Condition	Sounding	Surface pH	Penetration Depth (in.)	VANDA Rating
Effluent Crown (12:00)	Hard	Solid	12	1/16	1
Effluent Below Spring line (3:00)	Hard	Solid	12	1/16	1
Influent Below Liner (5:00)	Exposed Agg.	Solid	8 (At-Depth pH)	1/16	3

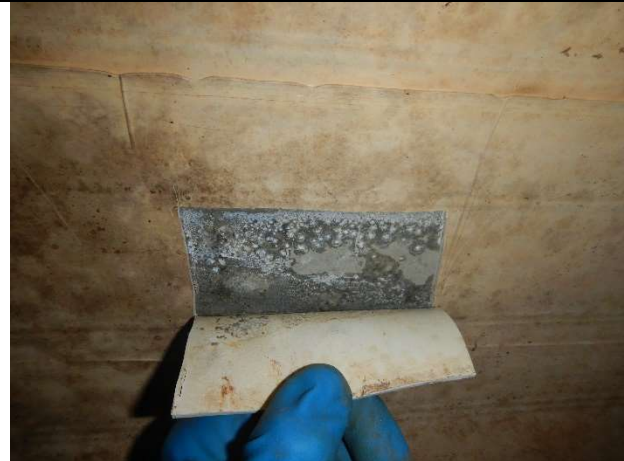
Effluent pipe liner cut at the crown (12:00)

Location	Surface Condition	Sounding	Surface pH	Penetration Depth (in.)	VANDA Rating
Effluent Crown (12:00)	Hard	Solid	12	1/16	1
Effluent Below Spring line (4:30)	Hard	Solid	12	1/16	1
Influent Below Liner (5:00)	Exposed Agg.	Solid	13 (At-depth pH)	1/8	3
