Santa Ana Riverwalk

Santa Ana Sucker Conservation Team Meeting

Final Project Presentation: Santa Ana Sucker Habitat Protection & Beneficial Use Enhancement Project

Santa Ana Sucker Fish Habitat Projects in the Santa Ana River Watershed

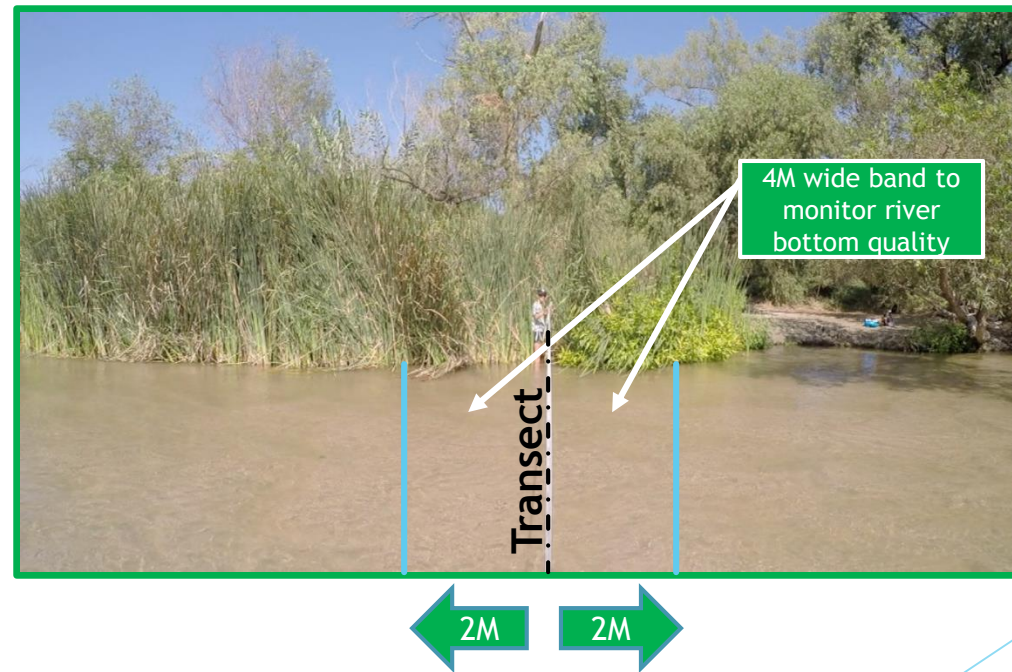
Field Data Collection

- ▶ The area within the band is then surveyed by visually identifying what type of material makes up the river bottom:
 - ▶ Mud/Silt
 - ▶ Sand
 - ▶ Gravel
 - ▶ Cobble
 - ▶ Boulder

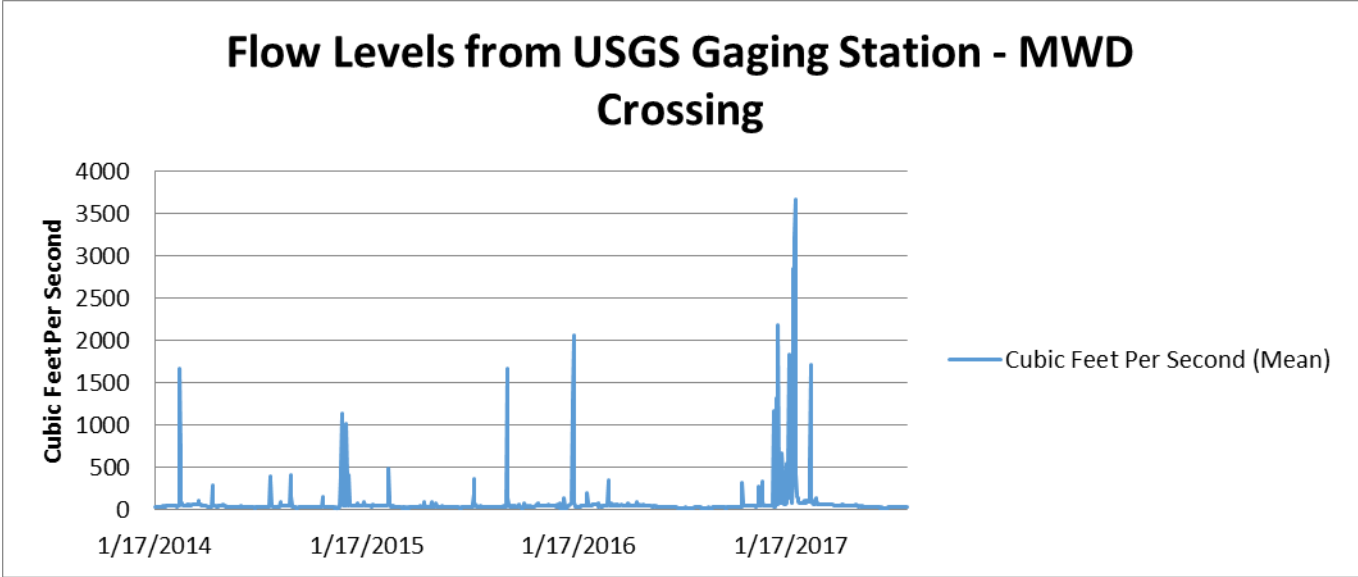
Riverwalk Data and Surface Water Flow

Governor declares drought ↑

2016 Riverwalk ↑

2017 Riverwalk ↑

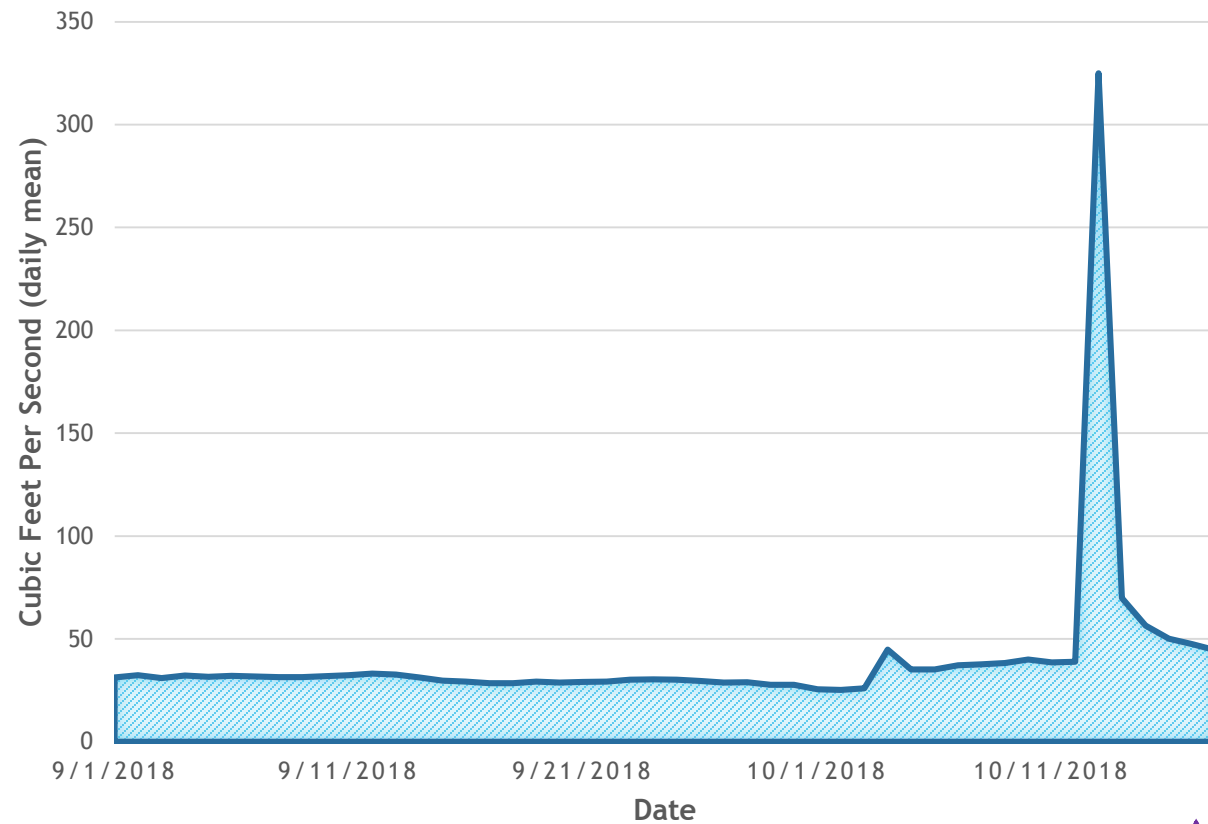
Fall 2018 Streamflow at USGS MWD Crossing Gaging Station

↑
2018 Riverwalk

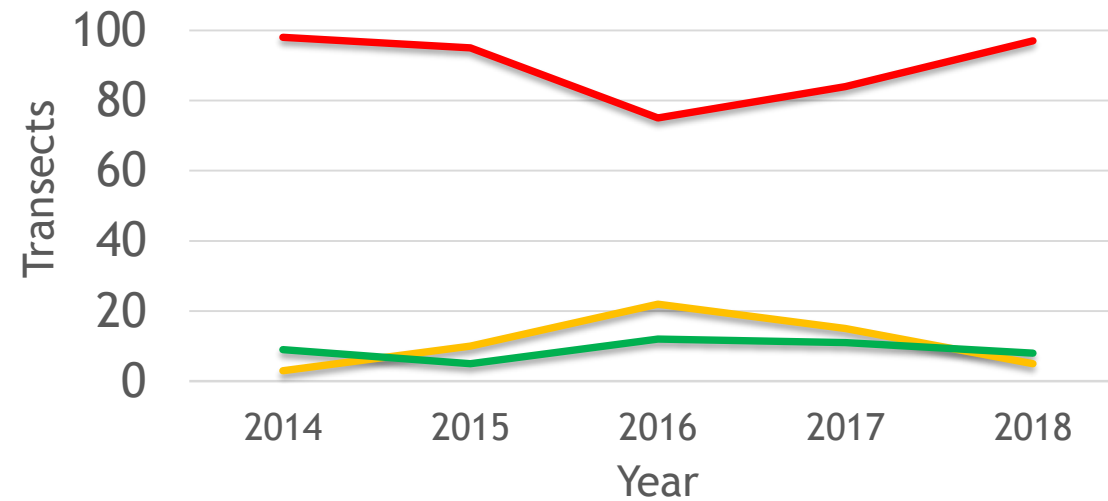
Summary of Recent Riverwalk Substrate Data

Using the categories described on the preceding pages, the distribution of the last five years of Riverwalk are shown in the following figure.

On average from 2014 to 2018, 82% of the 110 transects are categorized as having poor quality substrate.

— Poor — Marginal — Good

Total amount of transects: 110

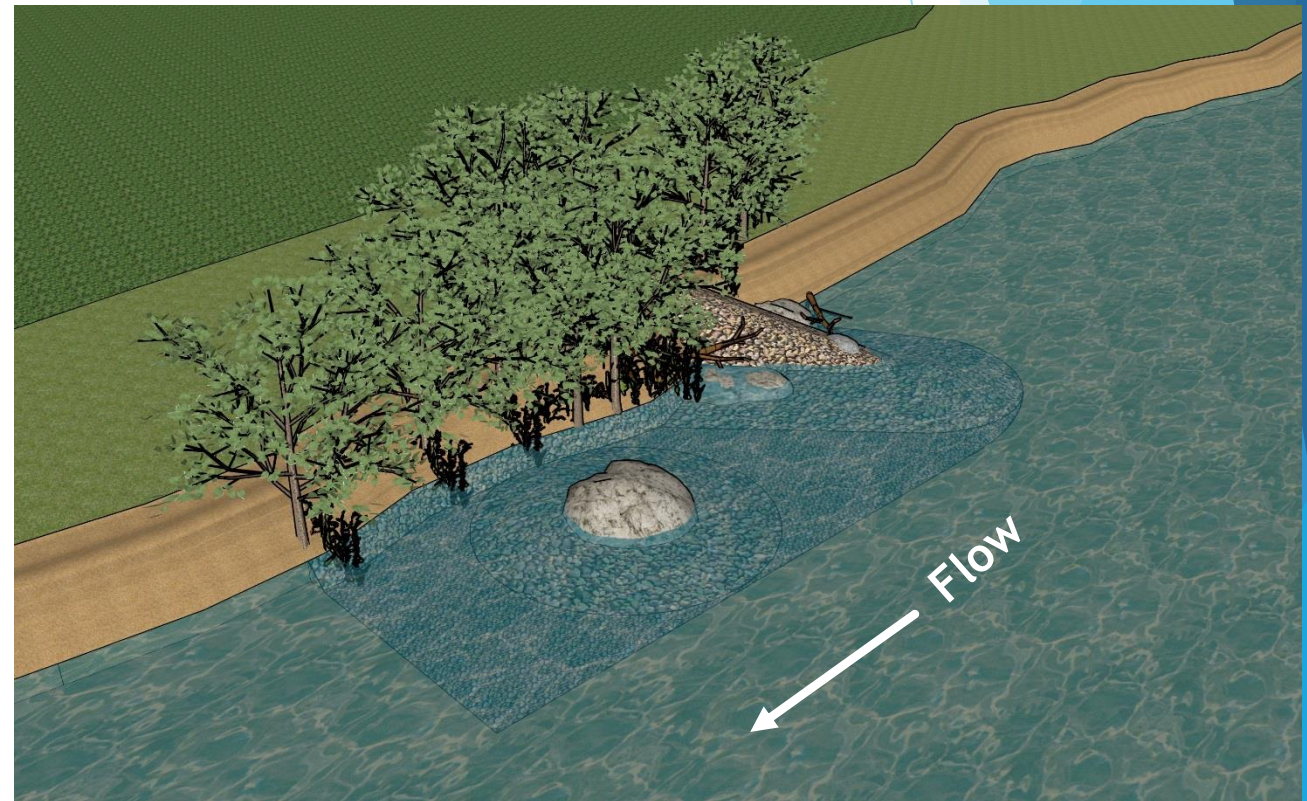
Partially Submerged Groin Design

- ▶ Groin tapered to function in range of water (and substrate) elevations
- ▶ End of groin to split stream into two so it flows past each side of the downstream boulder
- ▶ Visible rocks would be supported by a sub-surface base of rip rap (2 feet deep)
- ▶ Designed for 30 to 2,500 cubic feet per second river flows

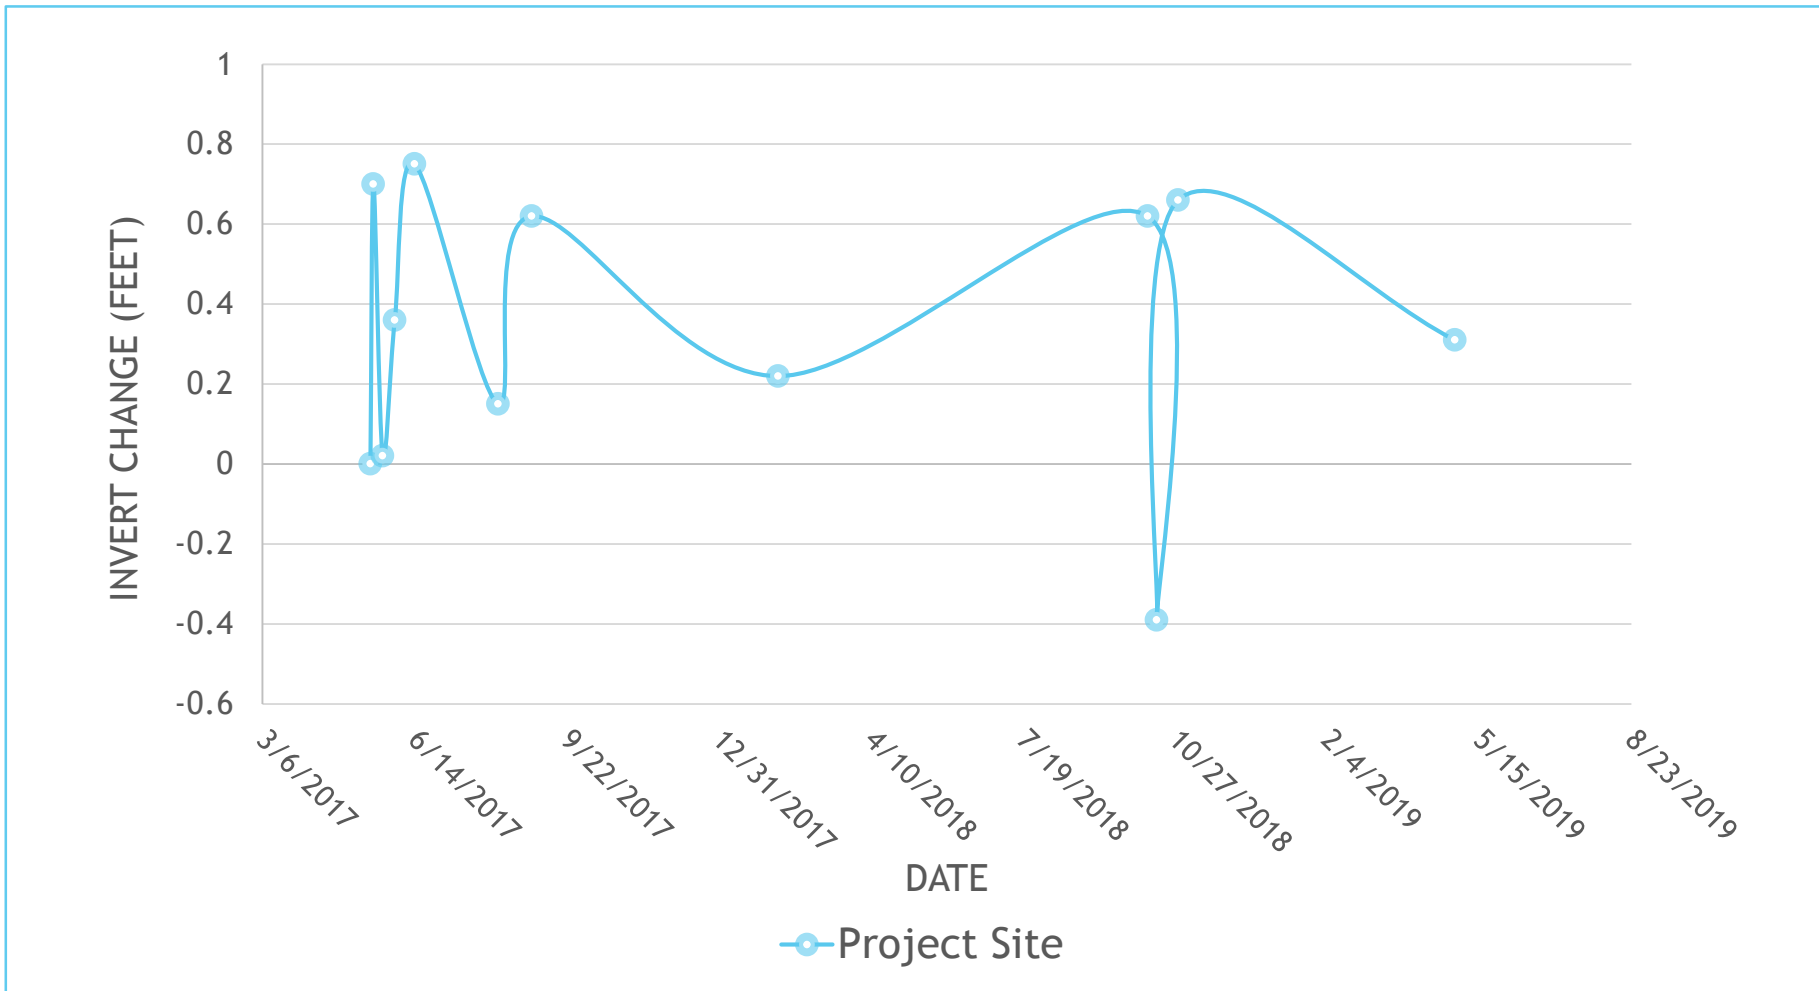
Low-Flow Channel Invert Elevation Change

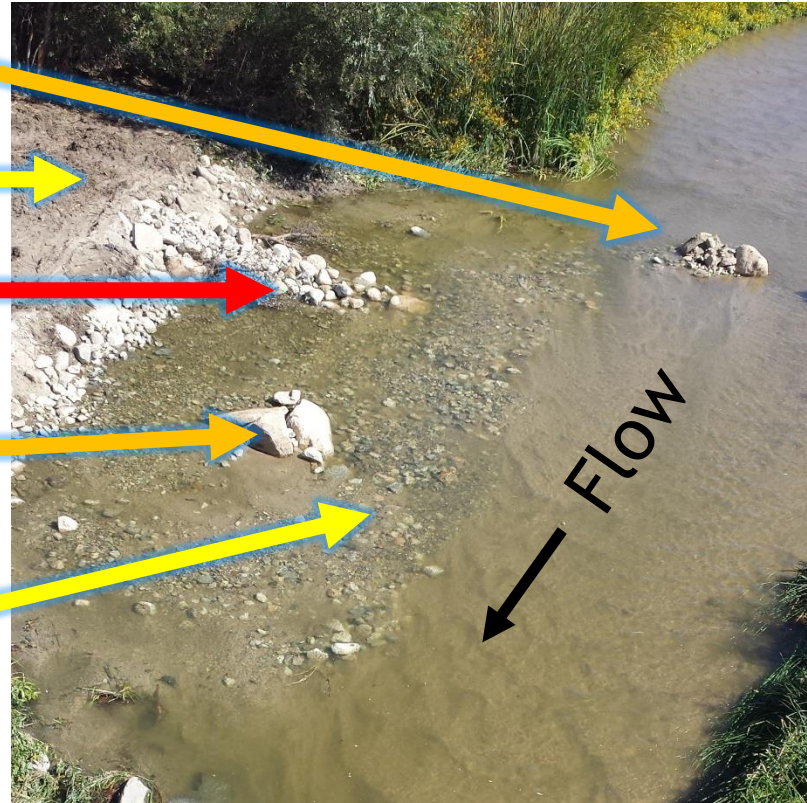
Partially Submerged Groin Post-Construction

- Upstream Boulder Cluster
- Cleared Vegetation
- Groin
- Downstream Boulder Cluster
- Cobble

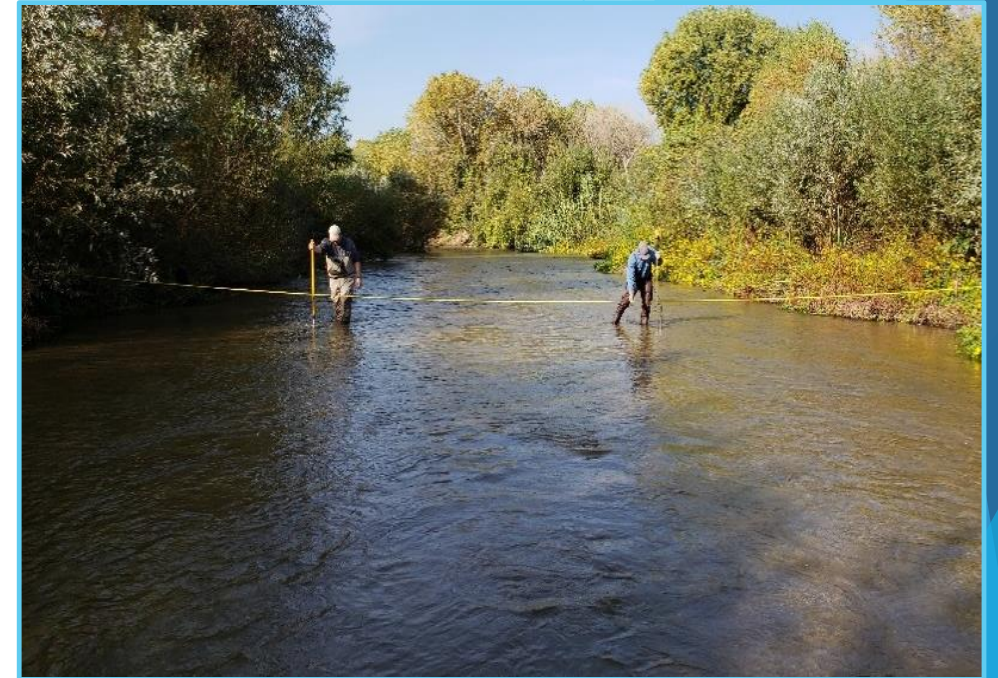
Gaging the Project's Success - Parameters Measured

- ▶ Low-flow channel invert elevation,*
- ▶ Streamflow,*
- ▶ Bedload,*
- ▶ Channel width,*
- ▶ Maximum depth,*
- ▶ Depth at banks,*
- ▶ River substrate composition,**
- ▶ Riparian vegetation canopy cover over the transect,**
- ▶ Dissolved oxygen, temperature and water appearance,*
- ▶ Fish count,** and
- ▶ Documentation of gravel/sand bars.**

Those parameters marked with * were measured along a transect line drawn from bank to bank in the low flow channel. Those marked with ** were measured within a transect band with a longitudinal length that was 50 feet upstream and 50 feet downstream of the transect line.

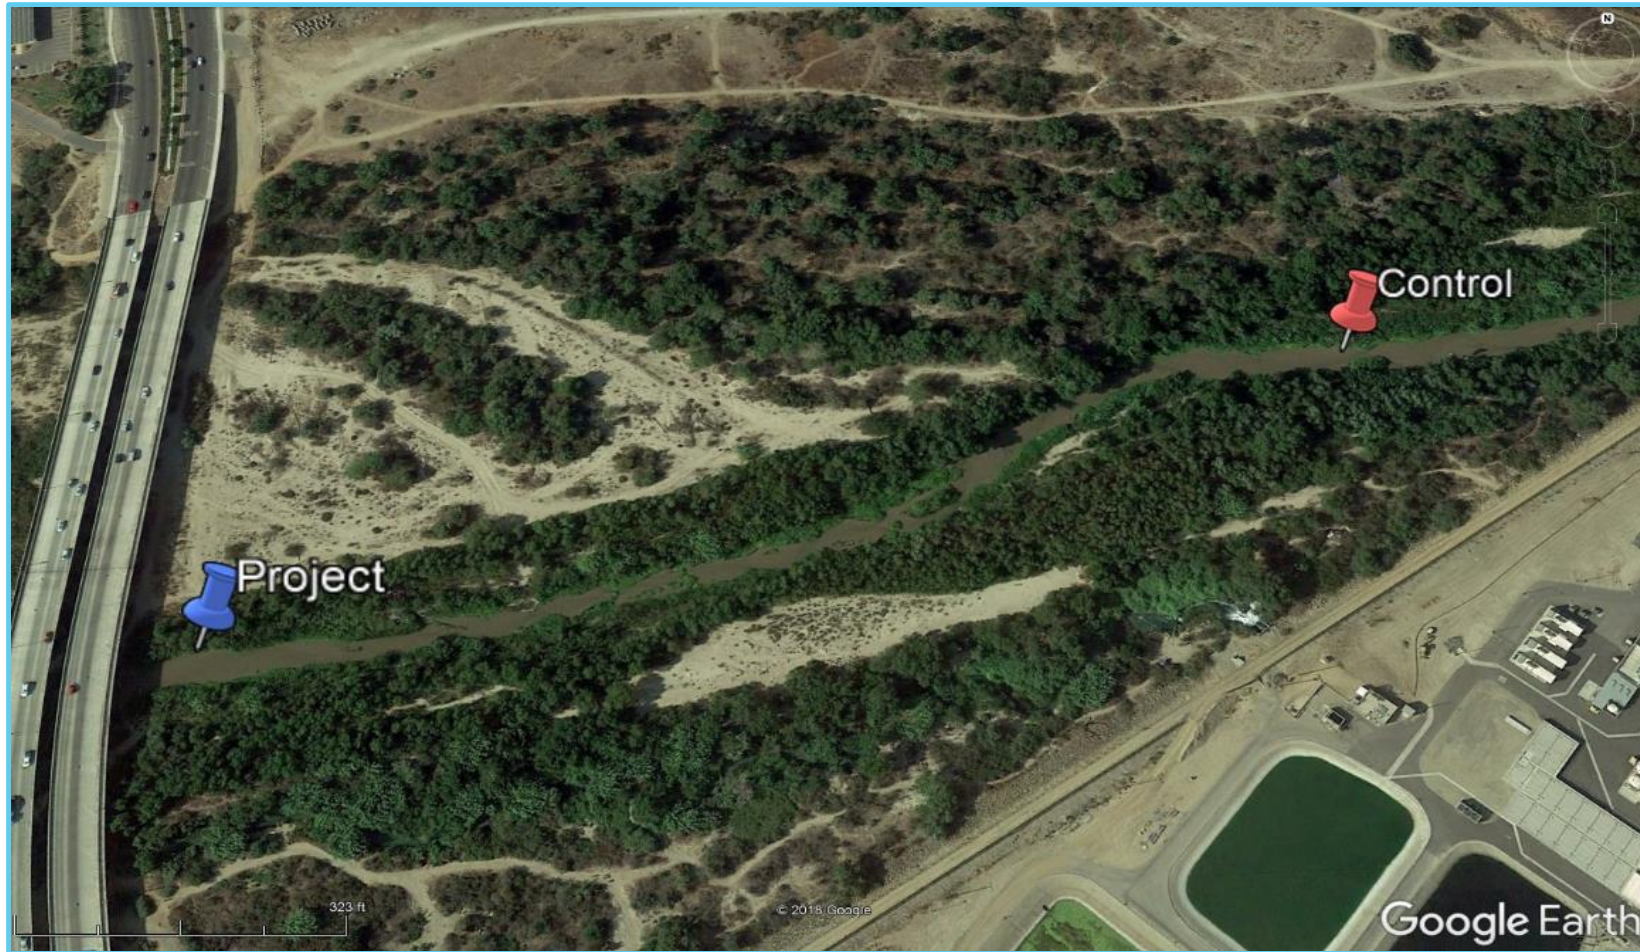
Project and Control Site Monitoring

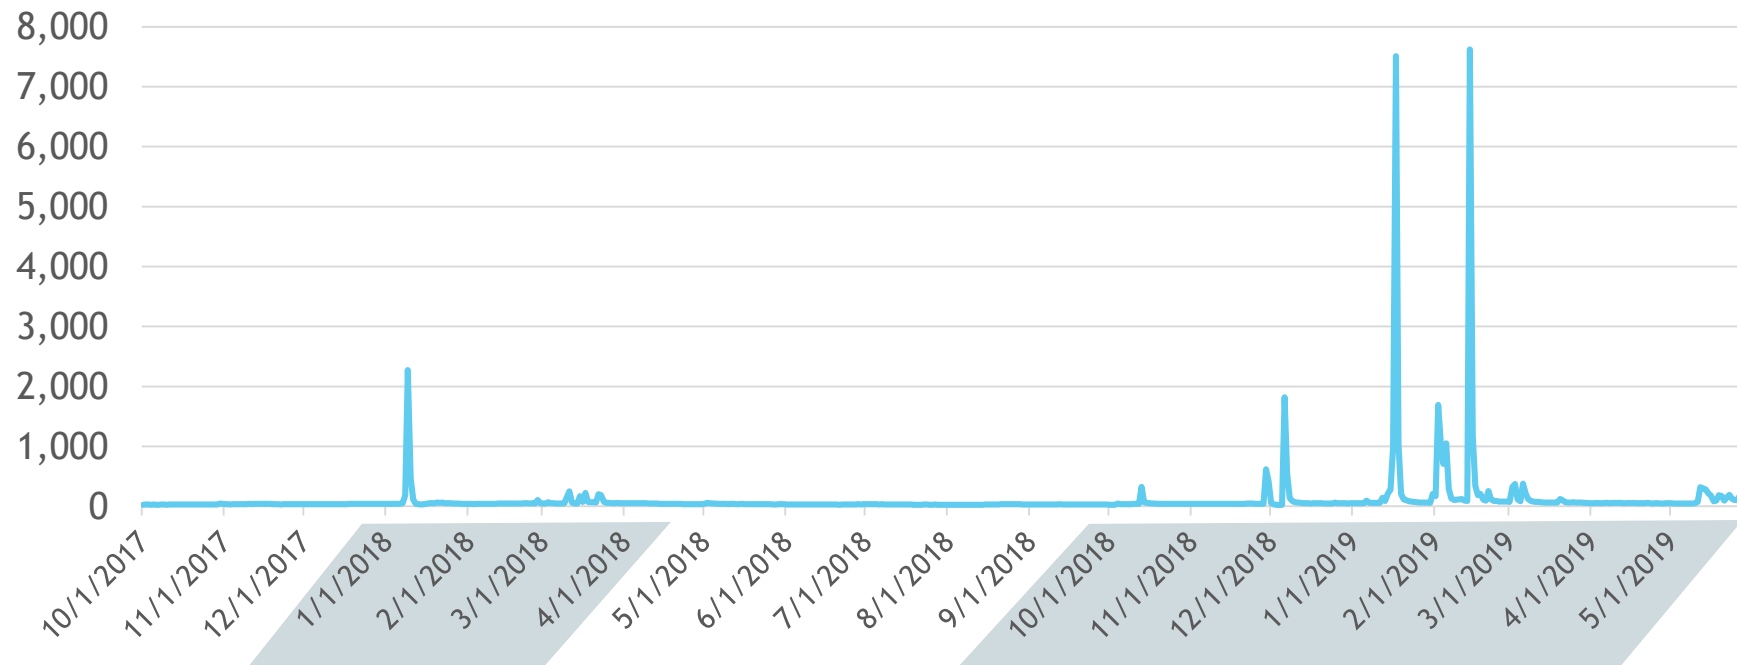
Streamflow (Cubic Feet Per Second - Daily Mean)

Storm season:

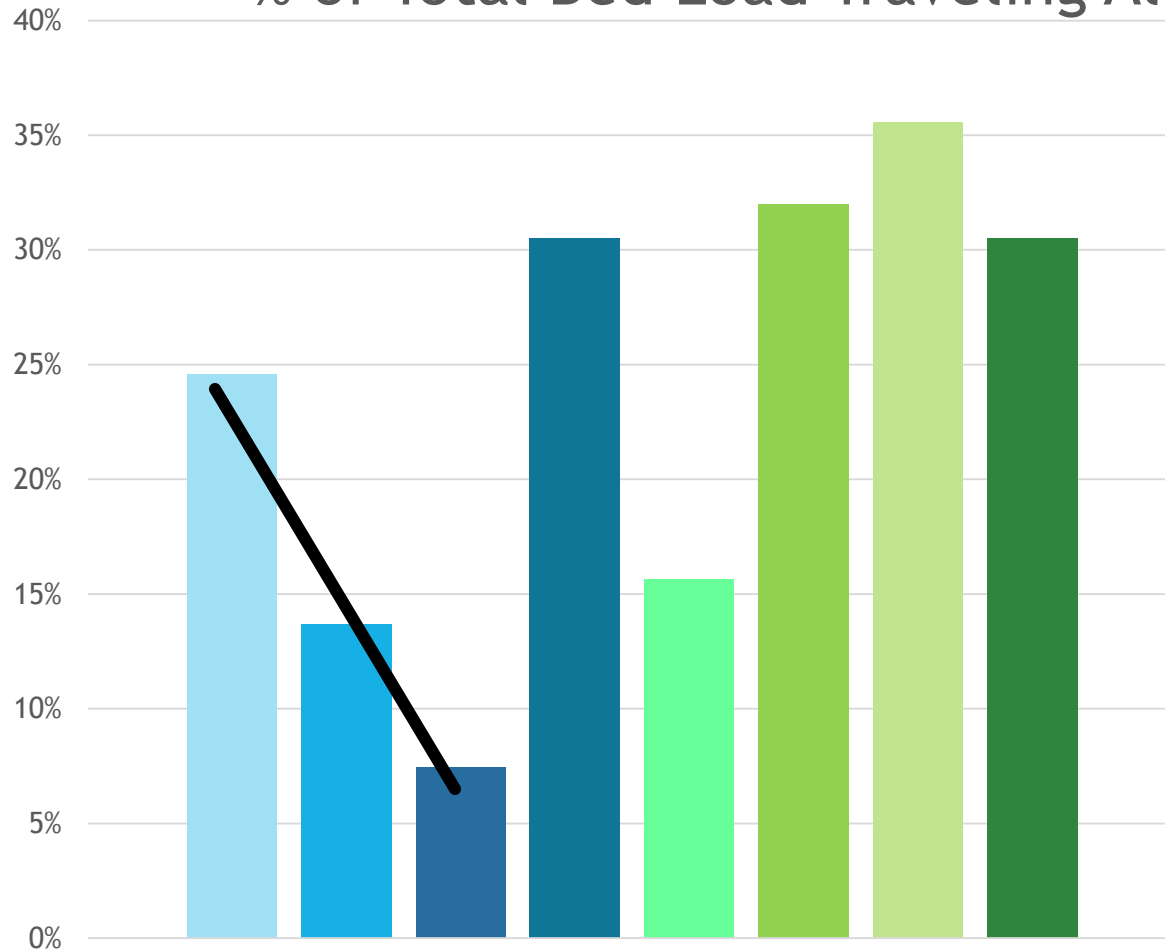
% of Total Bed Load

- Project Site Baseline Right Bank 9/19/2018
- Project Site Post 1 Right Bank 10/29/2018
- Project Site Post 2 Right Bank 12/21/2018
- Project Site Post 3 Right Bank 4/29/2019
- Control Site Baseline Right Bank 9/21/2018
- Control Site Post 1 Right Bank 10/29/2018
- Control Site Post 2 Right Bank 12/21/2018
- Control Site Post 3 Right Bank 4/29/2019

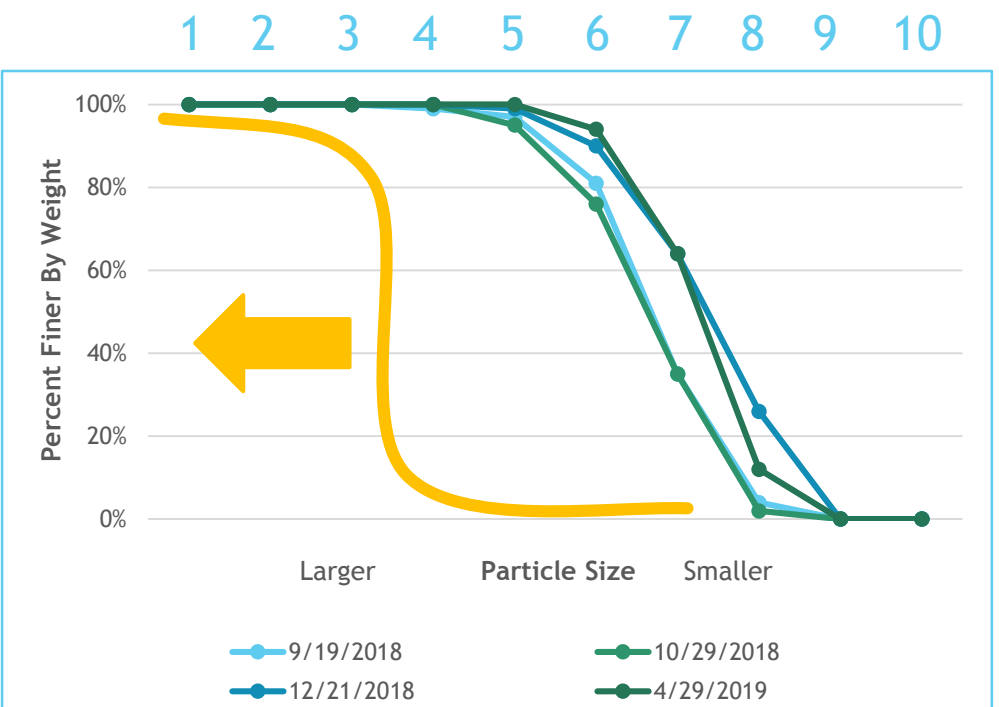
Bed Load Particle Size at Right Bank

Note: Project Installed: 10/15/2018

Gradation 5: Coarse Sand (2.36 mm or No.8); **Gradation 6:** Medium Sand (1.18 mm or No.16); **Gradation 7:** Medium Sand (0.6 mm or No.30); **Gradation 8:** Fine Sand (0.3 mm or No.50)

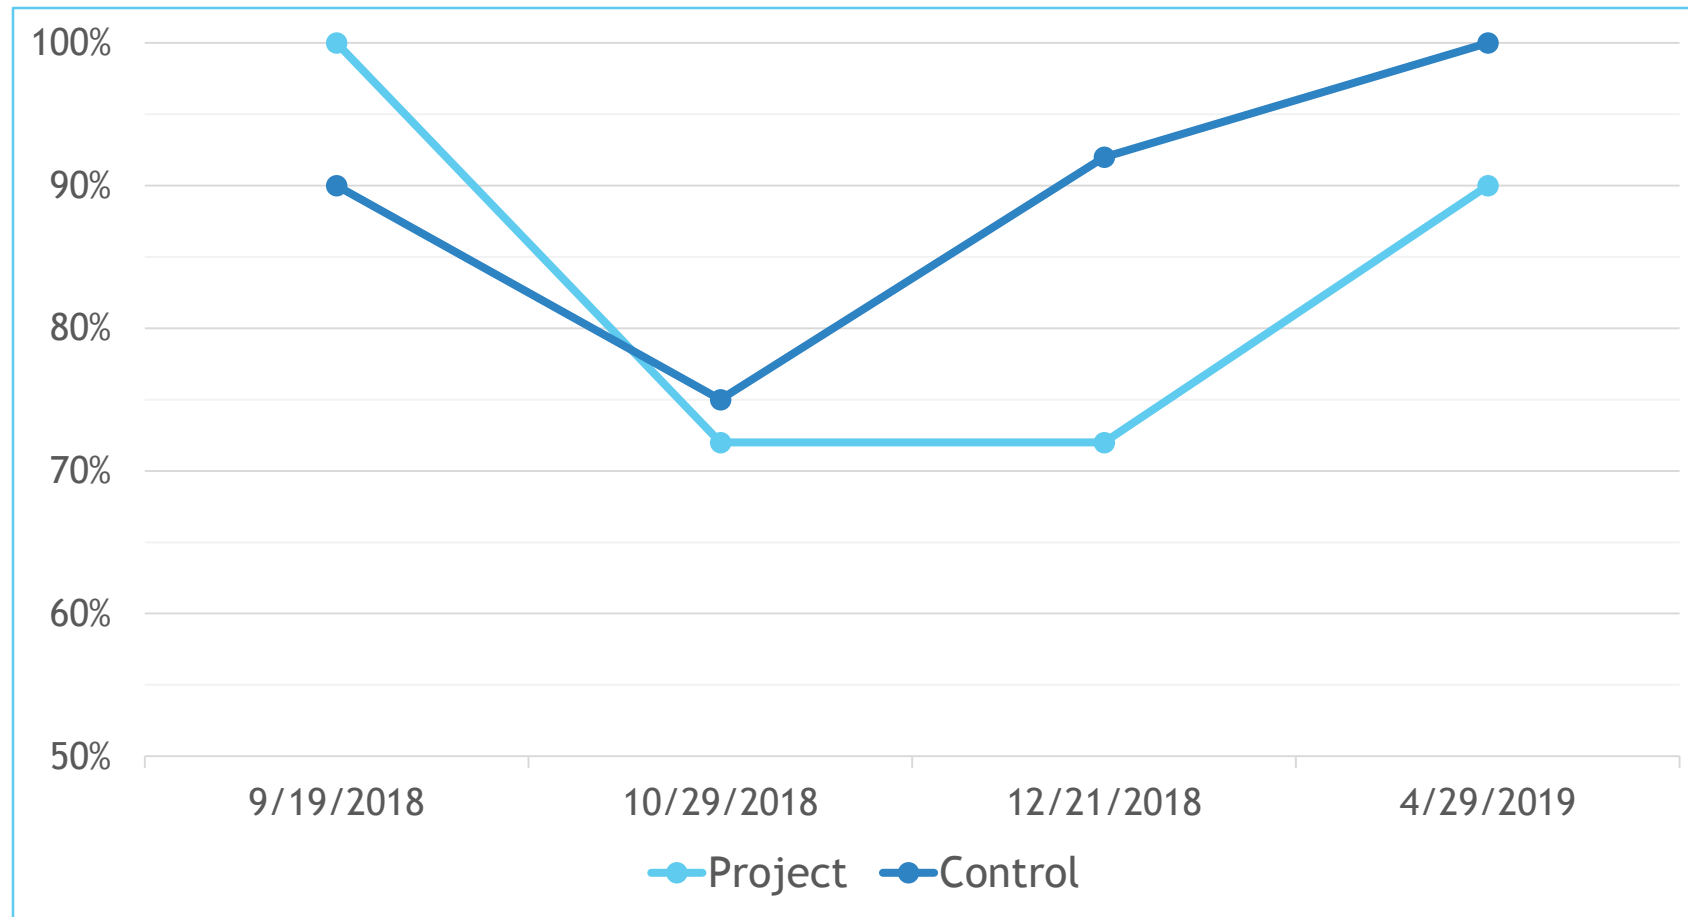
Substrate Data - Percent Sand

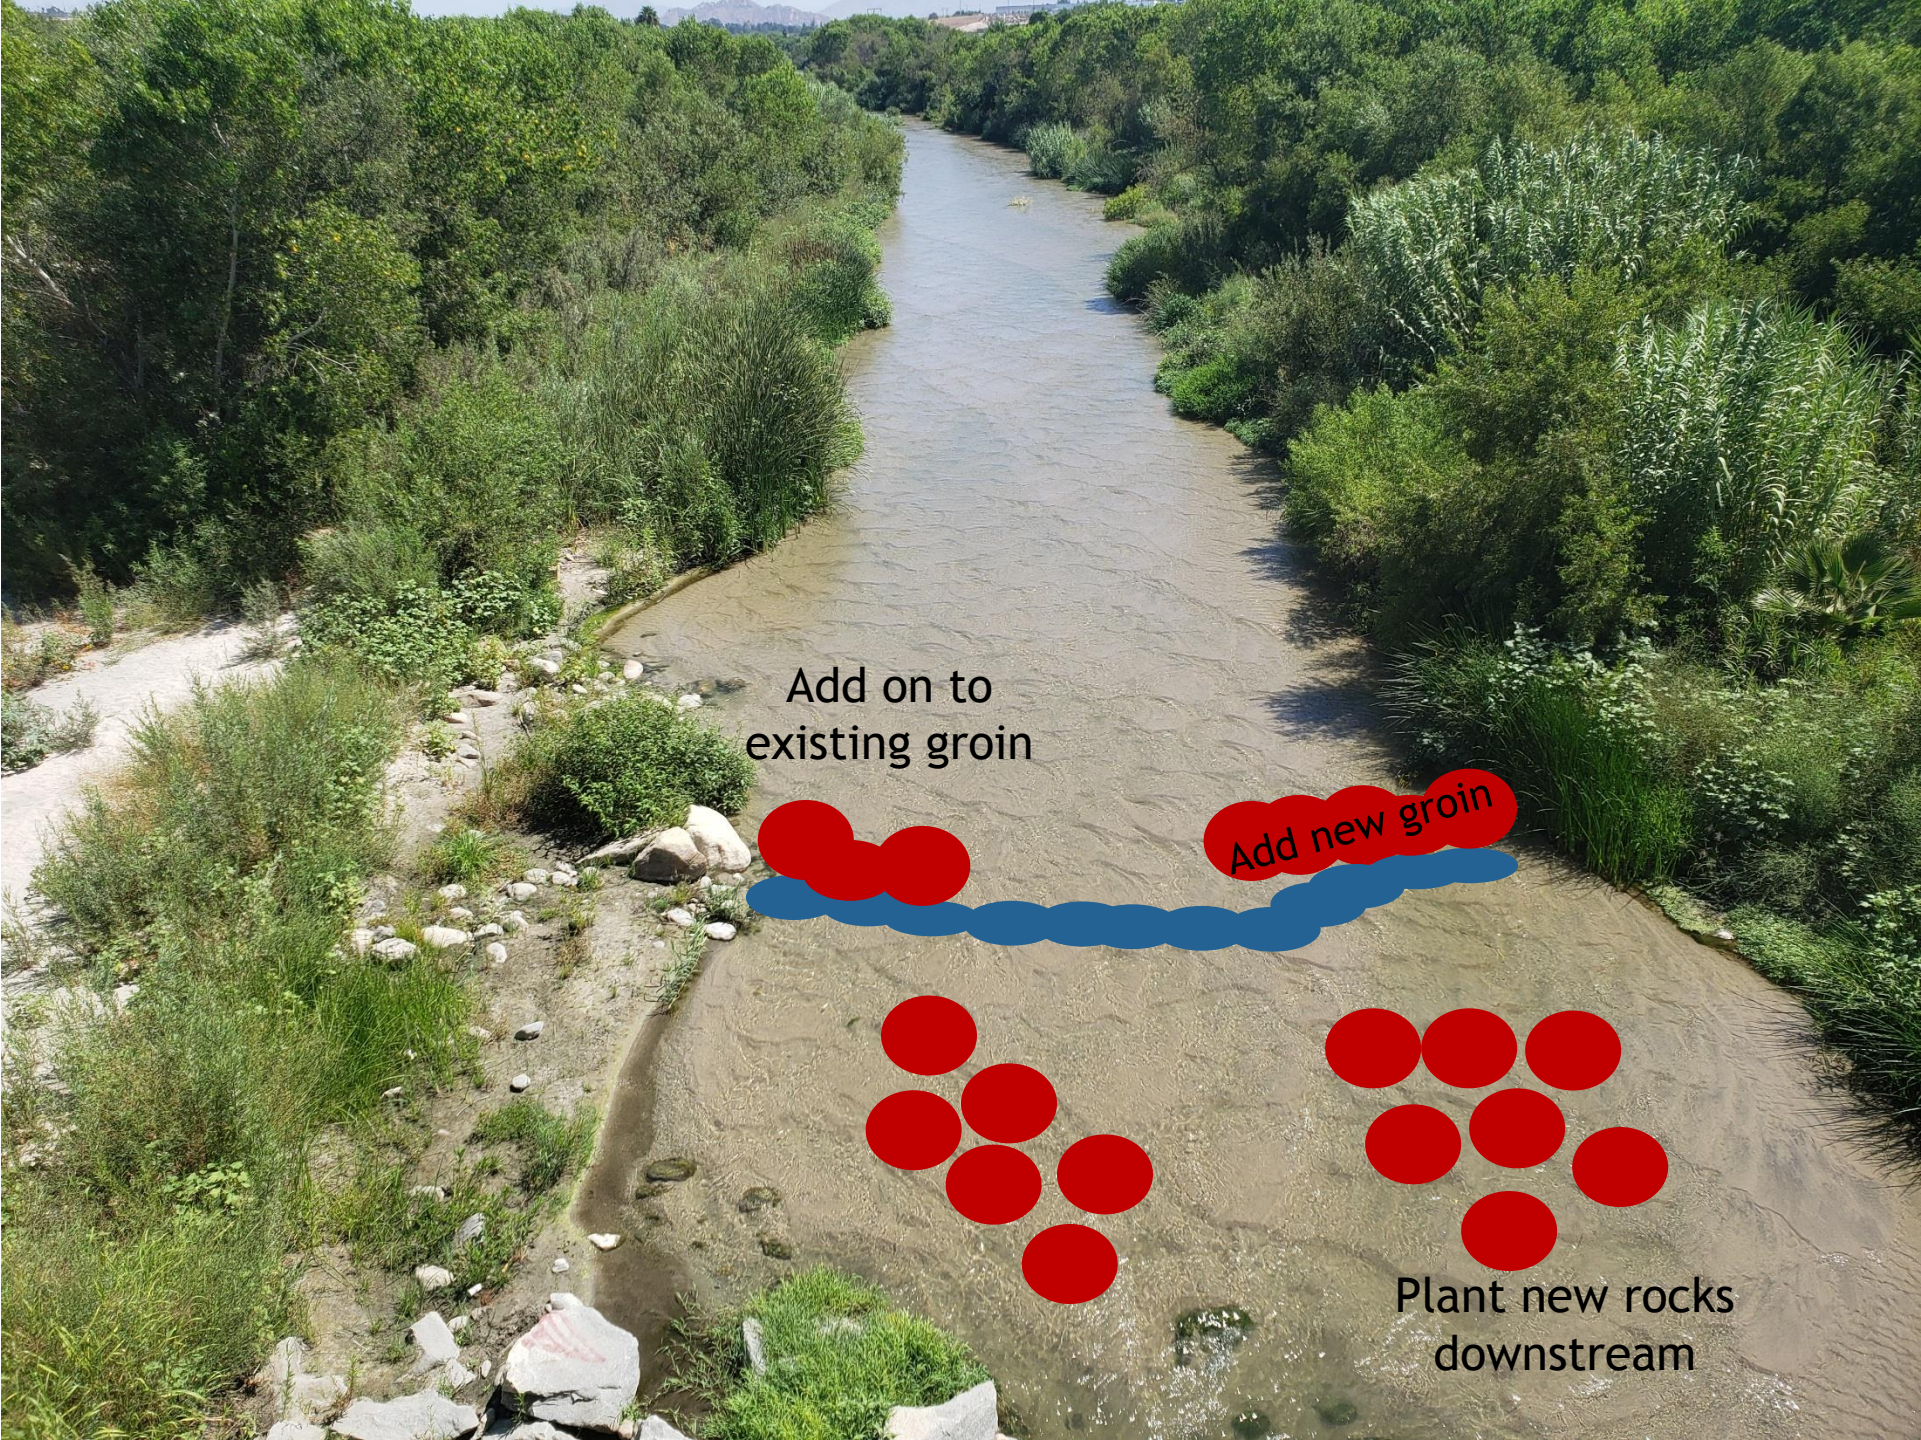
Add on to existing groin

Add new groin

Plant new rocks downstream

- ▶ Use existing funds to remove sandbars, extend groin by hand, and remove vegetation affecting the structure.
- ▶ Maintain the re-planted vegetation in the Project area to mitigate for the 0.3 acres of riparian vegetation that was cleared.
- ▶ Investigate the placement of an additional groin and downstream boulders (2' to 3')
