# **Draft**Riverwalk Atlas

A map-based summary of Santa Ana River habitat surveys conducted annually from 2006-2023.

Provided by the Santa Ana Sucker Conservation Team

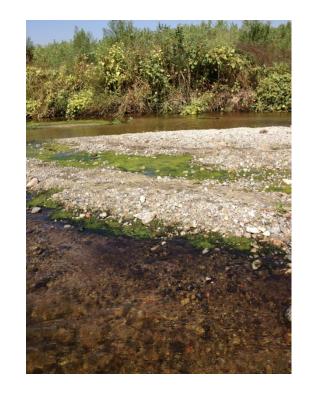
For information sharing purposes, the quality of the river bottom (substrate) is generalized in this Atlas in the following categories:

Riverwalk Rating	Formula for Rating	Rating Threshold
Poor		≤30%
Marginal	Sum of gravel, cobble and boulder	>30% to <65%
Good		≥65%

For example, if the sum of gravel, cobble and boulder is 29% of the total substrate (and the remaining 71% is sand, and/or mud) the Riverwalk transect will receive a poor rating.

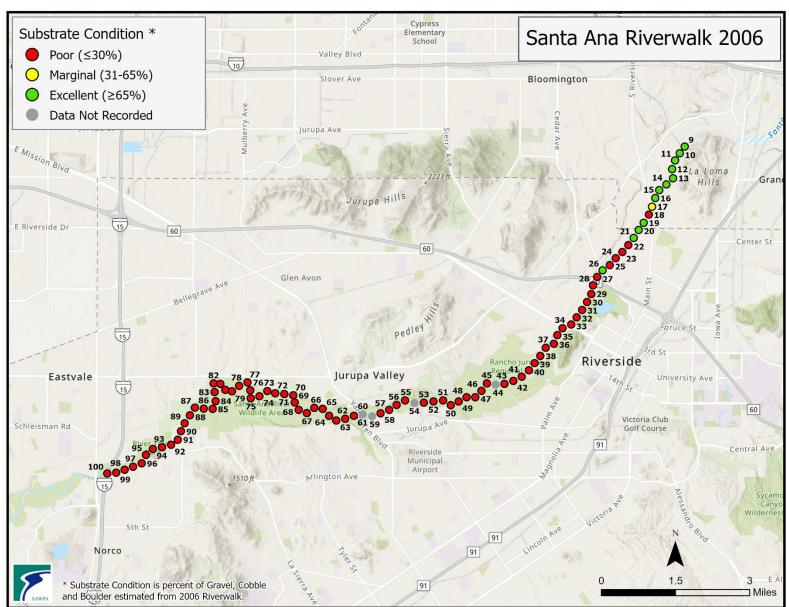
P:\Projects\lan\Riverwalk\_2006-2010Update\RiverwalkUpdate.aprx LoRiverwalk2006 SW-3290

Poor Average (2006 to 2023)	81
Poor	78
<mark>Marginal</mark>	1
Good	12
Total Transects This Year	91

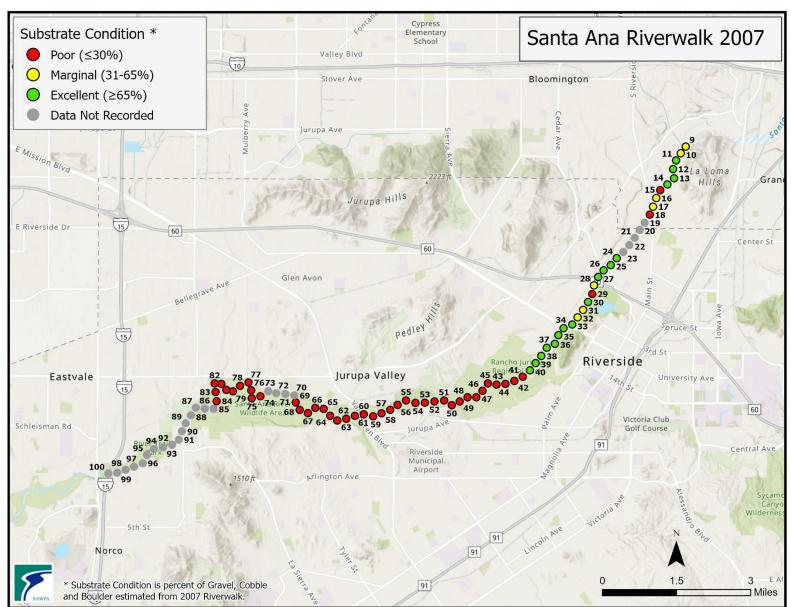
P:\Projects\lan\Riverwalk\_2006-2010Update\RiverwalkUpdate.aprx LoRiverwalk2007 SW-3291

Poor Average (2006 to 2023)	81
<mark>Poor</mark>	43
<b>Marginal</b>	7
Good	17
Total Transects This Year	67

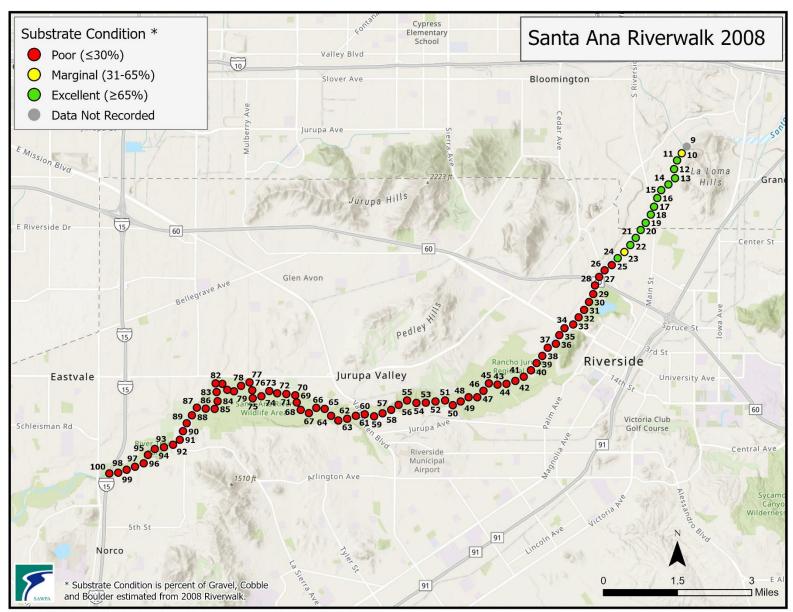
Poor Average (2006 to 2023)	81
Poor	76
<b>Marginal</b>	2
Good	13
Total Transects This Year	91

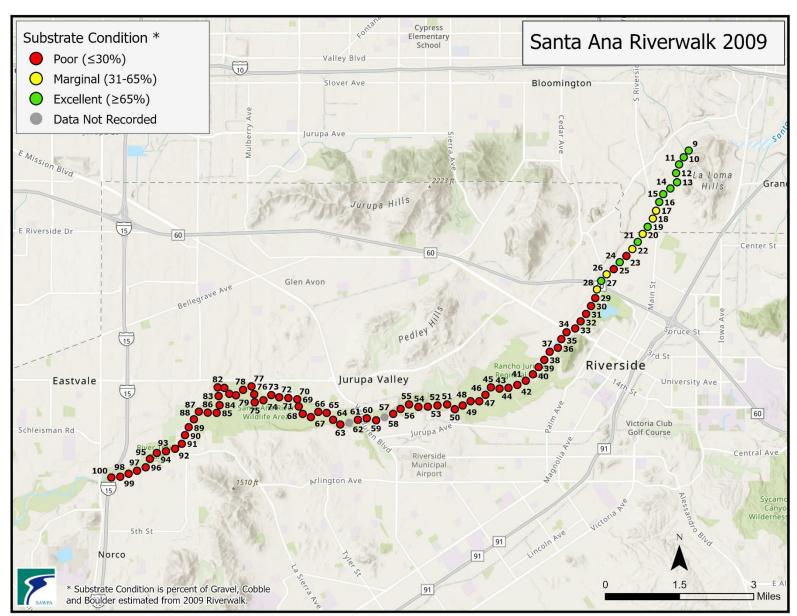
Poor Average (2006 to 2023)	81
Poor	74
<b>Marginal</b>	6
Good	12
Total Transects This Year	92

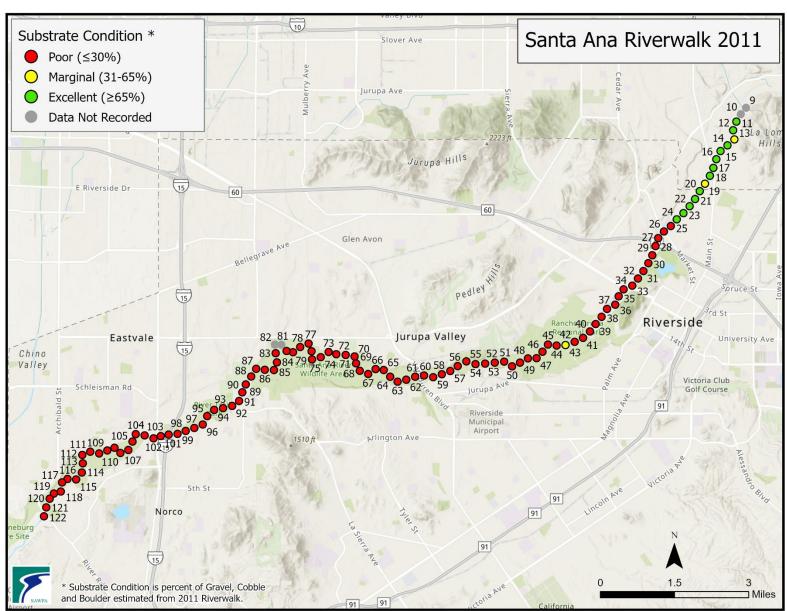
Poor Average (2006 to 2023)	81
<mark>Poor</mark>	96
<b>Marginal</b>	3
Good	12
Total Transects This Year	111

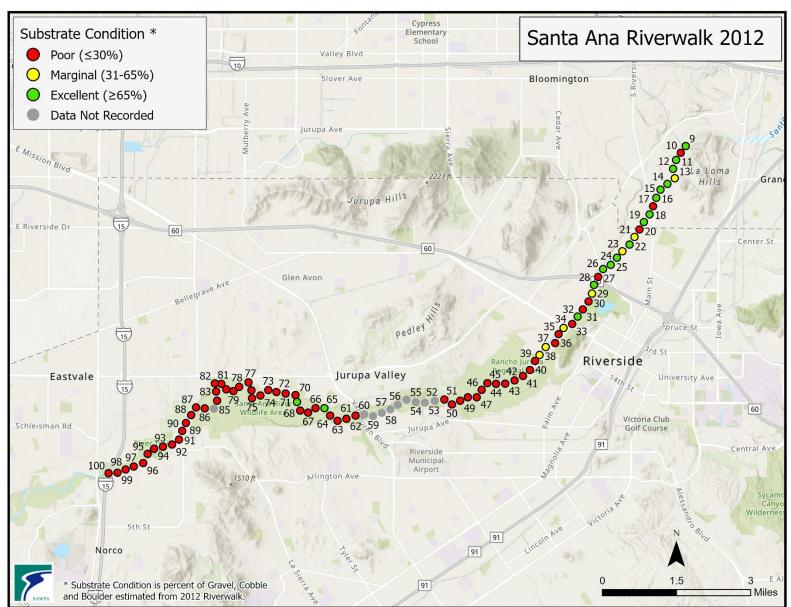
P:\Projects\lan\Riverwalk\_2011\_2019Update\RiverwalkUpdate\RiverwalkUpdate.aprx LoRiverwalk2012 SW-3298

Poor Average (2006 to 2023)	81
<mark>Poor</mark>	59
Marginal Marginal	7
Good	16
Total Transects This Year	82

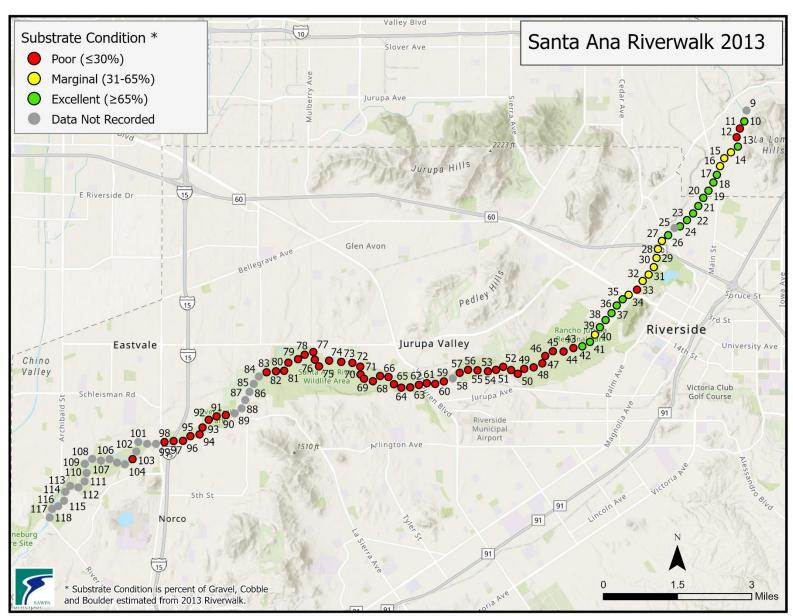
Poor Average (2006 to 2023)	81
<mark>Poor</mark>	79
<b>Marginal</b>	11
Good	18
Total Transects This Year	108

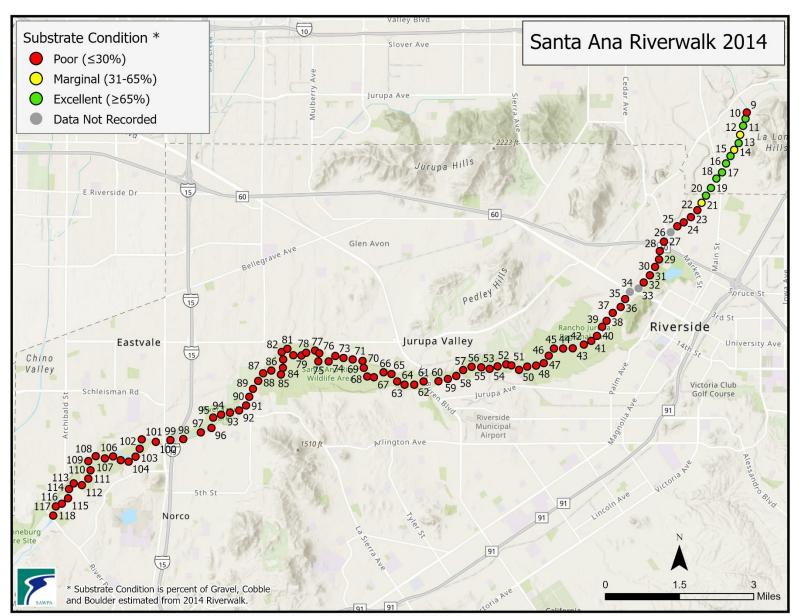
Poor Average (2006 to 2023)	81
Poor	98
<mark>Marginal</mark>	3
Good	9
Total Transects This Year	110

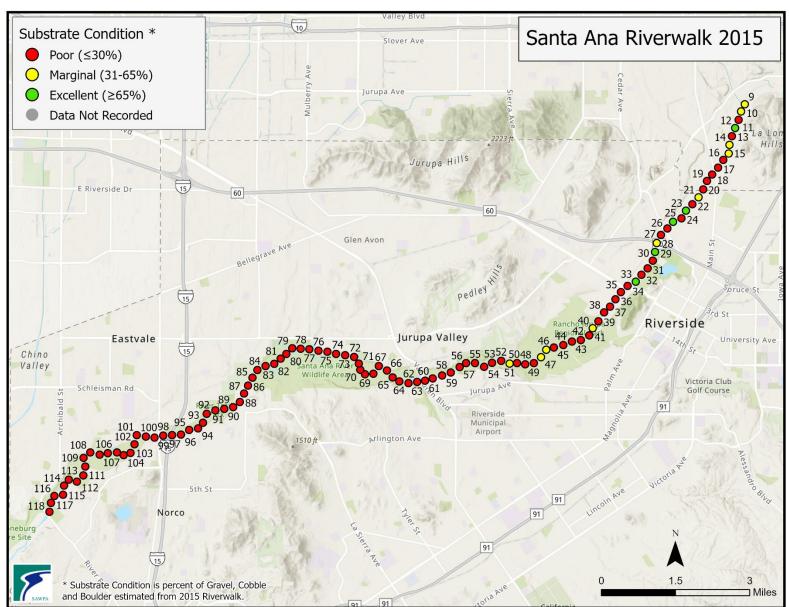
Poor Average (2006 to 2023)	81
<mark>Poor</mark>	95
<b>Marginal</b>	10
Good	5
Total Transects This Year	110

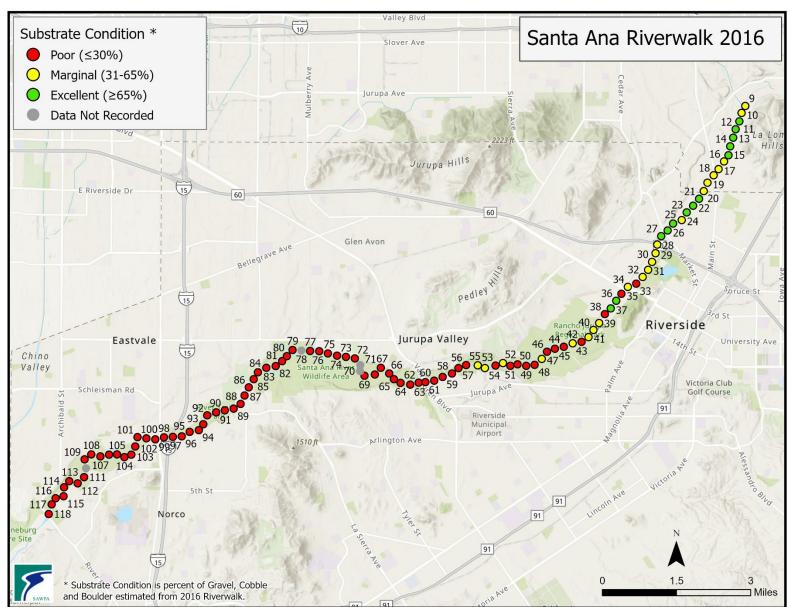
P:\Projects\lan\Riverwalk\_2011\_2019Update\RiverwalkUpdate\RiverwalkUpdate.aprx LoRiverwalk2016 SW-3302

Poor Average (2006 to 2023)	81
Poor	75
<b>Marginal</b>	22
Good	13
Total Transects This Year	110

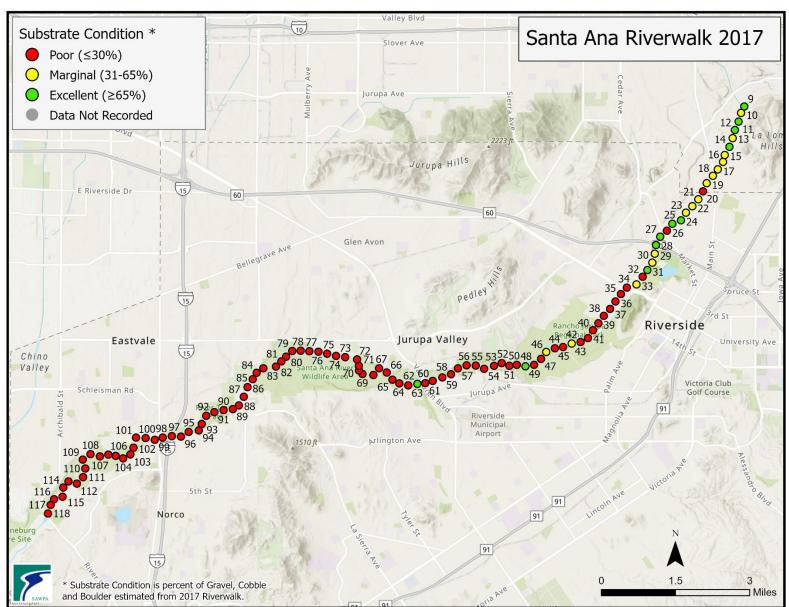
P:\Projects\lan\Riverwalk\_2011\_2019Update\RiverwalkUpdate\RiverwalkUpdate.aprx LoRiverwalk2017 SW-3303

Poor Average (2006 to 2023)	81
<mark>Poor</mark>	84
<b>Marginal</b>	15
Good	11
Total Transects This Year	110

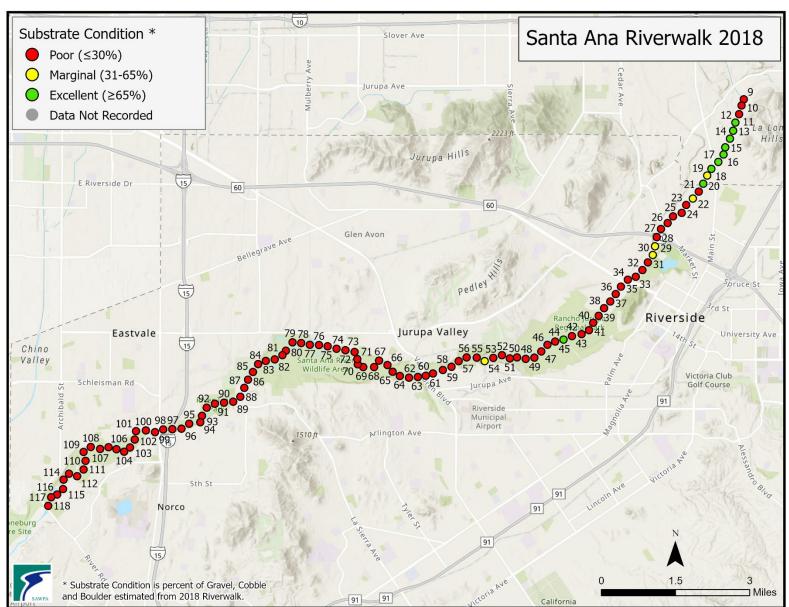
P:\Projects\lan\Riverwalk\_2011\_2019Update\RiverwalkUpdate\RiverwalkUpdate.aprx LoRiverwalk2018 SW-3304

Poor Average (2006 to 2023)	81
Poor	97
Marginal Marginal	5
Good	9
Total Transects This Year	111

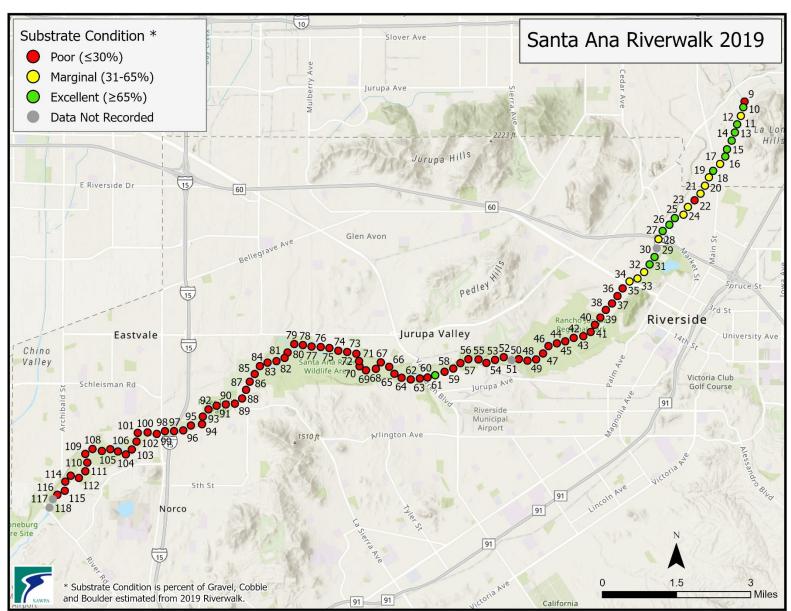
P:\Projects\lan\Riverwalk\_2011\_2019Update\RiverwalkUpdate\RiverwalkUpdate.aprx LoRiverwalk2019 SW-3305

Poor Average (2006 to 2023)	81
Poor	81
Marginal Marginal	12
Good	13
Total Transects This Year	106

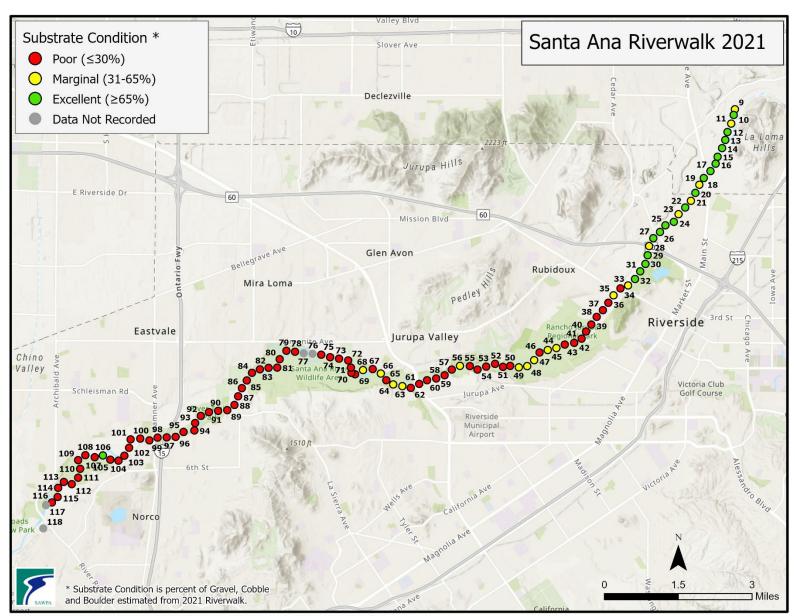
P:\projects\lan\RiverWalk2021\Riverwalk2021Map\Riverwalk2021Map.aprx LoRiverwalk2021 SW-3109

Poor Average (2006 to 2023)	81
Poor	69
<b>Marginal</b>	18
Good	19
Total Transects This Year	106

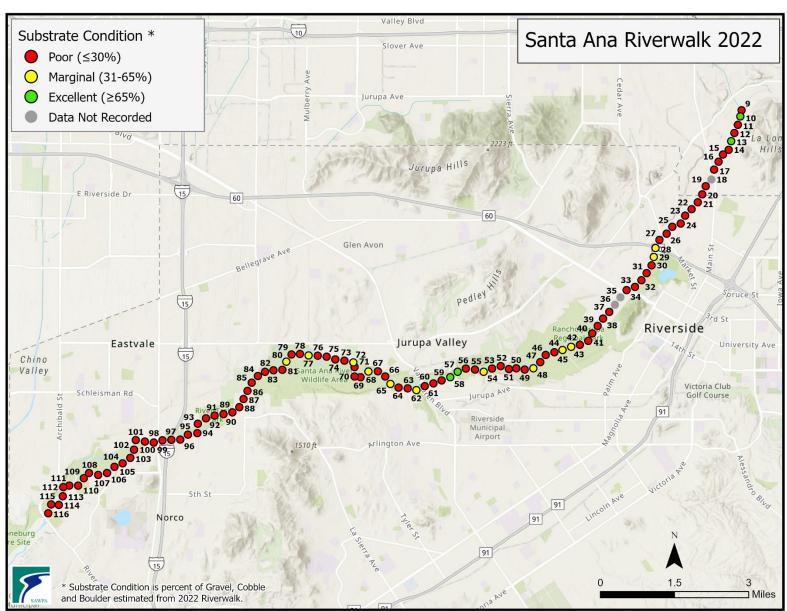
P:\Projects\lan\Riverwalk2022\Riverwalk2022Map\Riverwalk2022Map.aprx Layout SW-3295

Poor Average (2006 to 2023)	81
Poor	89
<mark>Marginal</mark>	12
Good	4
Total Transects This Year	105

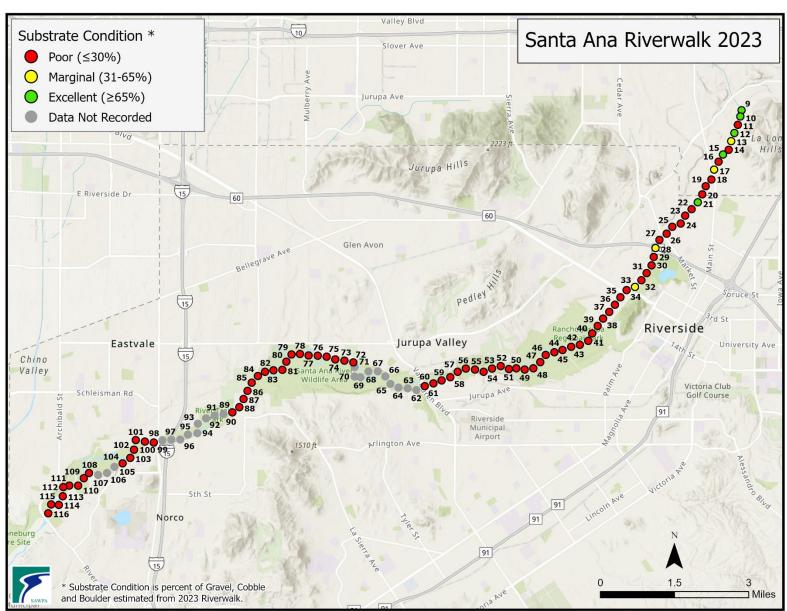
P:\Projects\lan\Riverwalk2023\Riverwalk2023Map\Riverwalk2023Map.aprx Layout SW-3296

Poor Average (2006 to 2023)	81
Poor	76
<mark>Marginal</mark>	5
Good	5
Total Transects This Year	86
