SANTA ANA WATERSHED PROJECT AUTHORITY

REGULAR COMMISSION MEETING TUESDAY, OCTOBER 16, 2018 – 9:30 A.M.

A. INLAND EMPIRE BRINE LINE REACH 4D REHABILITATION WORK PLAN (CM#2018.106)..... 19

Reach 4D Manned Entry Condition Assessment

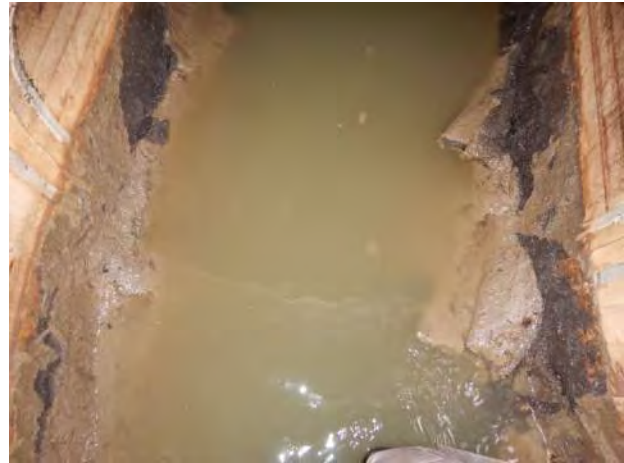
Photo 3-2. Typical slime layer.

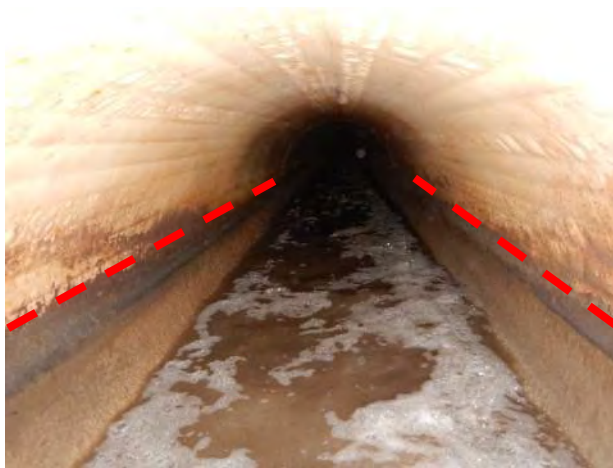
Photo 3-5. Typical water level indicated by slime layer (red dashed line).

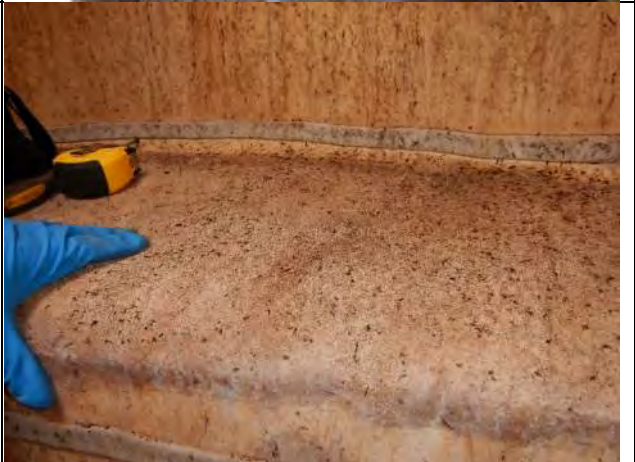
<p>C</p>	<p>Liner was not embedded in bench, yet still covered concrete surface.</p>

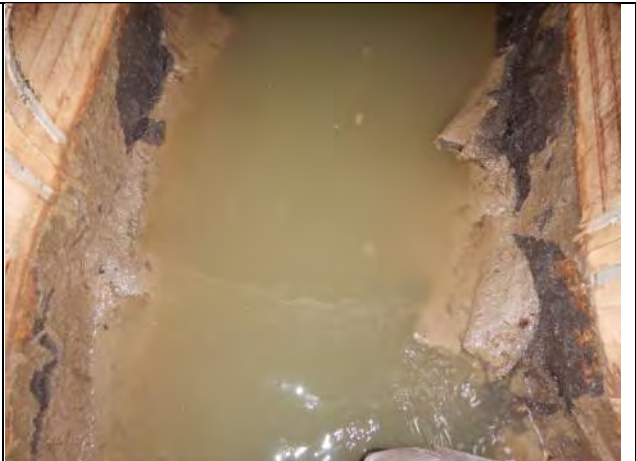
<p>D</p>	<p>Slime layer appeared to be up to the typical waterline.</p>

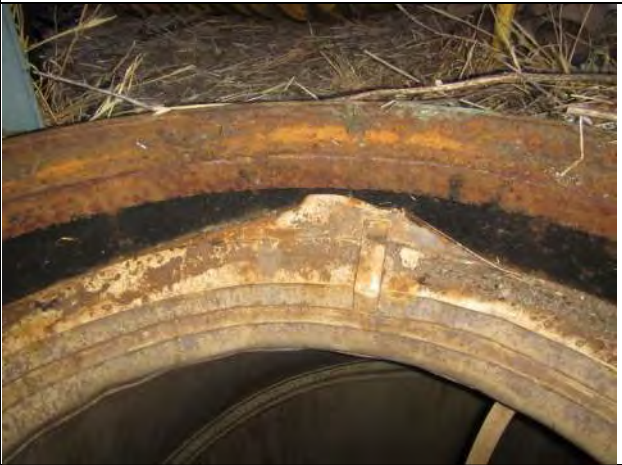
Observations:		
<p>A</p>	<p>Liner termination loose at rim. Minor surface corrosion on rim.</p>

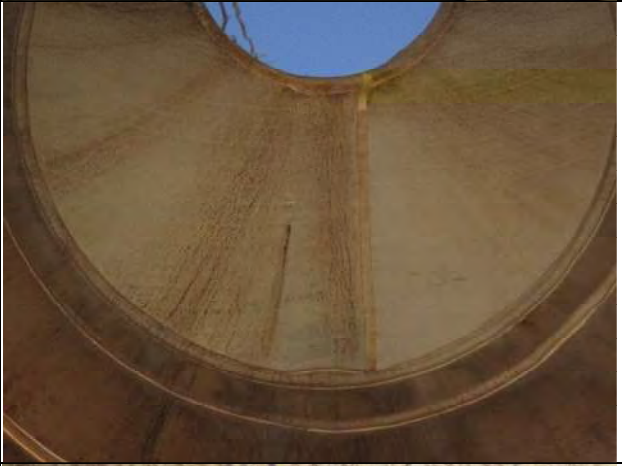
<p>B</p>	<p>Liner weld strips loose at cone.</p>

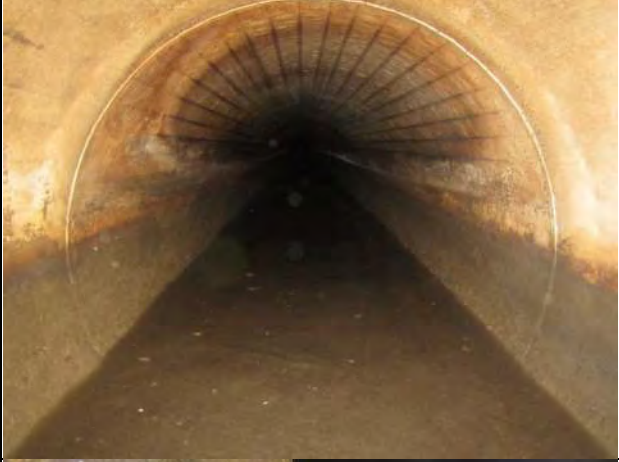
<p>D</p>	<p>Minor liner blisters on effluent pipe. Slime layer appeared to be up to the typical waterline.</p>

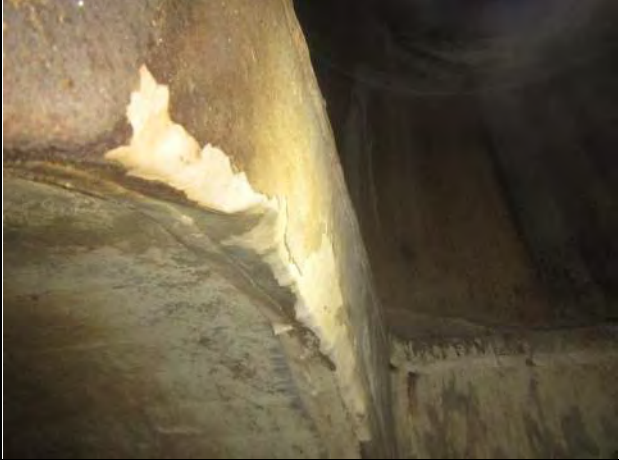
<p>E</p>	<p>Loose weld strips at effluent pipe connection.</p>

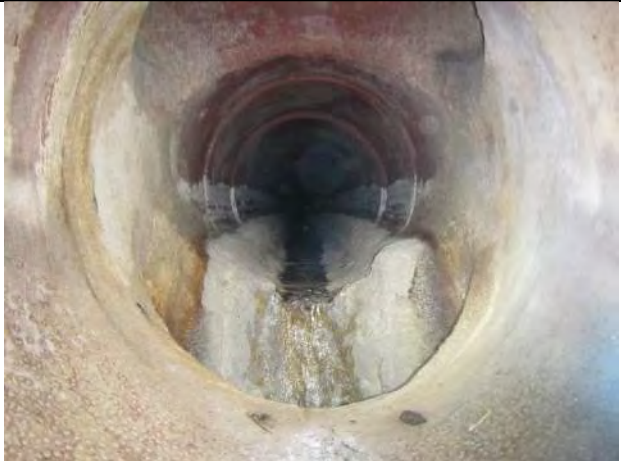
<p>G</p>	<p>Inside top opening of outside drop inlet. Mineral encrustation inside vitrified clay pipe.</p>

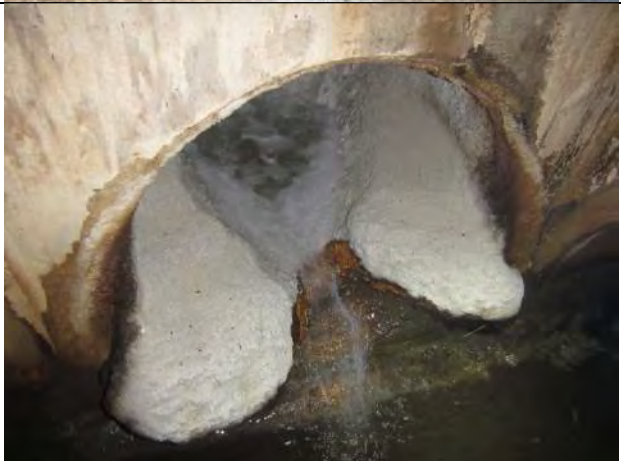
<p>H</p>	<p>Mineral encrustation at bottom opening of outside drop inlet. Liner termination appeared to be in good condition.</p>

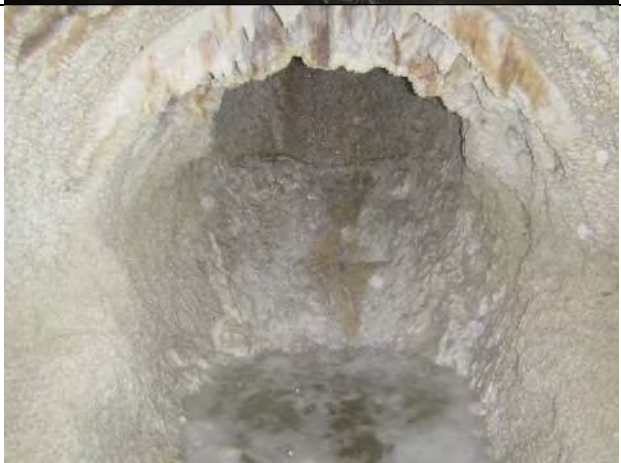
<p>I</p>	<p>Mineral encrustation inside bottom opening of outside drop inlet.</p>

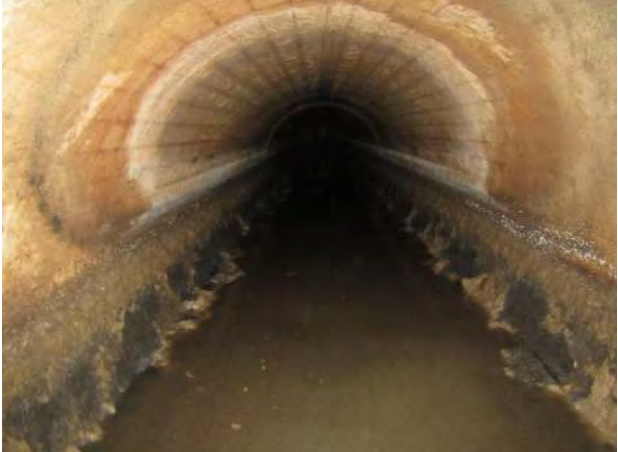
<p>J</p>	<p>Influent pipe had minor liner blisters. Slime layer appeared to be up to the typical waterline.</p>

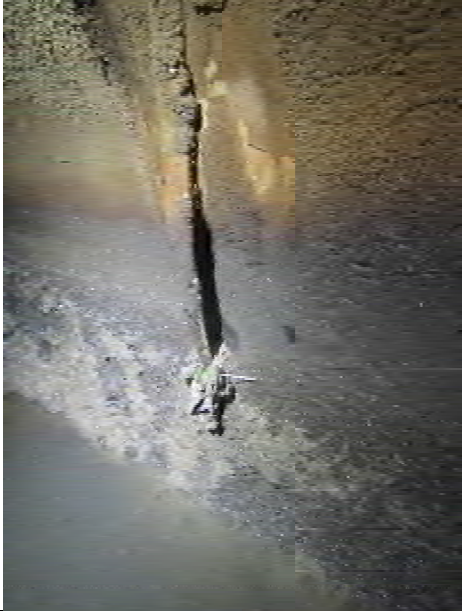
<p>K</p>	<p>Liner weld strip loose near influent pipe connection.</p>

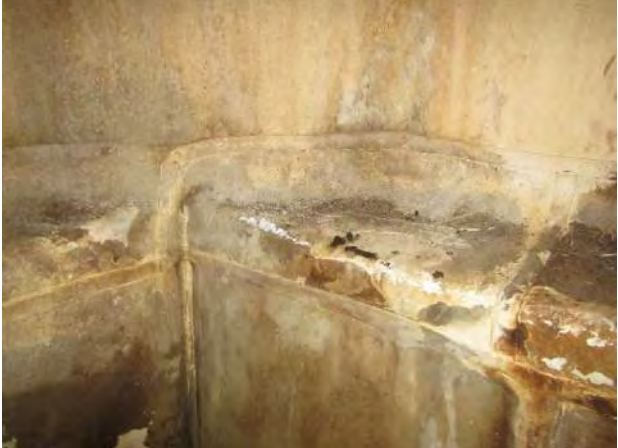
<p>L</p>	<p>Liner was not embedded in bench, yet still covered concrete surface. Unknown if a PVC sheet was originally installed with embedded tees or only with an adhesive.</p>

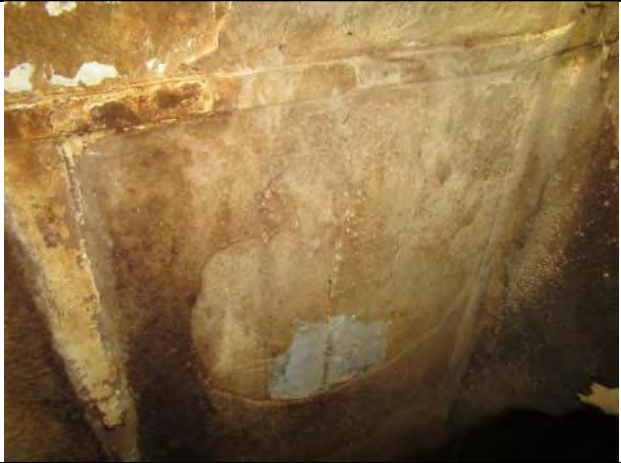
M	Encrustation on liner surface.

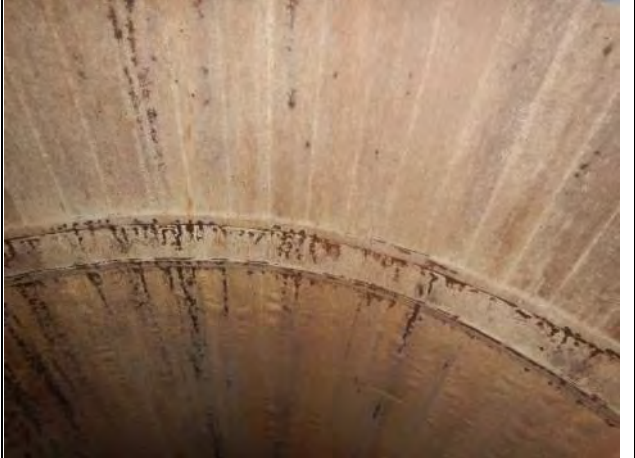
C	Wall liner had minor blisters. Weld strips were in good condition.

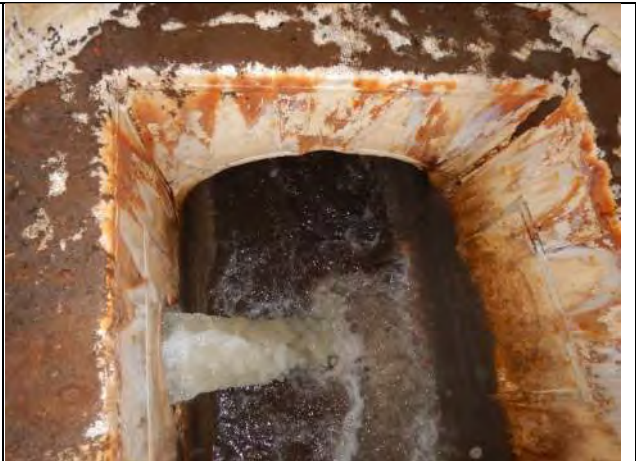
<p>D</p>	<p>Liner was not embedded in bench, yet still covered concrete surface.</p>

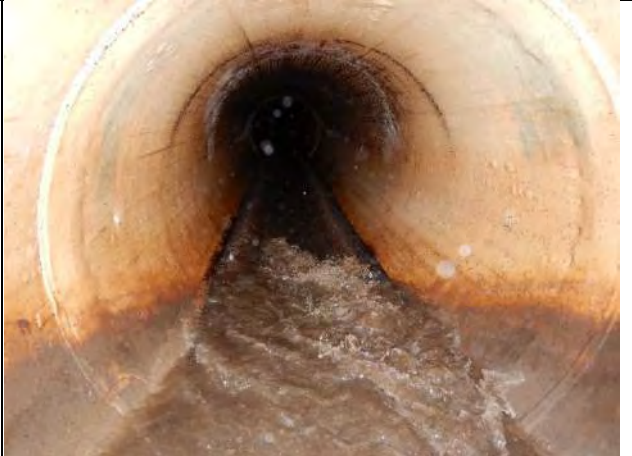
<p>H</p>	<p>Influent pipe liner had minor blisters. Weld strips were in good condition. The liner termination was undermined and unattached. Significant slope noticed in upstream pipe segments.</p>

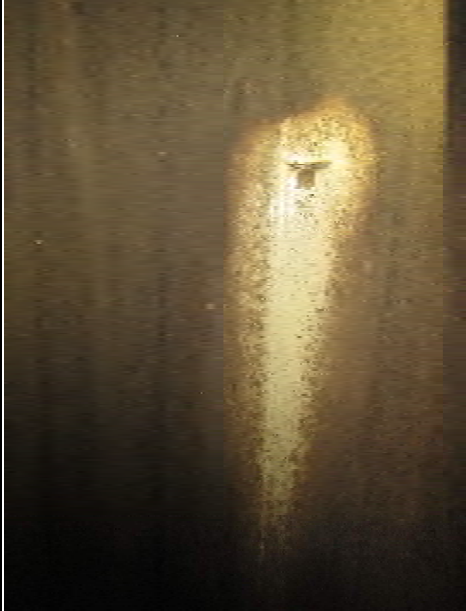
<p>A photograph showing a close-up of a hole in a pipe liner. The hole is roughly circular and appears to be about 3 inches wide. The surrounding pipe material is a light brownish-tan color. A bright light source is visible, creating a strong glare and illuminating the hole.</p>
<p>B</p>	<p>Bulges between T-Lock ribs for manhole wall. Liner ribs appeared to be still attached.</p>

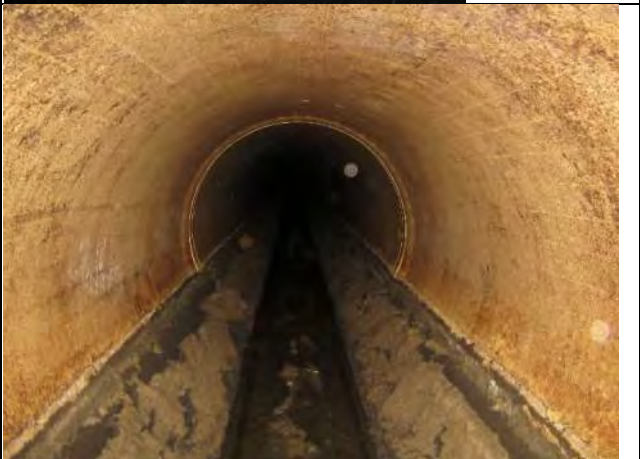
<p>D</p>	<p>Cut in liner at effluent pipe crown. Cuts appeared to be from a CCTV camera cable.</p>

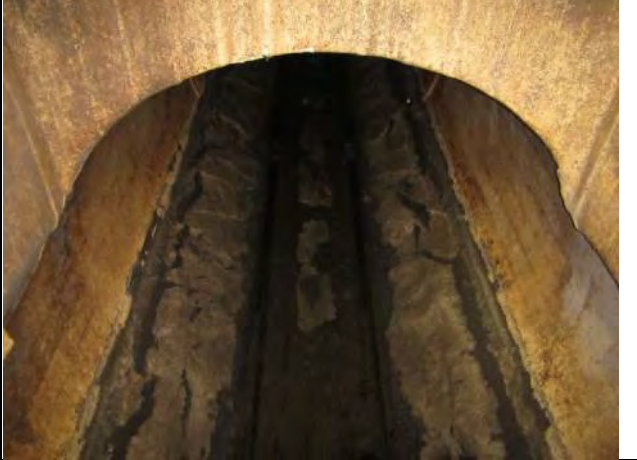
<p>I</p>	<p>Influent pipe had minor liner blisters.</p>

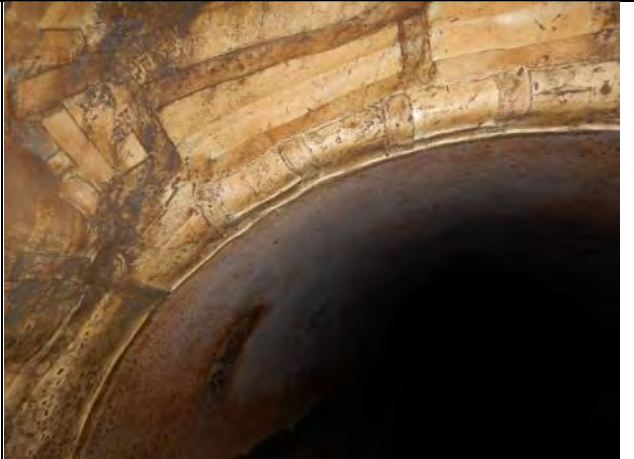
<p>E</p>	<p>Effluent pipe liner was in good condition (no blisters). Liner termination was attached and not undermined. Slime layer appeared to be up to the typical waterline.</p>

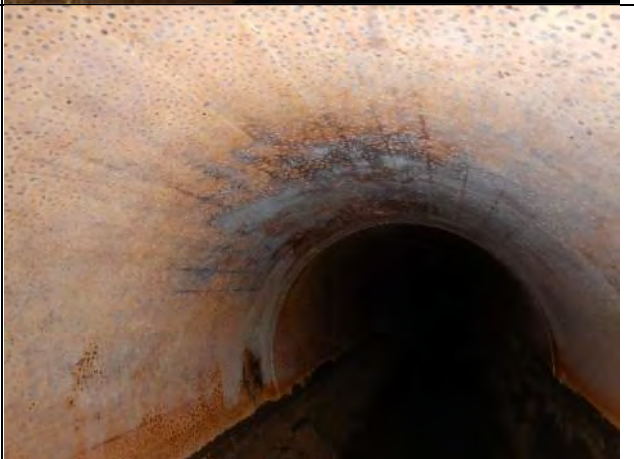
<p>F</p>	<p>Lateral with gas flap. Liner termination at pipe connection was in good condition. Flap appeared to be attached and operable.</p>

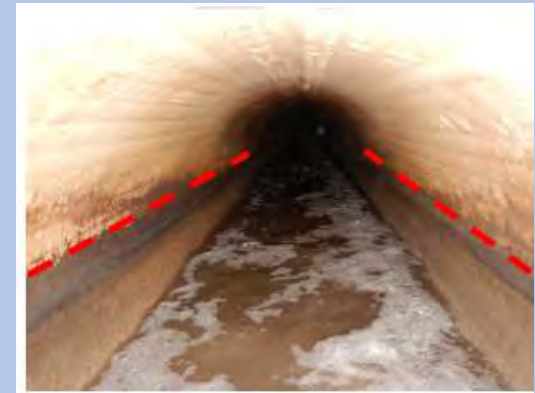
Photo 3-5. Typical water level indicated by slime layer (red dashed line).
