SANTA ANA WATERSHED PROJECT AUTHORITY
11615 Sterling Avenue, Riverside, California 92503 • (951) 354-4220

REGULAR MEETING OF THE PROJECT AGREEMENT 24 COMMITTEE TUESDAY, APRIL 1, 2025 – 10:00 A.M. (or immediately following the 9:30 a.m. SAWPA Commission meeting)

- B. **INLAND EMPIRE BRINE LINE REACH IV-D CONDITION ASSESSMENT FINAL REPORT (PA24#2025.10)**53

Inland Empire Brine Line Reach IV-D Condition Assessment Report

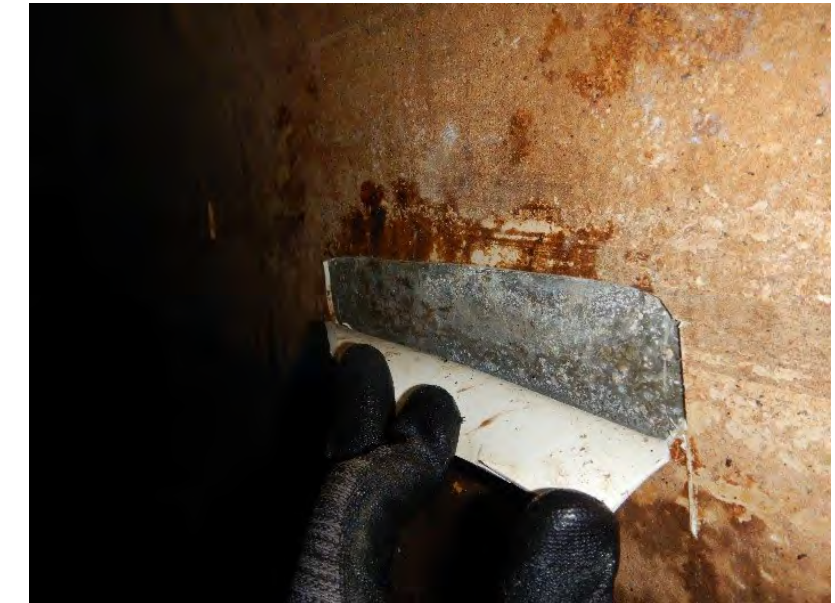
Figure 1: Behind the liner testing

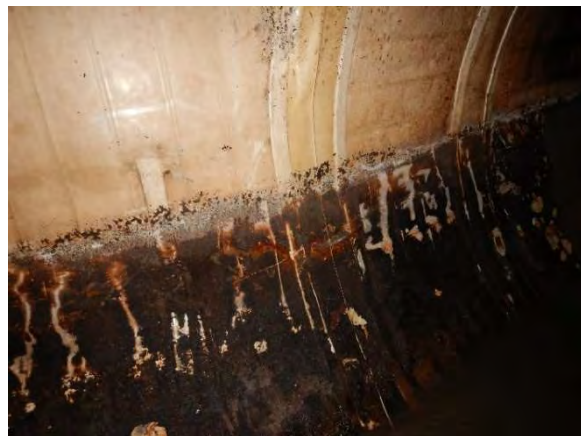
Photo 3-6. Typical slime layer.

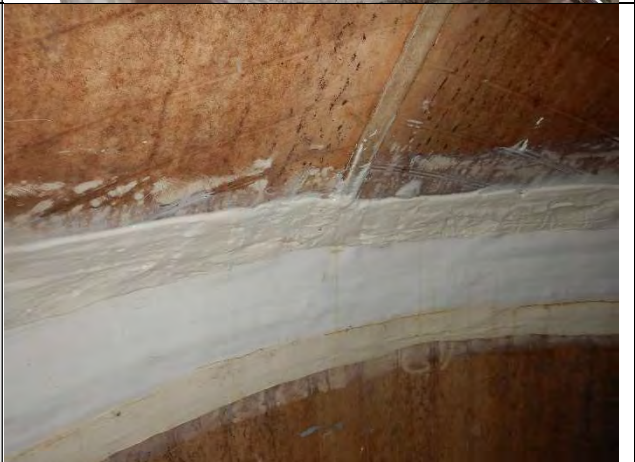
<p>C</p>	<p>Exposed epoxy anchor beneath steel cover plate.</p>

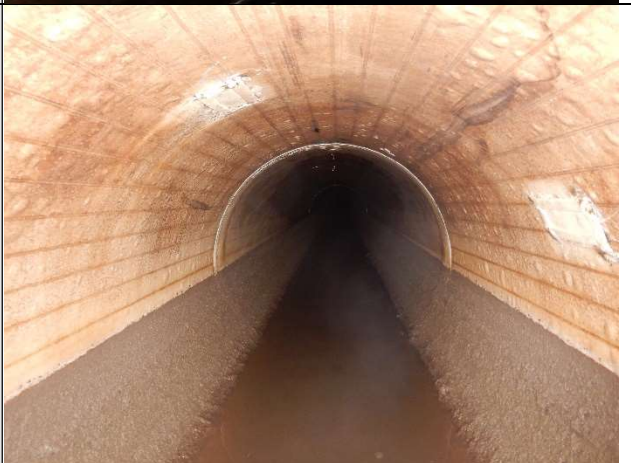
<p>F</p>	<p>Influent pipe. Minor blisters between 1 to 2-in in diameter (typical).</p>

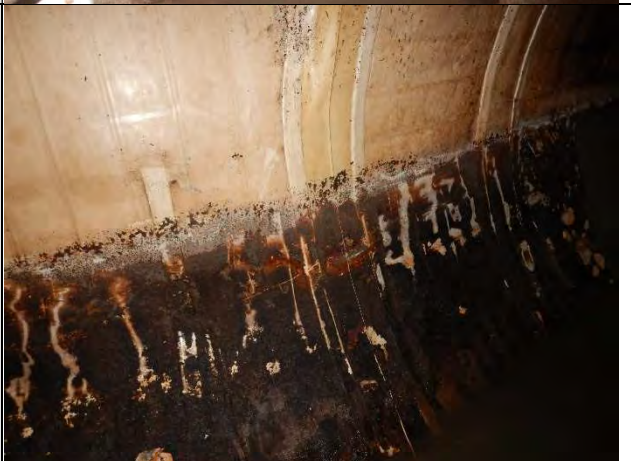
<p>I</p>	<p>Effluent Pipe. Heavy staining on liner beneath the sludge layer.</p>

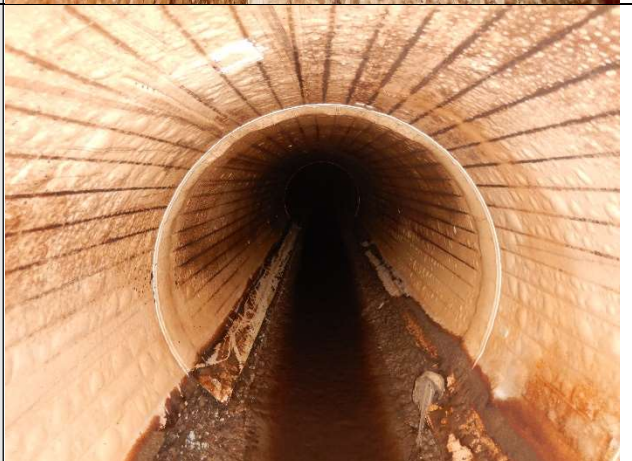
<p>F</p>	<p>Large blisters up to 2-in on influent pipe walls, typical throughout.</p>

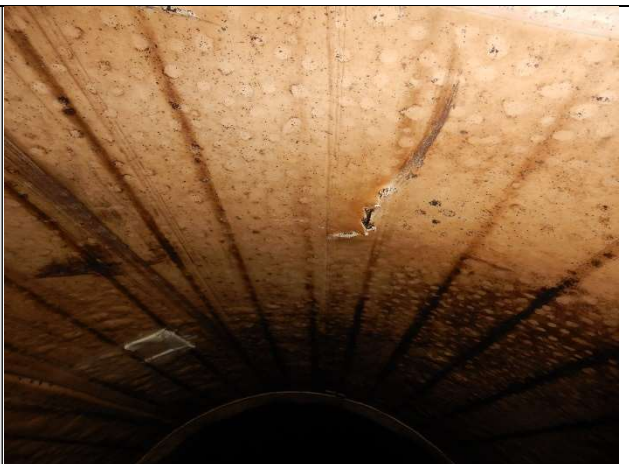
<p>H</p>	<p>Multiple tears up to 4-in near first joint upstream of the MAS.</p>

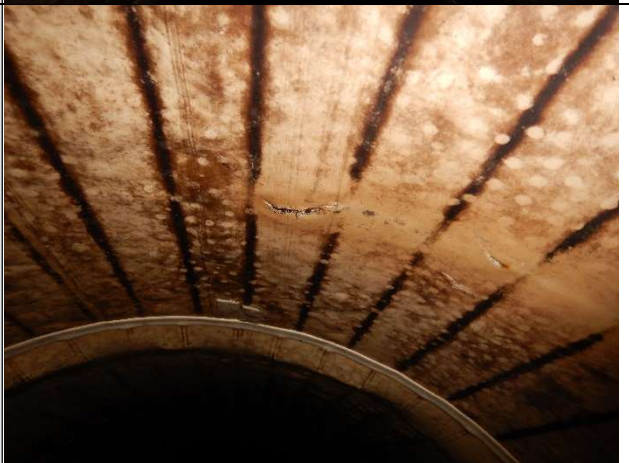
<p>I</p>	<p>Effluent piping, facing south. Large blisters up to 1.5-in typical throughout. Steep slope.</p>

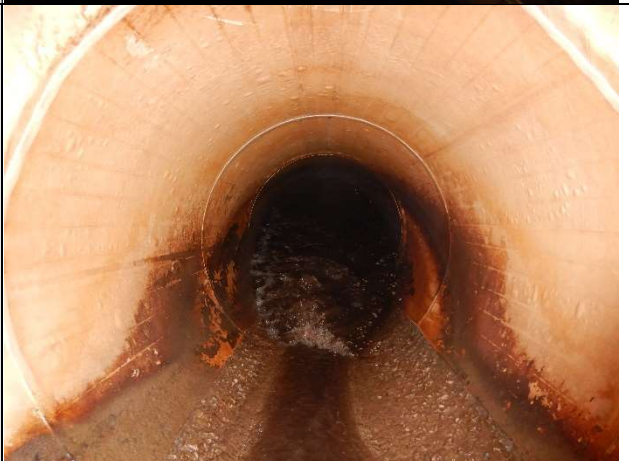
Table A-5. Pipe Liner Termination Testing Results – MAS 4D-0060

Location	Liner Condition	Concrete Deterioration Depth (in.)	VANDA Concrete Rating
Influent Pipe	Uplifted and undermined.	1 - 1 ½	3
Effluent Pipe	Uplifted and undermined.	1/4 - 1/2	2

1. Maintaining the flow inside the pipe so that the lower termination edge is continuously immersed and not exposed to the headspace in the pipe.
2. Repair and line the exposed concrete invert to extend the useful life of the pipeline. Lining considerations are discussed in Section 4.4.
3. Perform minor liner spot repairs to seal holes and repair weld strips. Lining considerations are discussed in Section 4.4.

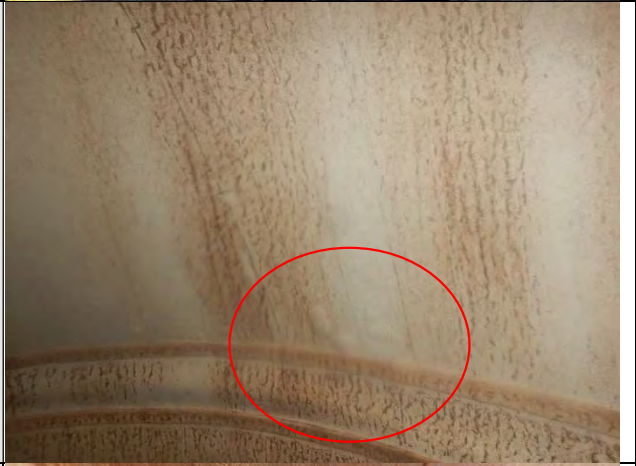
<p>C Liner in chimney and cone sections in great overall condition.</p>

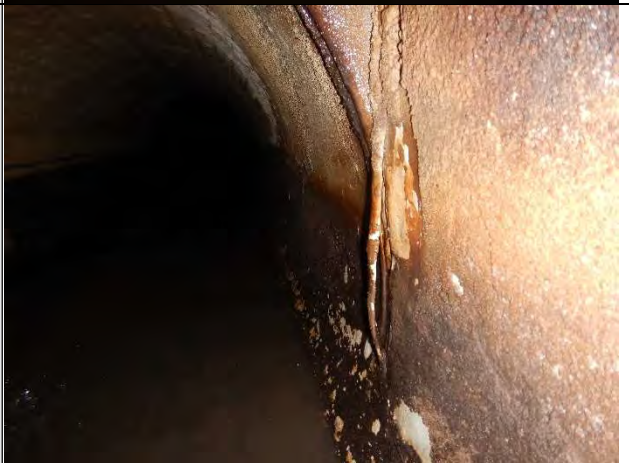
<p>F</p>	<p>Heavy mineral deposits were observed in the 30-in VCP drop-inlet pipe.</p>

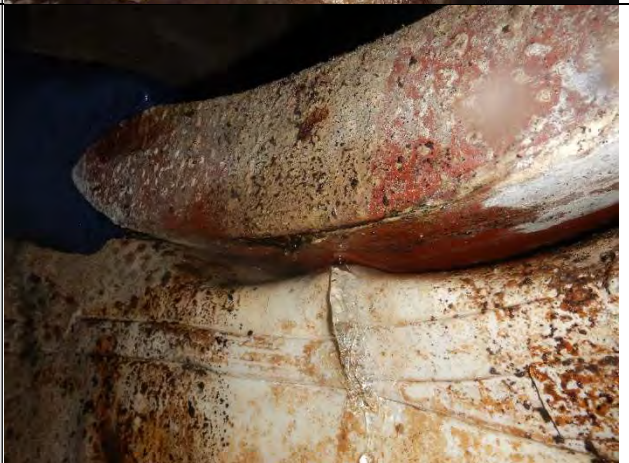
<p>I</p>	<p>Infiltration shown entering the MAS from behind liner joint, approximately 8-ft-1-in from the invert.</p>

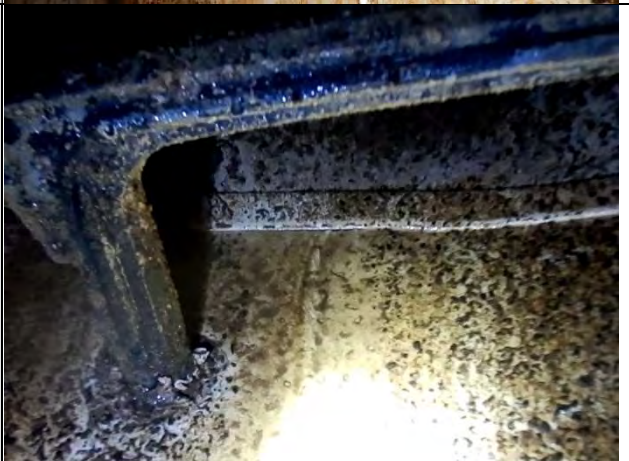
<p>J</p>	<p>Liner termination at pipe connections are in good condition (typical). Infiltration shown running down the MAS structure on the north wall.</p>

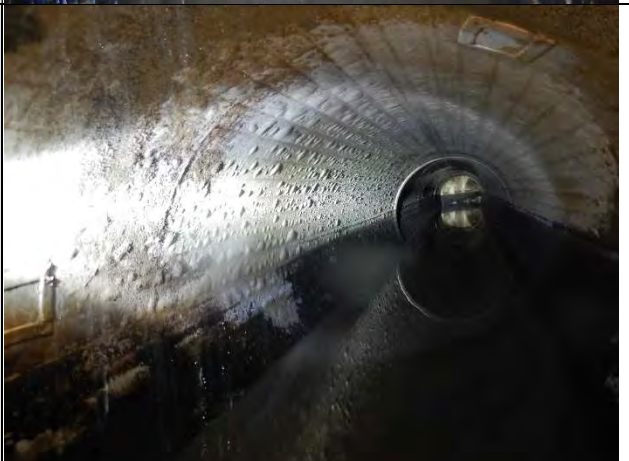
M	<p>Effluent Pipe, facing south. Sludge layer up to the springline. Liner termination is underwater. Blisters up to 3-in (typically 2-in) in diameter were observed on the west side of the pipe. Blisters appear to be intact and the concrete was not exposed.</p>

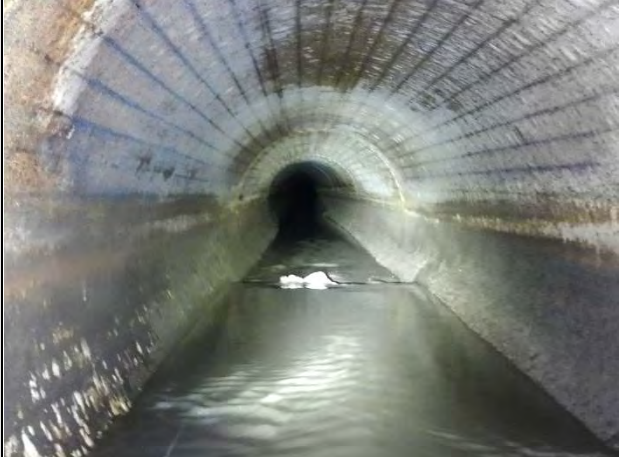
N	<p>Drop in elevation in the effluent pipe, approximately 50-ft downstream of the MAS.</p>

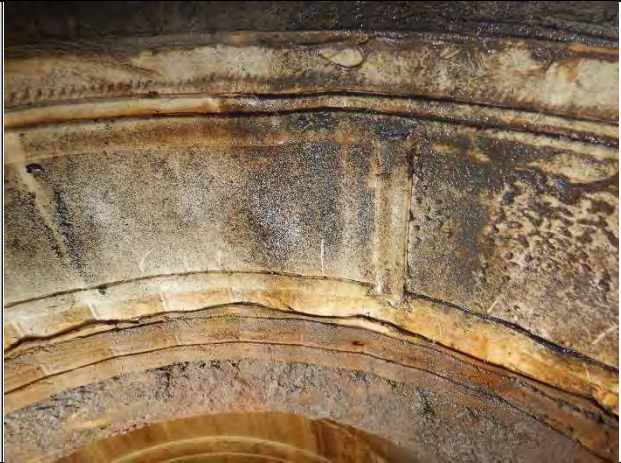
Observations:	
A	<p>The interior of the access framing and chimney is in good condition, and no defects have been noted.</p>

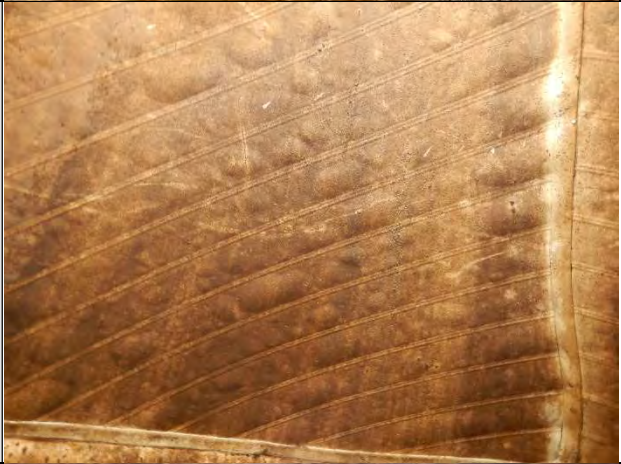
B	<p>Excessive blistering on the cone.</p>

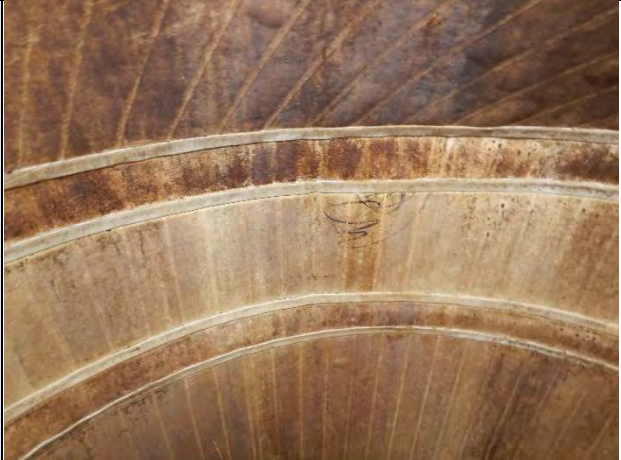
C	<p>All the weld strips in the barrel, cone, and chimney are in good condition.</p>

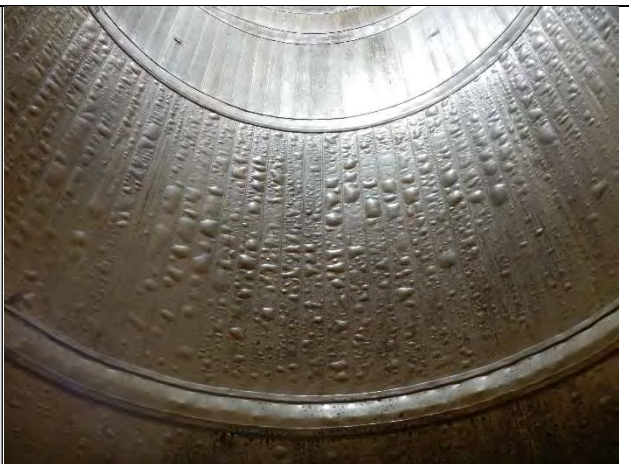
<p>D</p>	<p>Excessive blistering on the third barrel.</p>

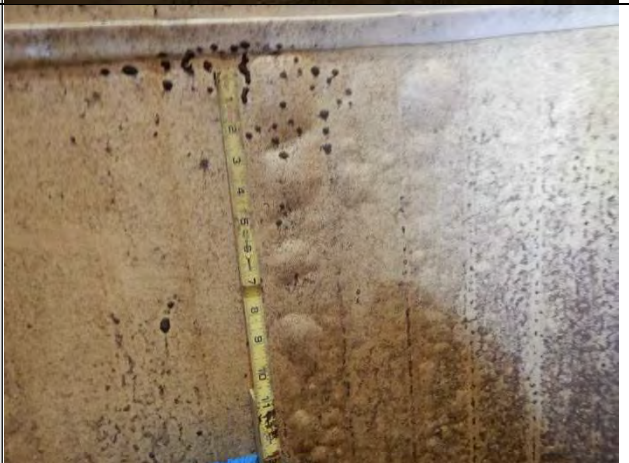
<p>E</p>	<p>Excessive blistering on the first barrel.</p>

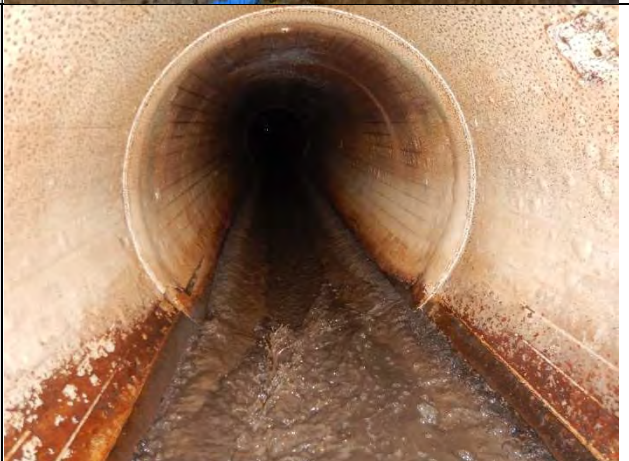
<p>F</p>	<p>Influent pipe. Liner stained behind sludge layer (typical).</p>

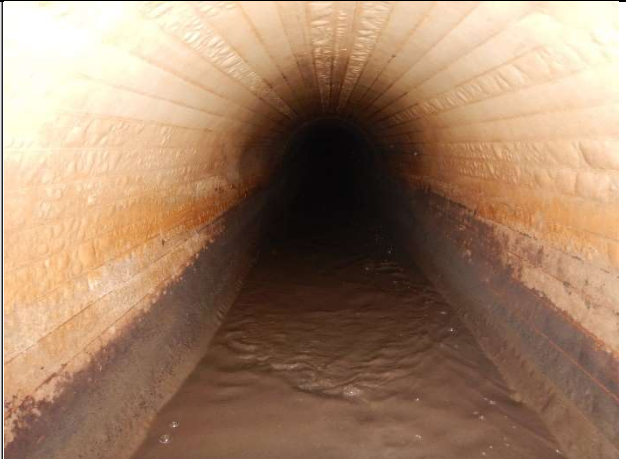
<p>G</p>	<p>Effluent pipe. Blisters between 1 to 3-in in diameter (typical).</p>

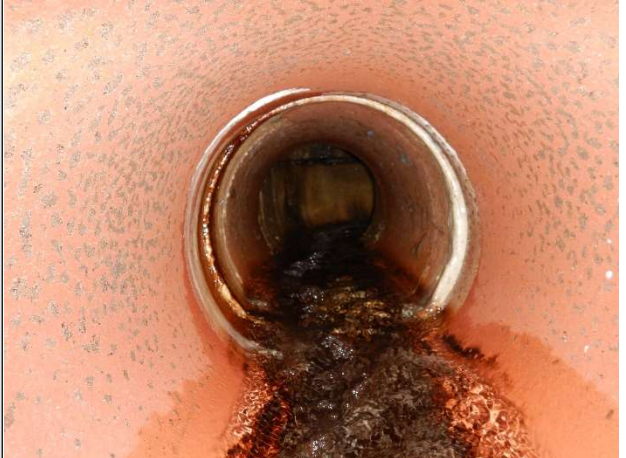
<p>H</p>	<p>The north lateral line welds are in good condition.</p>

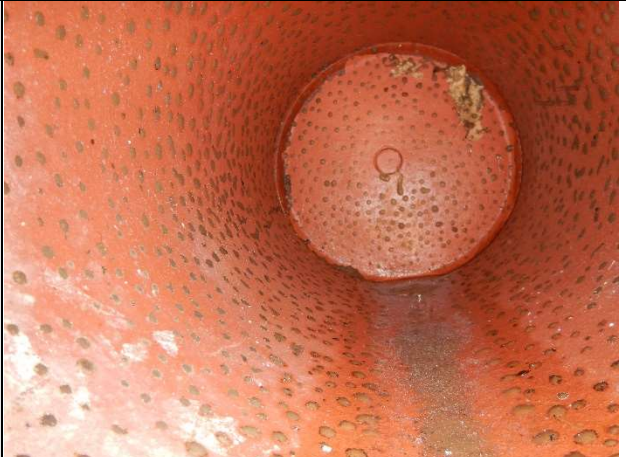
<p>I</p>	<p>The south lateral is sealed.</p>

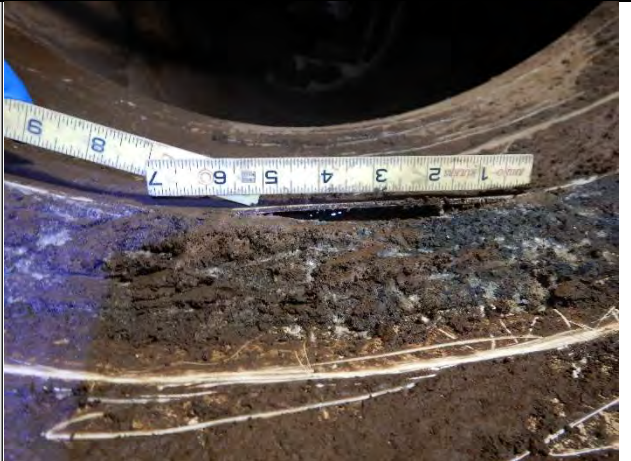
Observations:		
A	Interior of the chimney. A 6-in cut.

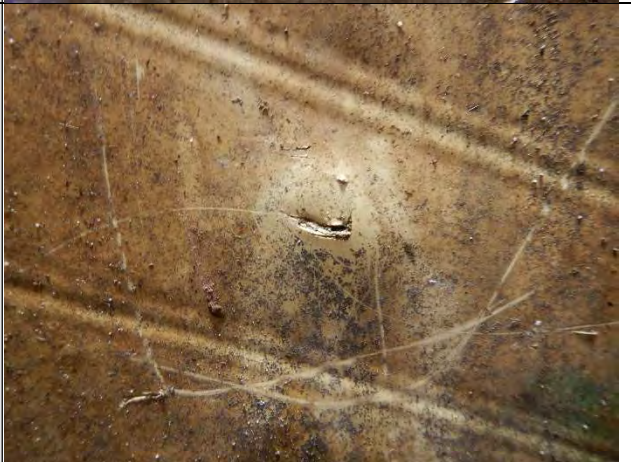
<p>A photograph showing the interior of a chimney. A yellow ruler is placed horizontally across the top of the chimney, indicating a 6-inch cut. The interior surface is dark and appears to be made of brick or concrete, with some debris and a thin layer of material on the floor.</p>
B	A 1/2-in puncture in the cone.

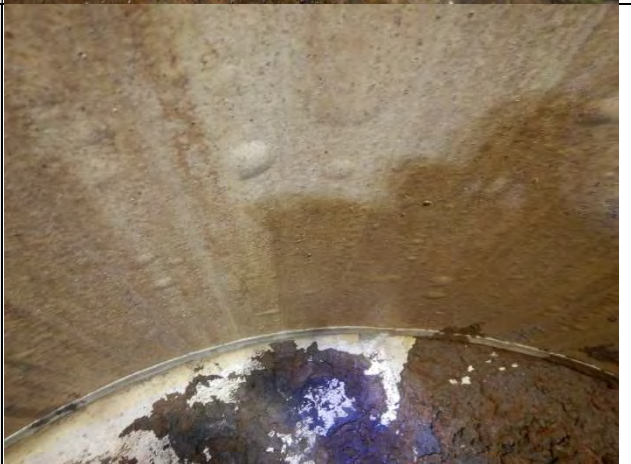
<p>A close-up photograph of a concrete surface. A small, dark, irregular puncture is visible in the center of the frame. The surrounding concrete is light brown and shows some texture and minor discoloration.</p>
C	The first barrel walls have 15 to 20 blisters, up to 3-in in diameter blister.

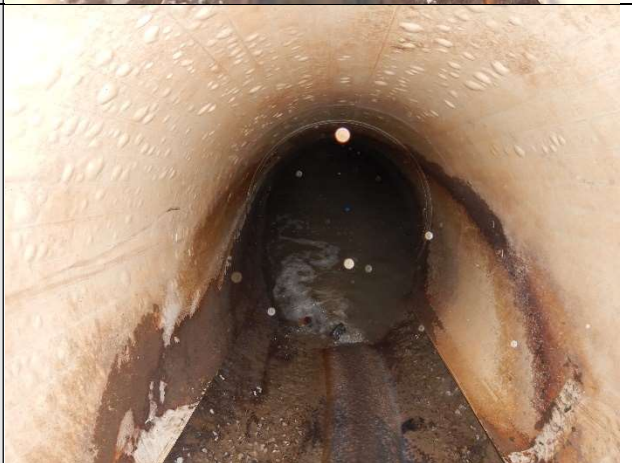
<p>E</p>	<p>The effluent pipe liner has blisters up to 4 inches.</p>

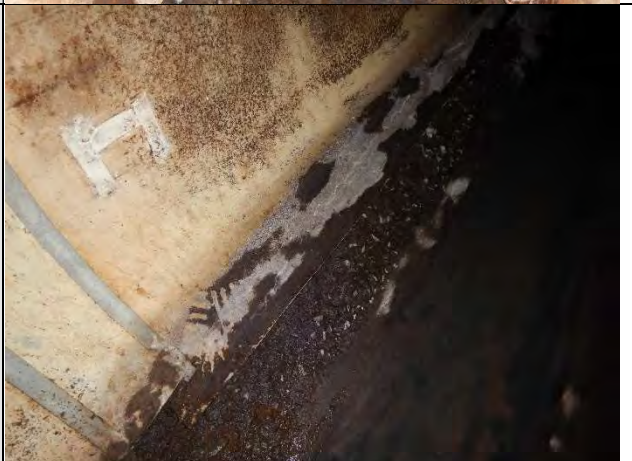
<p>F</p>	<p>The influent pipe has exposed aggregate up to 1-in of wall loss.</p>

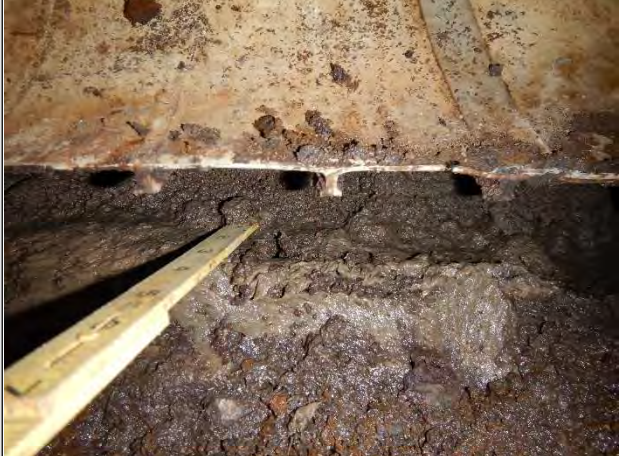
<p>G</p>	<p>The effluent pipe has up to 1-in of wall loss.</p>

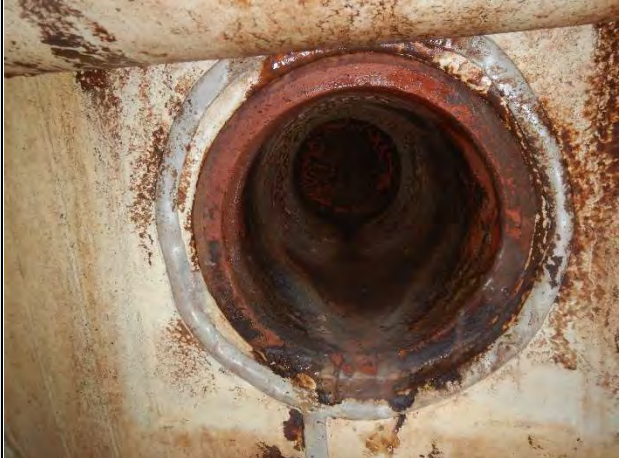
<p>H</p>	<p>The lining at the sealed lateral penetration was in good overall condition.</p>

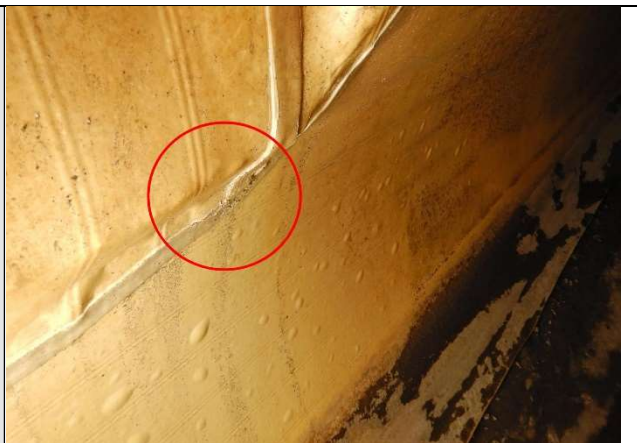
<p>K</p>	<p>Influent pipe had minor bulges in liner. Bulges are benign and pose no risk to lining at this time.</p>

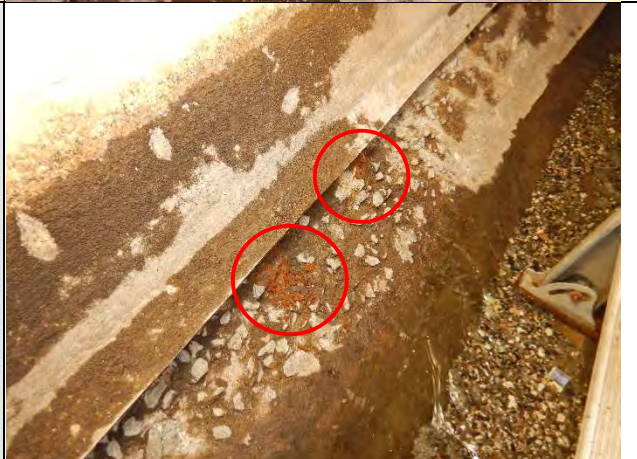
<p>L</p>	<p>Corrosion staining evidence of embedded reinforcement corrosion. Exposed aggregate at unlined concrete channel.</p>

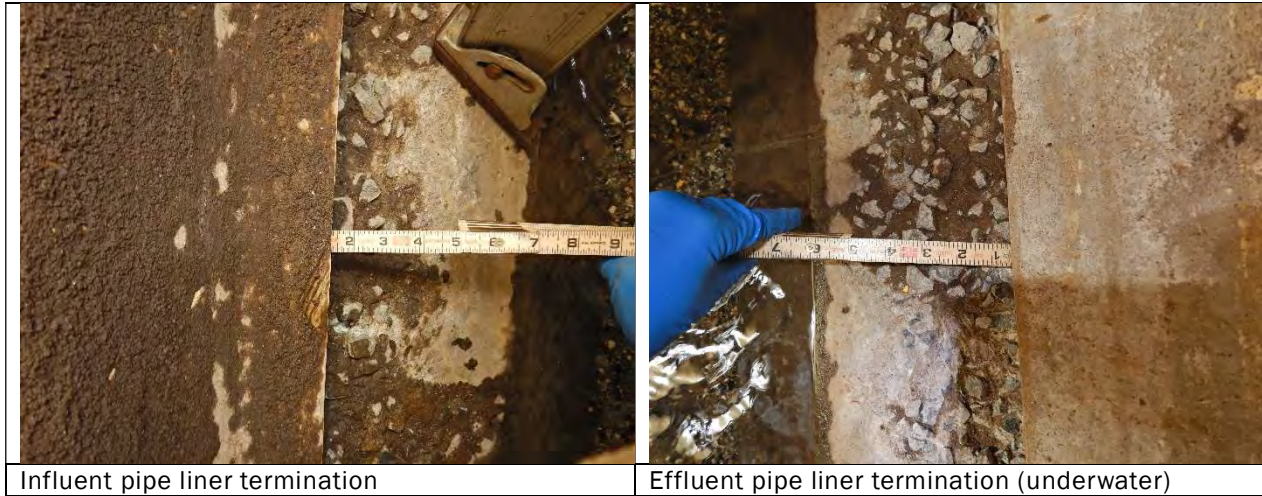
Influent pipe liner termination

Location	Liner Condition	Concrete Deterioration Depth (in.)	VANEA Concrete Rating
Influent Pipe	Uplifted and undermined	1-5/16	3-4
Effluent Pipe	Embedded and not undermined.	1/2	3

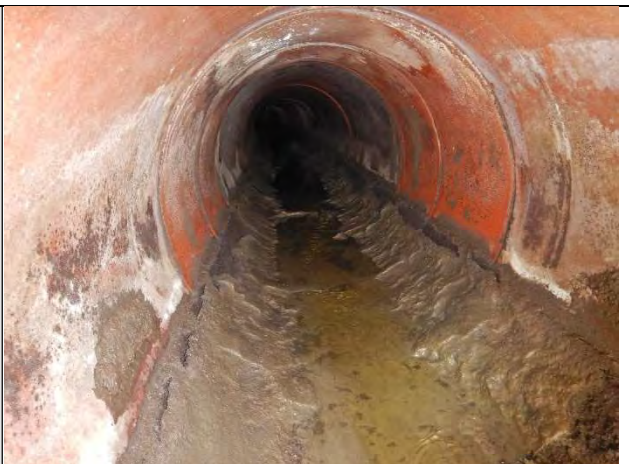
<p>H</p>	<p>Liner at influent pipe termination in good condition.</p>

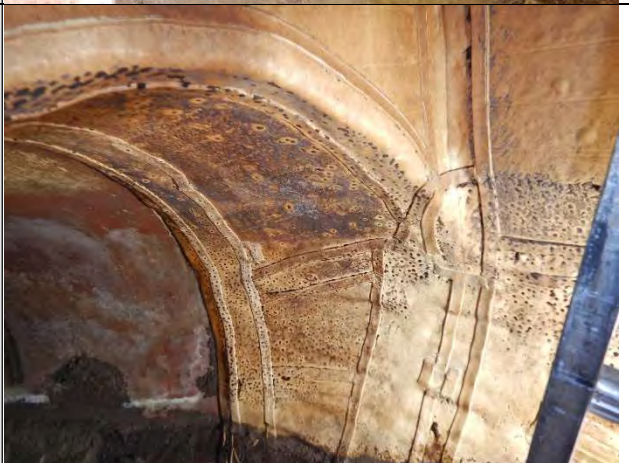
<p>I</p>	<p>Channel liner in good condition. Minimum separation from pipe bottom.</p>
